YARD NO. 590

MS VIKING SALLY

The German Group of Experts investigating the sinking of M/V "ESTONIA"

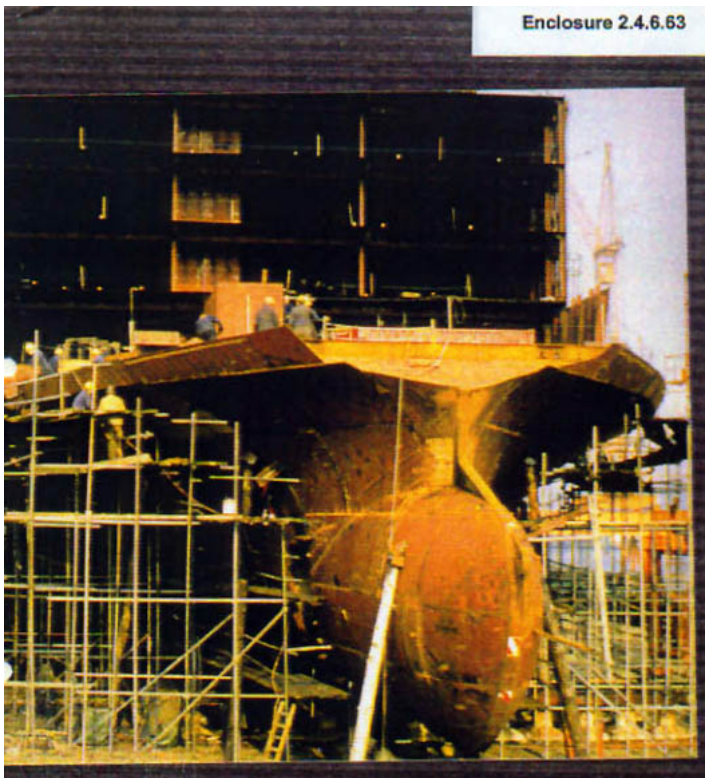
Photos showing fore ship area

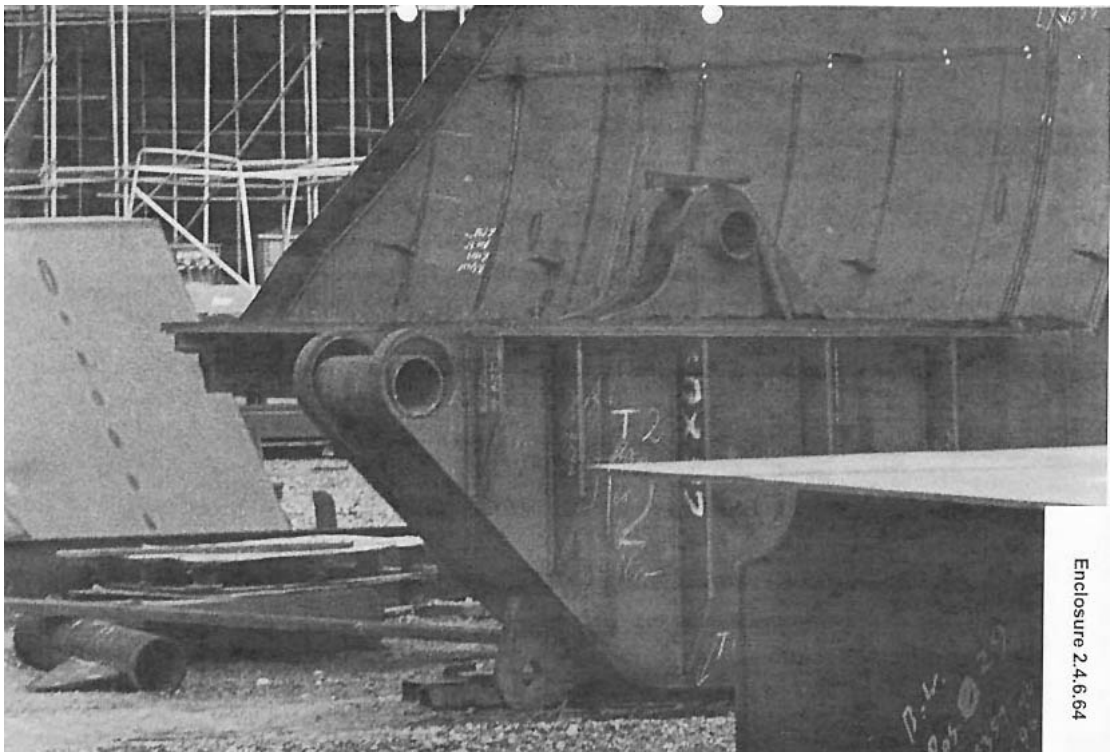
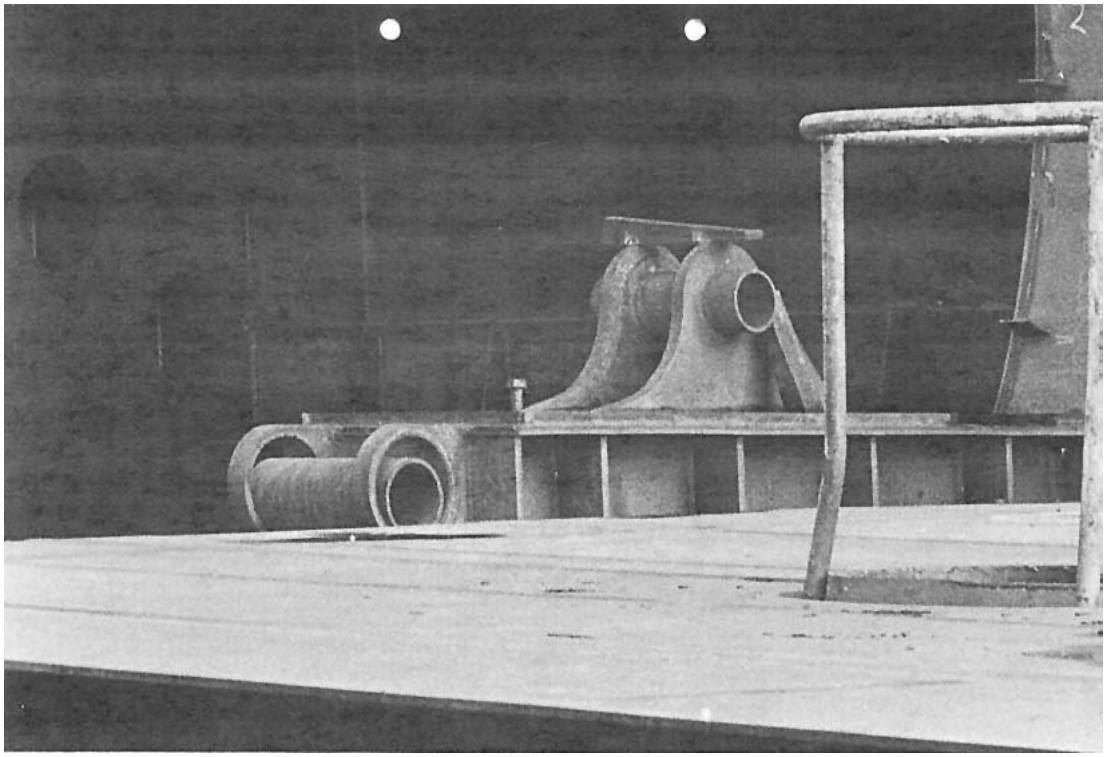
Detail photo of the starboard visor hinge plate

Upon being shown some underwater pictures from the damaged hinge remains I am of the opinion that the rust on the Nirosta bolt could have been caused by the disappearance of the bronze bushing, i.e. steel bushing in contact with Nirosta bolt. Also in case of bad greasing a bronze bushing will disappear more quickly.

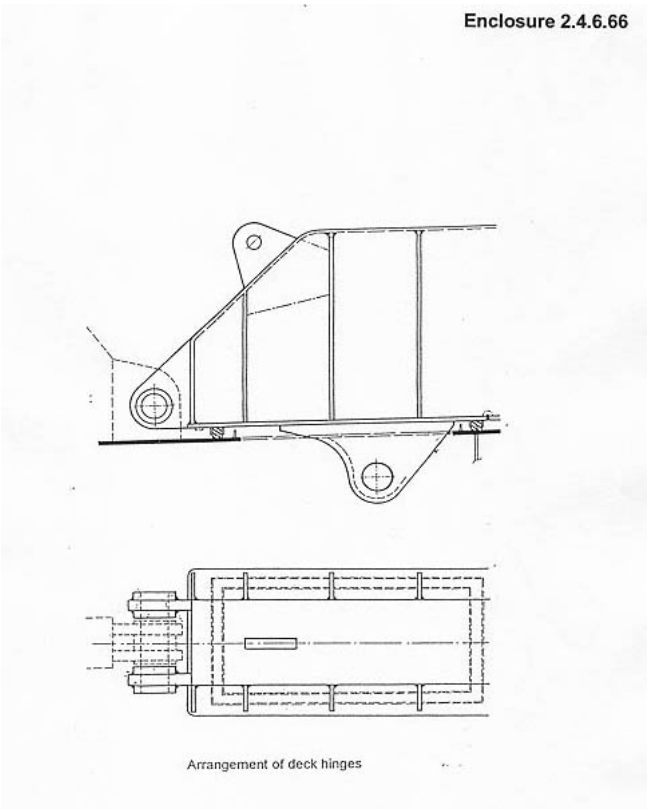
Drawing arrangement if the visor hinges

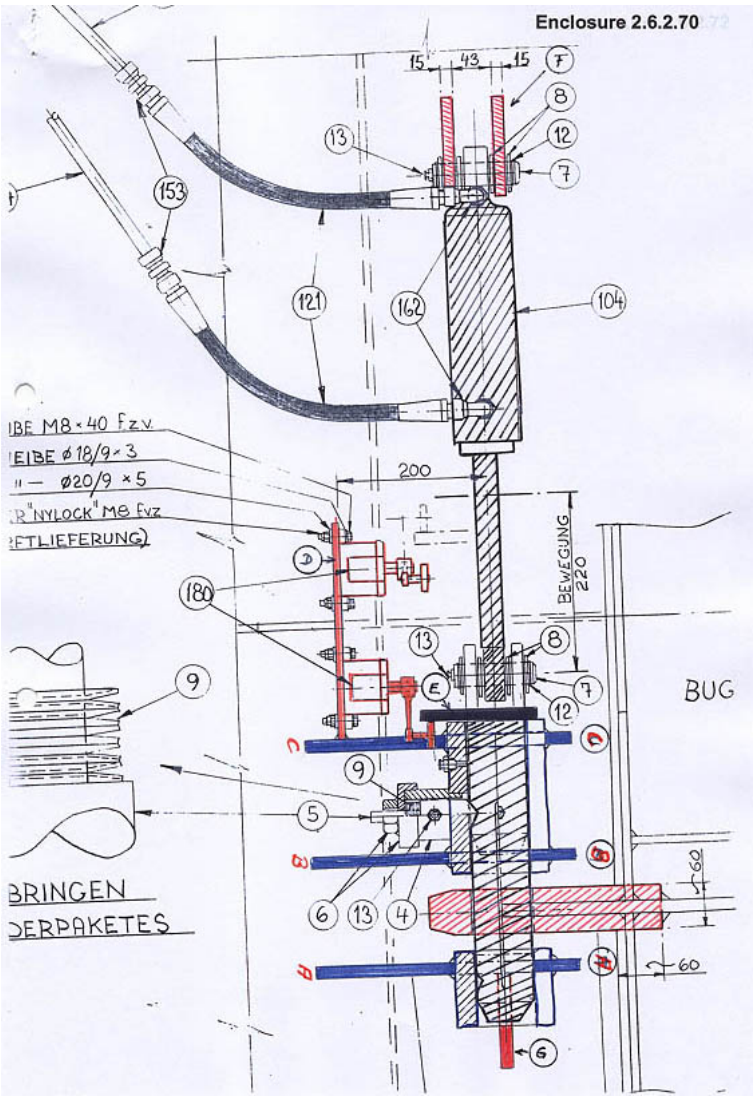
Drawing atlantic lock

9. In summary it has to be concluded that in case it can be proved that L. is right the 3 lugs at vessel's side are not original which would explain the good looking but too thin welds at centre and port lugs, whilst the starboard lug had subsequently been repair welded. It would also explain the longer support bracket at the starboard lug when comparing it with the drawing.

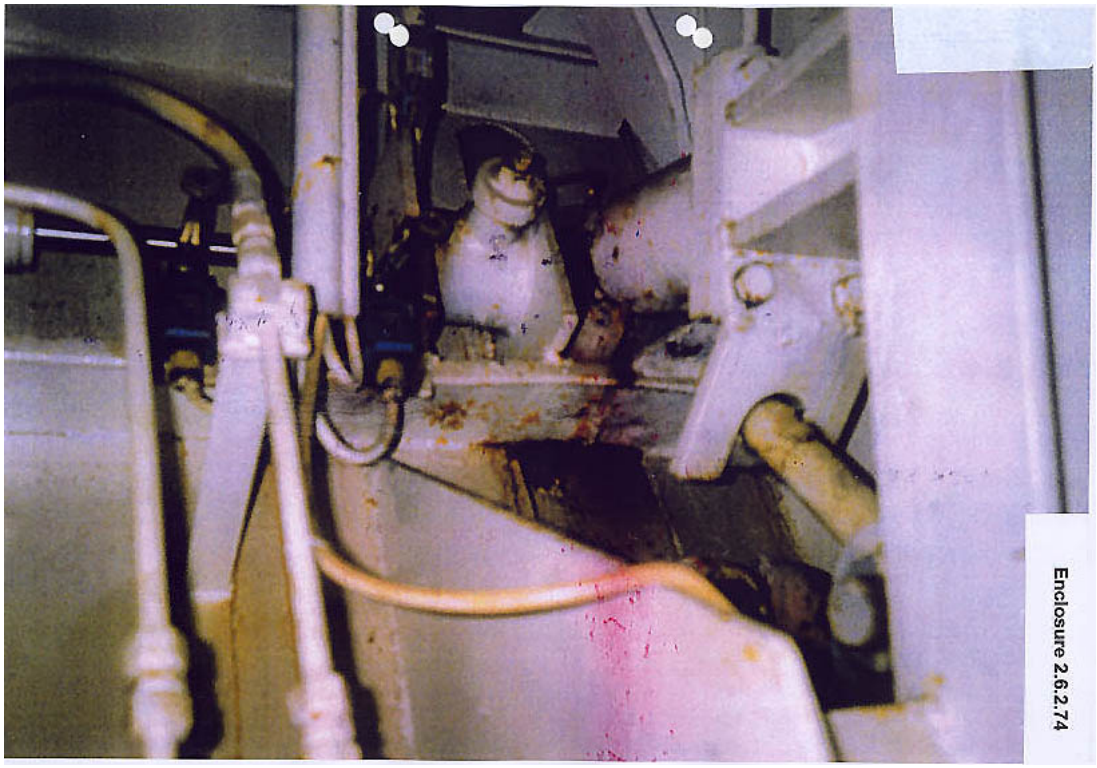
Photo showing hydraulic an manual side locks

- the sidelocks, the Atlantic lock, and also explained that they had never engaged the manual sidelocks.
   - At some time in 1982 they realized that the visor was no more closing properly because it was in a misaligned condition athwortships, he believes that the starboard corner was standing a bit up. It was for this reason that the Atlantic lock bolt could no more move through the visor lug. The matter was discussed with the engine people and it was considered what could be done. Engine repairman Koivisto considered himself to be the visor expert and offered to rectify the Atlantic lock to the effect that the bolt would fit again. L. believes that Koivisto was even called back from vacation to do the modification.

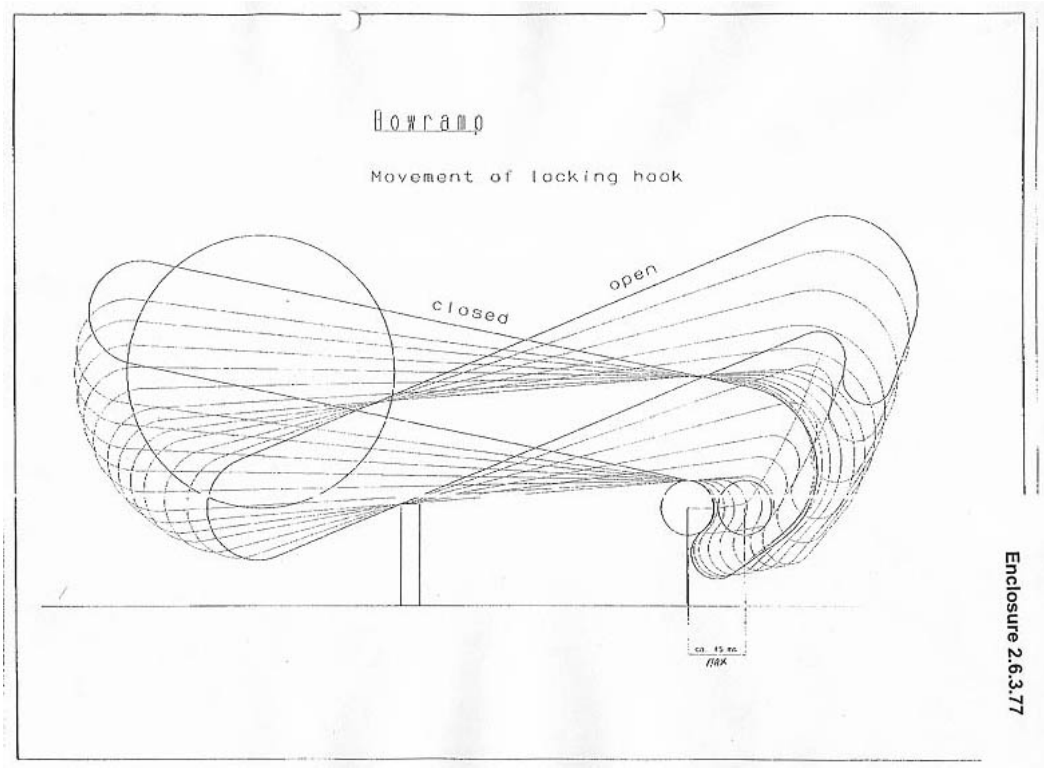
Drawing showing moving range of locking hook

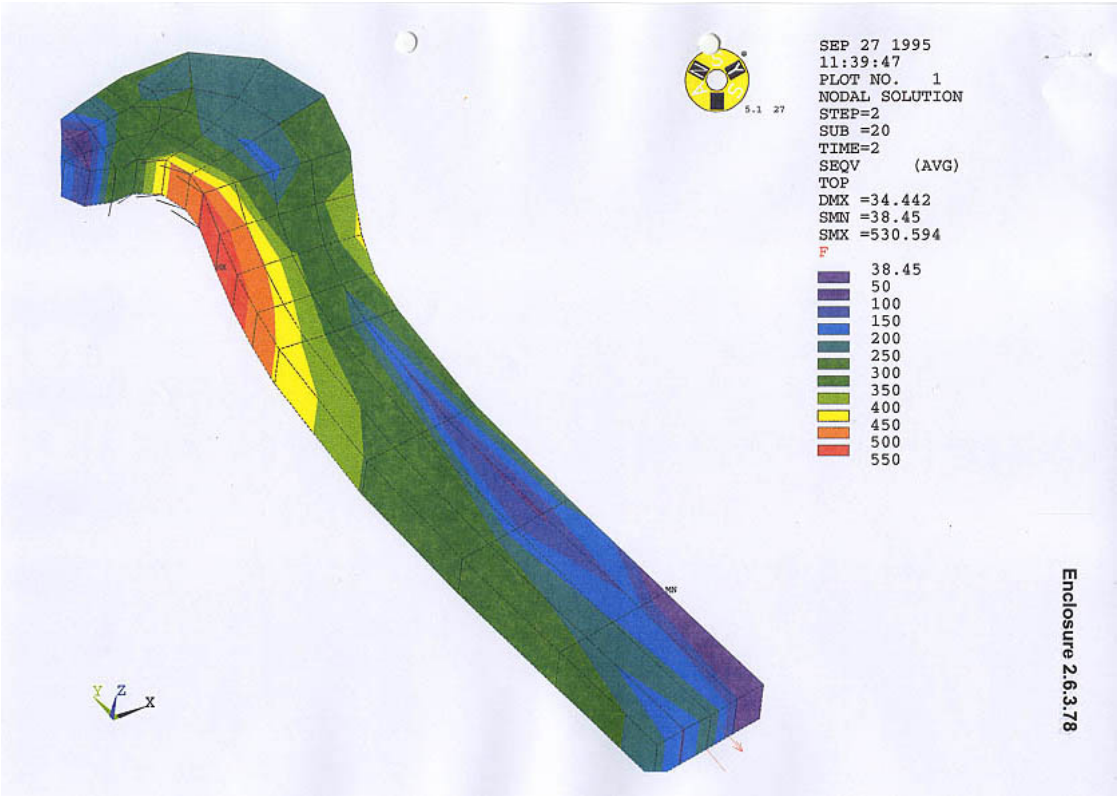
Load distribution on bow ramp hooks 2
