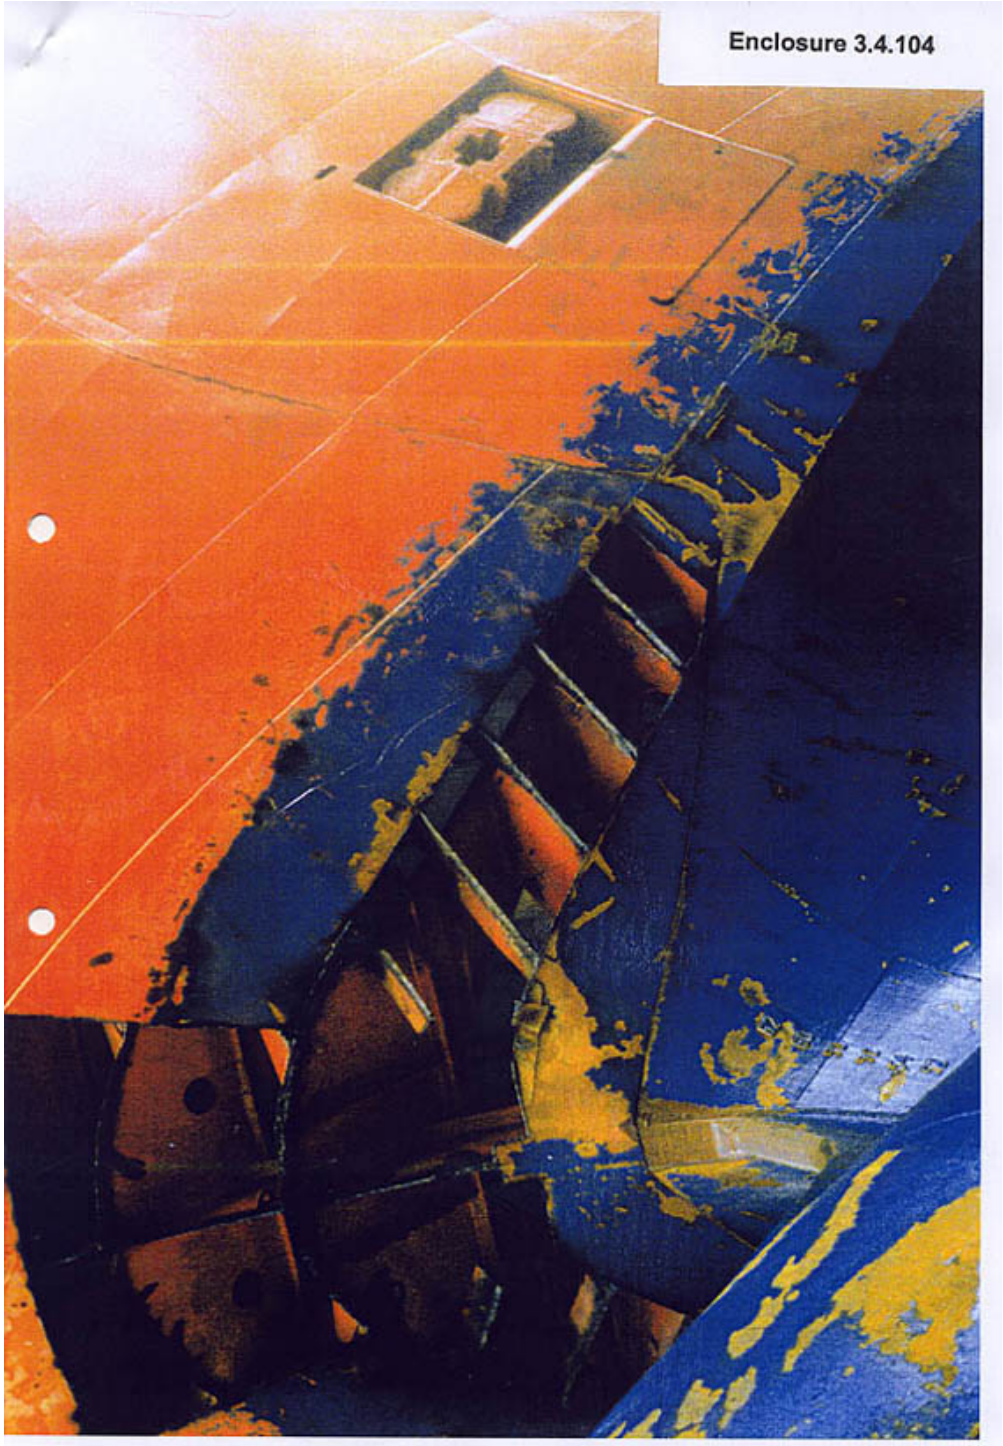
Heavy ice damage to shell plating in way of strakes A, B, and C from bow thruster to the fore ends of the bilge keels between frames 10-120 up to 20 mm deep.

Photo showing damaged visor plating

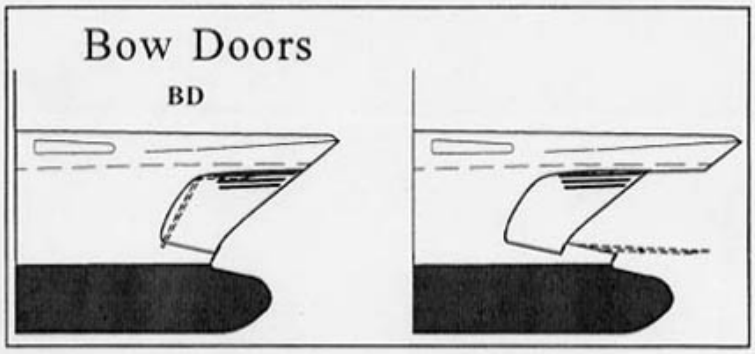
- **Bow doors** are normally hinged on heavy arms. The doors are opened by hydraulic cylinders moving the doors outside along the ship's sides. There are also some old designs where the doors are swinging. In closed position, pressure forces acting on the doors are transferred to the ship's hull via reinforced supports. Though the framework along the contours of the doors absorb some forces, the primary function is to keep the sea away from the space between the ramp and the doors. The primary function of locking devices is to prevent the doors from falling out from the ship.

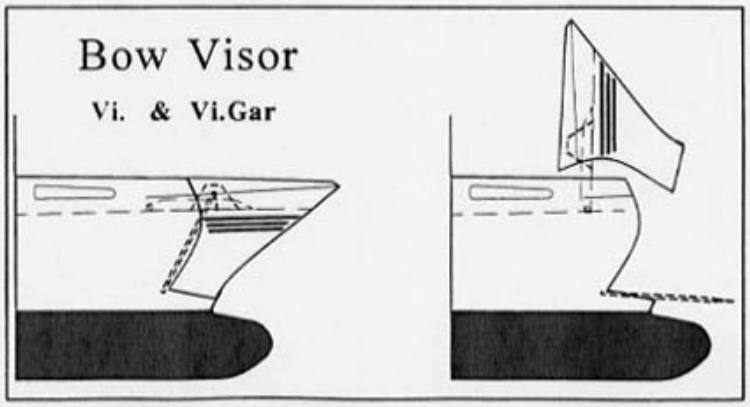
- **A bow visor** forms the bow on a ship. The visor is normally hinged on the forecastle deck and is opened upwards by hydraulic cylinders. The visor's supporting structures in the hull doesn't prevent the visor from opening. Only the locking devices have that function. The space between the visor and the ramp is sealed to the sea along the visors contouring frame. Depending on the geometry of that frame and the elasticity of the visor the frame may absorb some of the forces acting on the visor.

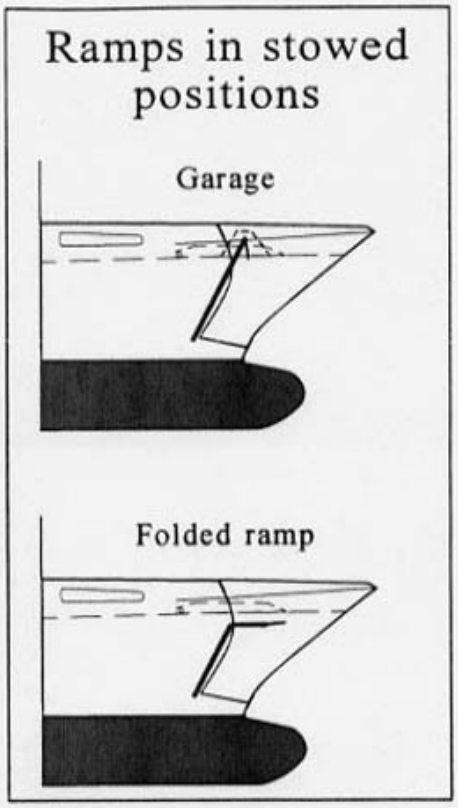
The other solution was to make the uppermost part of the ramp foldable forward under the mooring deck. The shapening of the bow limited the length of the folded part. This was also in practice an "integration" of the visor and the ramp. Thus if the visor for some reason was moved outside its normal track it could effect the folded part of the ramp.

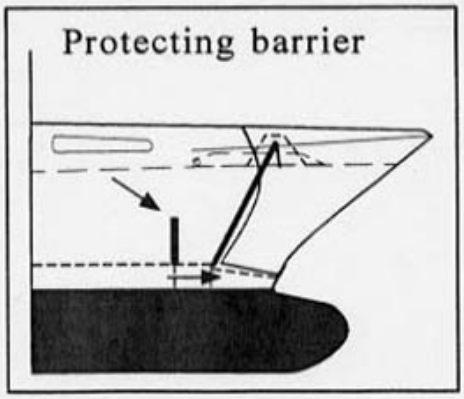
There was also a solution aiming to reduce the required length of the ramp. The pivoting point of the ramp was simply forward and thus could the ramp be made shorter. Often this was not sufficient so this was often combined with the above described arrangements. When the ramp was moved forward the ramp couldn't in general fulfill the requirements as an extension of the forward collision bulkhead as specified in SOLAS. That had to be compensated. To arrange a 2,3 m high extra barrier behind the ramp was then considered as an equivalent solution to the rules in SOLAS.

M/S Estonia had a garage built on the visor to accommodate the upper part of the ramp. The ramp was moved forward and therefore did not fulfill the rules as an extension of the collision bulkhead. The arrangement could have complied with the rules of SOLAS if an additional barrier had been arranged.

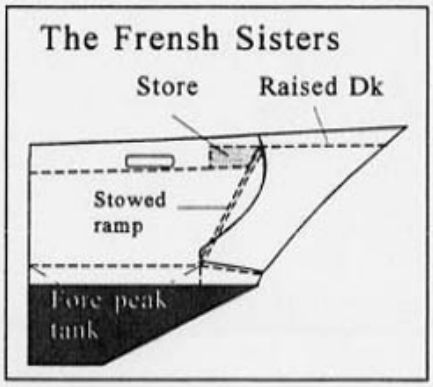
The "French Sisters" Svea Corona, Wellamo and Bore Star had an interesting solution. Instead of the garage a store was arranged on the fore castle deck. The ramp was stowed towards the forward bulkhead of that store. The foremost part of the forecastle deck belonging to the visor was then raised to the same level as the roof of that store. Thus the ramp and the visor was no longer an integrated design.

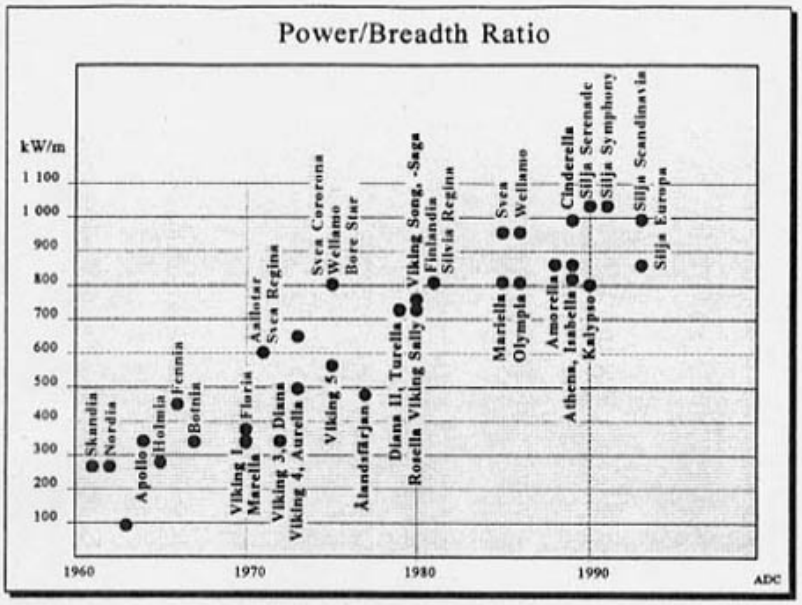
Consequently most Owners in the West also learnt that the engine power of "modern" ships could endanger the ship if the power resource was not handled gently. The diagram below shows the ratio of ship power to breadth over the years, in this traffic. The ratio just mirrors the potential a ship has to maintain speed through rough sea. Since also other factors are influencing on the ships performance in rough sea the plotting in the diagrams shall just be regarded as indications.

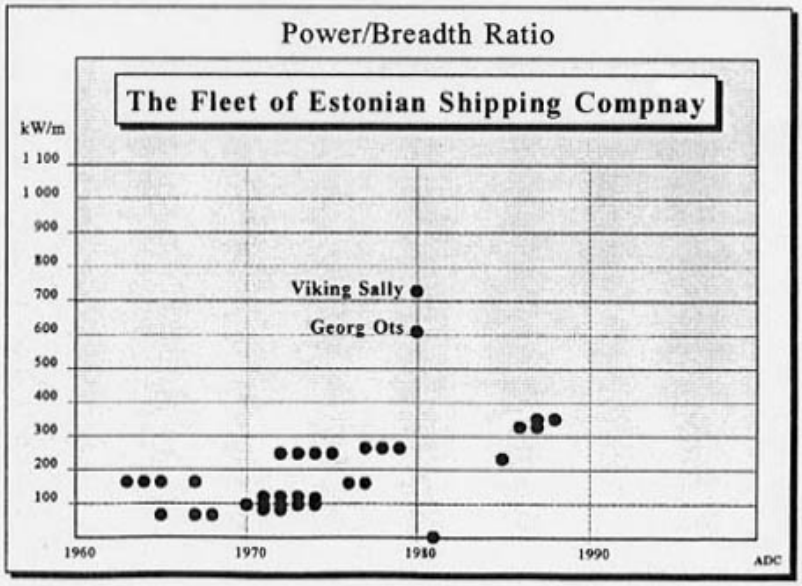
The crew of M/S Estonia (M/S Viking Sally) was recruited from Estonian Shipping Company (ESCO). The diagram shows the corresponding power/breadth ratio of the ESCO fleet in early 1993.

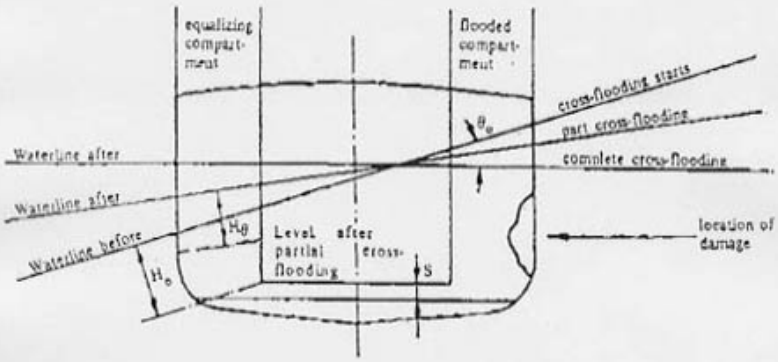
FIGURE 1

Time required from commencement of cross-flooding to $\theta°$ heel (or the angle of the margin line immersion)
