Enclosure 3.4.101

ANTECKNINGAR: Brott: Utredning av sjöolycka  
Anmäljan nr: 7020/S/10964/94

Docking and repair work of M/S Estonia  
 as per the enclosed specification

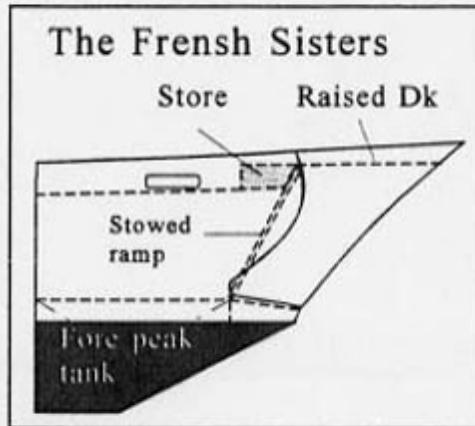
M/S Estonia had a garage built on the visor to accommodate the upper part of the ramp. The ramp was moved forward and therefore did not fulfill the rules as an extension of the collision bulkhead. The arrangement could have complied with the rules of SOLAS if an additional barrier had been arranged.

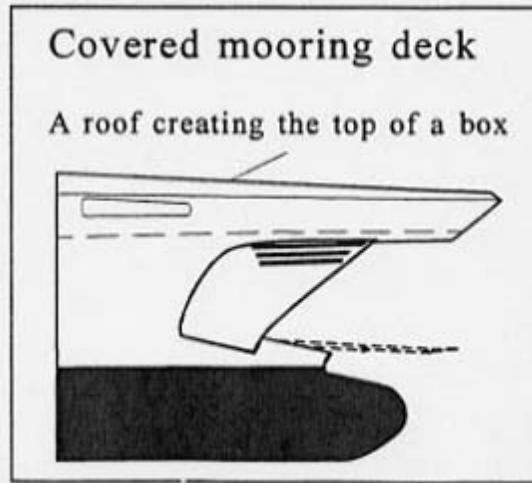
Most bigger relatively new Passenger/ RoRo cargo/ Ferries have bow doors. In some cases the impact forces from sea have been underestimated and the supporting structures have not been strong enough. Consequently when such doors have been overloaded the construction has jammed making the doors difficult to open. This is an example of how a failure didn't result in an unsafe situation.

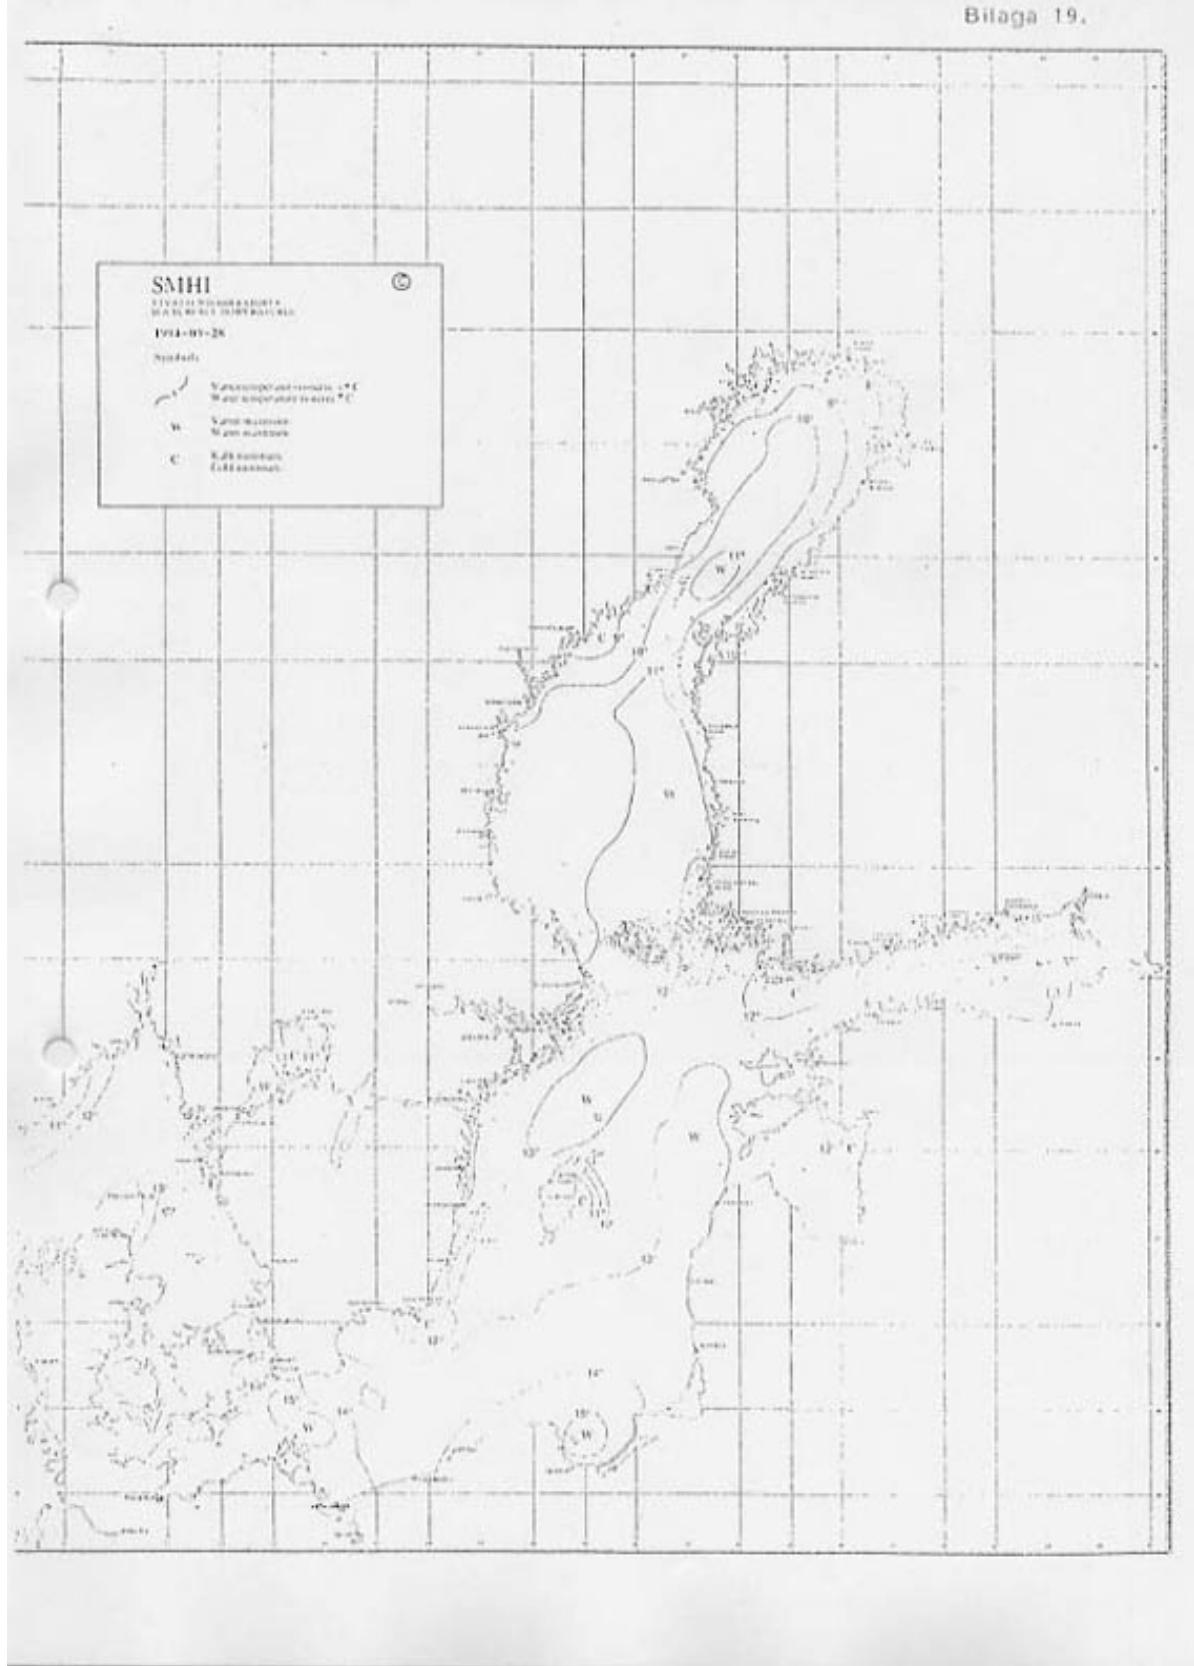
### Teoretisk uppskattning av vågorna vid Estonias förlisningsplats

På den position där Estonia förliste 59° 23,9', 21° 42,4' är djupet enligt sjökort betydligt större än det djup som skulle kunna medföra förändringar av djupvattenåghöjderna. Vågorna skulle teoretiskt vara omkring 4 m höga med enstaka vågor på över 8 m höjd d.v.s samma våghöjder som man får räkna med att möta över hela N Östersjön vid sydlig vind på 15 - 20 m/s.
