Newbuilding contract "diana II"

Part of GA plan dated 05.09.79

Newbuilding contract viking sally 11.09.79

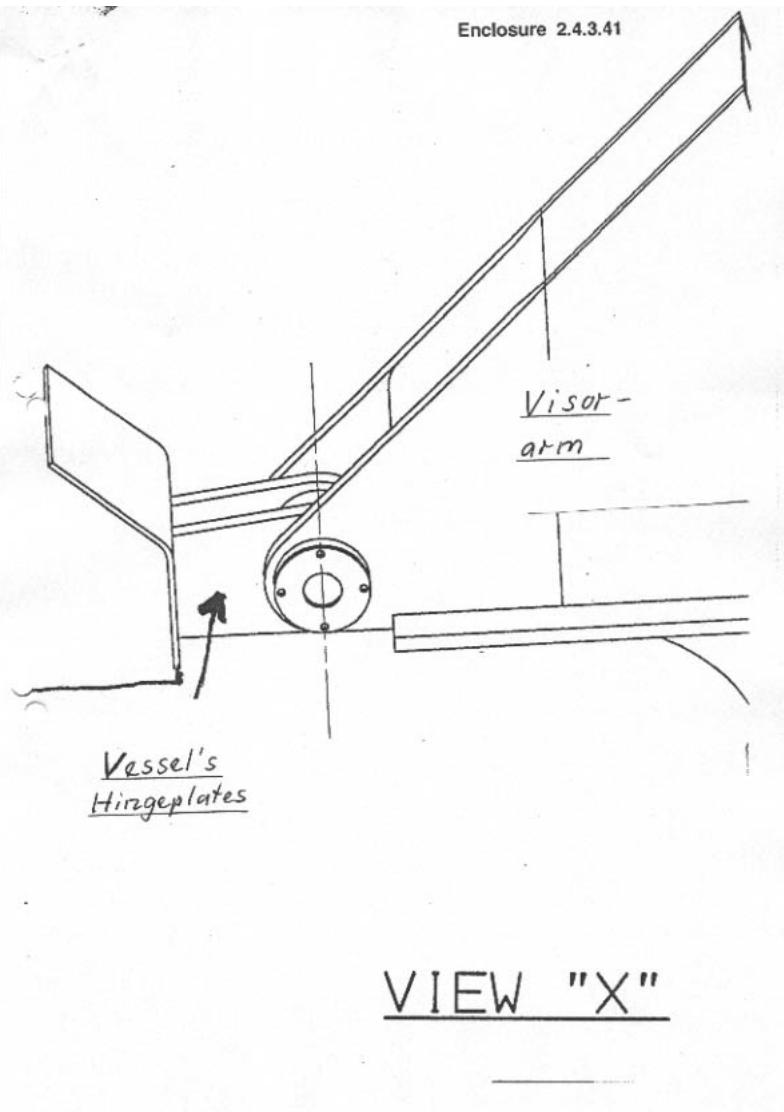
Drawings showing visor hinge arrangement

Photo showing visor hinge arrangements on viking sally

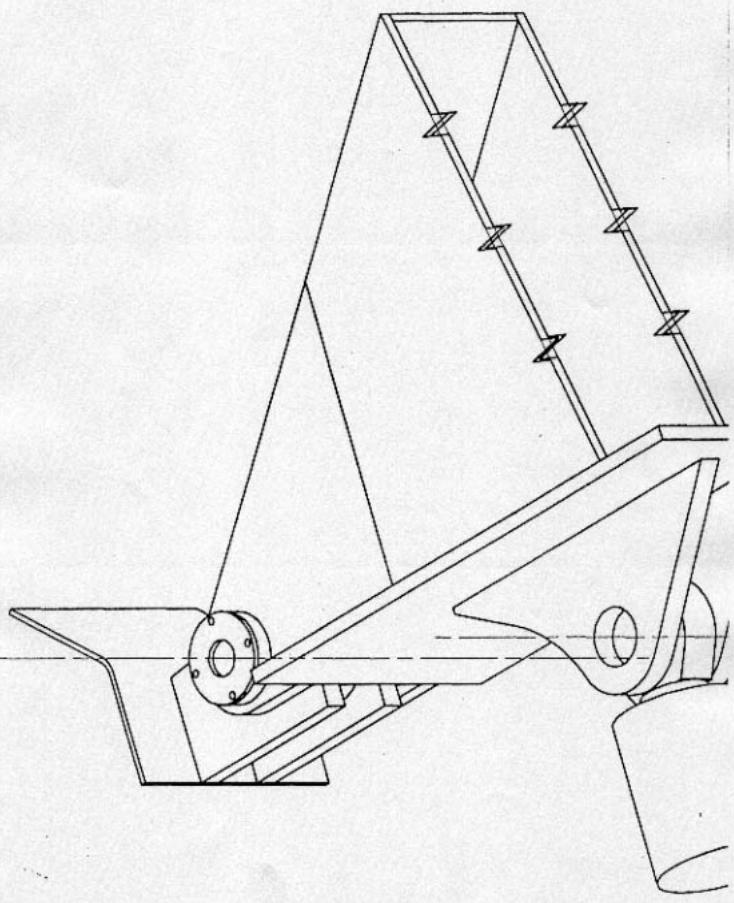
VIEW "X"

Change of drawing 1106 as to scharnierbleche/ hinge plates
