SLIDE GUIDE

WHAT BROKE, AND WHAT IT TAUGHT US — presentation of 4 November 2026, 21 sheets

GROUP 9 | OFF-GRID VEHICLE TRACKER — PART I – THE FAILURES — SHEET 05/21 REV D 2026-11-04

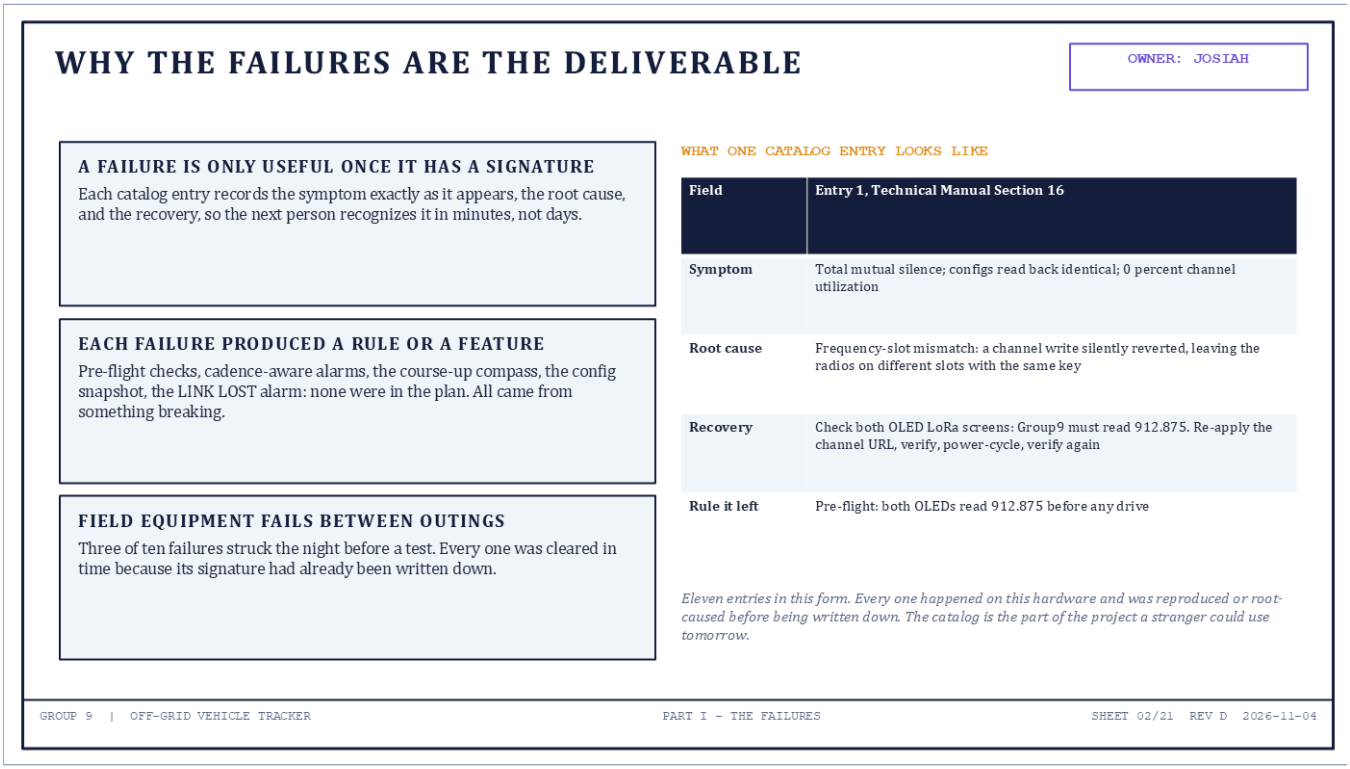
Sheet 2 — Why the failures are the deliverable JOSIAH

Three short claims on the left; on the right, a real entry from the failure catalog (Technical Manual, Section 16) laid out field by field: symptom, root cause, recovery, and the rule it left.

The catalog is a table in Section 16 of the Technical Manual with eleven entries. Each has four columns: the **symptom** written exactly as it appears to someone who does not know the cause ("total mutual silence; configs read back identical; 0 percent channel utilization"), the **root cause**, the **recovery** as concrete steps, and the rule or feature that came out of it. The entry shown is number 1, the silent frequency revert, which is also failure 7 on sheet 6.

The value of the catalog is time-to-diagnosis. Three of the ten failures happened the night before a test; every one was cleared in time because the signature had already been written down. That is the argument of the sheet: a failure that was merely survived will happen again; a failure with a signature is a test case.

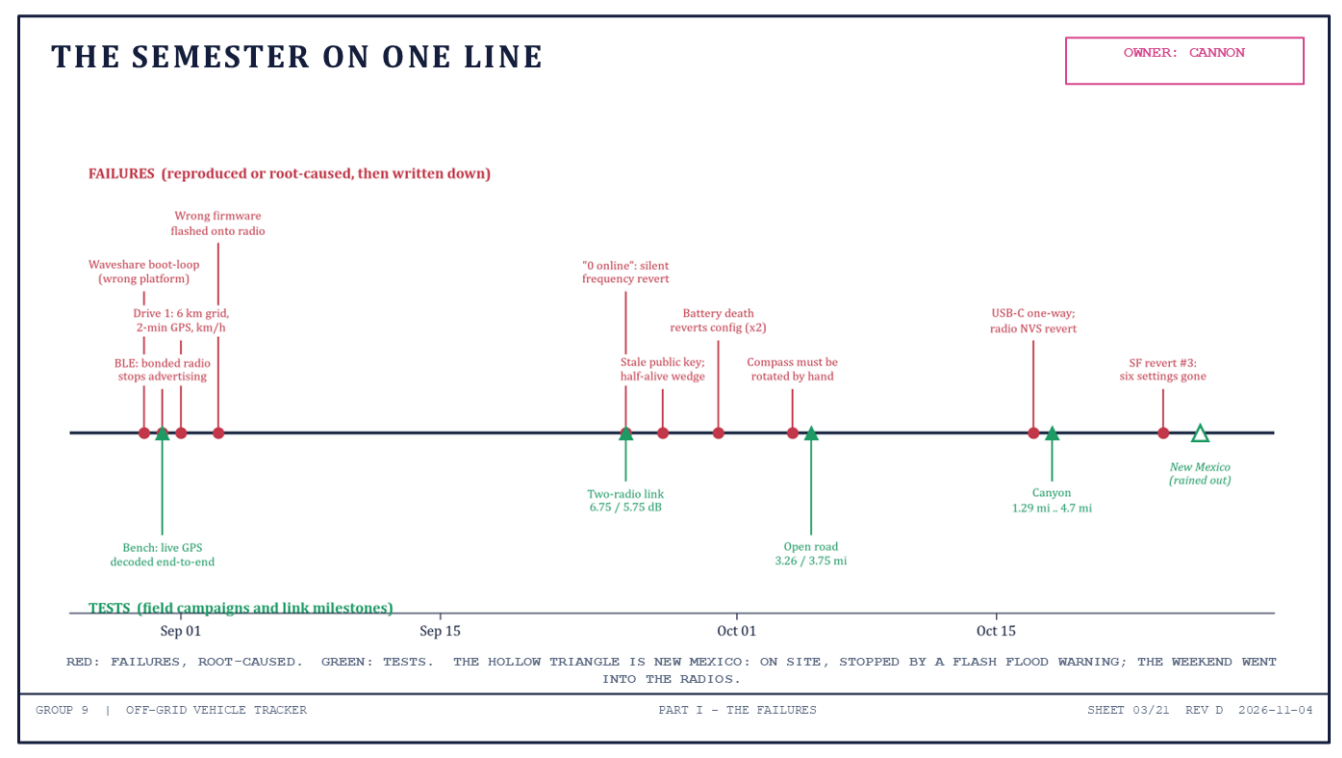
Sheet 3 — The semester on one line CANNON

A timeline from late August to late October. Red dots above the line are failures; green triangles below are tests. The hollow triangle at the end is New Mexico: the team was on site and a flash flood warning stopped the drive.

Two patterns to point at. First, failures cluster right before tests, because preparing for a drive is when the equipment gets exercised. Second, the same villain returns: battery death reverting the configuration appears on 30 September (both radios), 17 October (SF) and 24 October (SF). That repetition is what justified spending the rained-out weekend on Part II instead of waiting for the next drive.

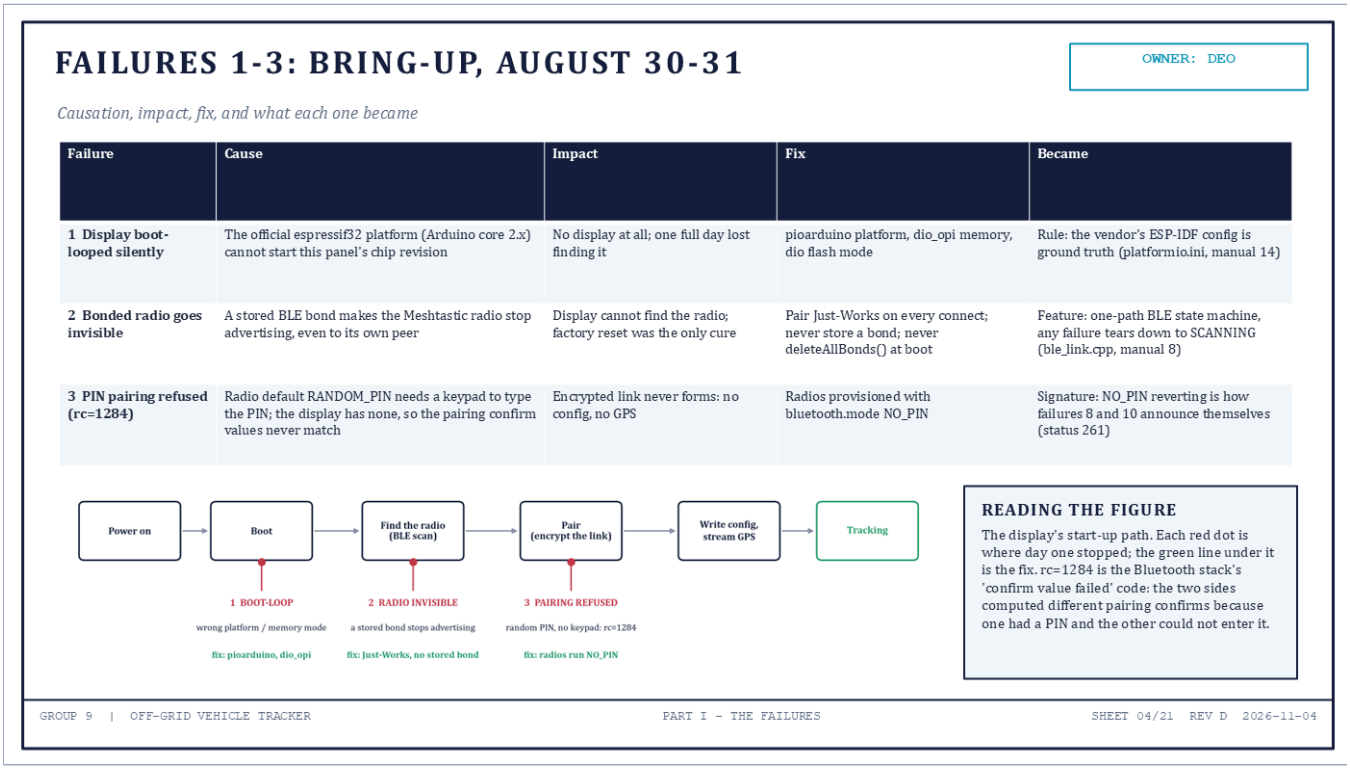
Sheet 4 — Failures 1 to 3: bring-up DEO

1. Boot-loop. The official espressif32 PlatformIO platform ships Arduino core 2.x, which cannot start the chip revision on the Waveshare panel. The fix was the pioarduino platform with `dio_opi` memory mode and `dio` flash mode, which is what the vendor's own ESP-IDF configuration uses. Rule: the vendor's IDF config is ground truth, not the vendor's Arduino screenshot.

2. Bonded radio goes invisible. If a BLE bond is stored, the Meshtastic radio stops general advertising, so nothing can find it, including the display that bonded to it. The fix is to pair Just-Works on every connection (still encrypted, no stored bond) and never call `deleteAllBonds()` at boot. It produced the one-path BLE state machine: any failure tears down to SCANNING and starts over.

3. PIN pairing refused, rc=1284. The radio shipped in RANDOM_PIN mode: it shows a six-digit PIN and expects the other side to type it. The display has no keypad. In BLE pairing each side computes a "confirm value" from the PIN and random numbers; with different PINs the values do not match and the stack reports 1284, which in NimBLE is 0x500 (Security Manager error on our side) + 4 ("confirm value failed"). Fix: provision the radios with `bluetooth.mode NO_PIN`. This matters later: NO_PIN is a stored setting, so when a radio's configuration reverts, the display log shows "status 261, insufficient authentication", the signature of failures 8 and 10.

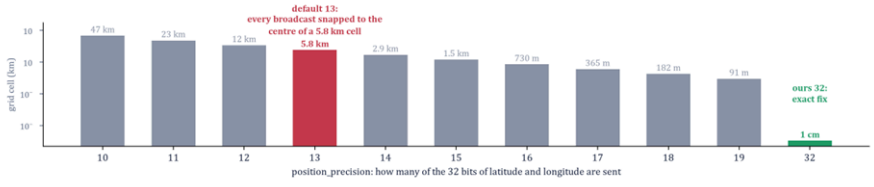
Failure	Cause	Impact	Fix	Became
4 First drive: five faults	Channel precision 13 snaps every position to a 5.8 km cell; GPS refresh 120 s; speed sent in km/h; GPS jitter read as speed; wrong time-zone line	Partner frozen on a grid, 4 min late, wrong speed, parked car 'moving', clock an hour off	Precision 32; GPS 10 s; km/h decode; 4.5 km/h deadband; time-zone bands to the NM border	Rule: validate every feature on the road, never on a windowsill (provisioning recipe, node_table.cpp)
5 Display firmware flashed onto a radio	Radios and displays share USB ID 303A:1001; a tool auto-picked the port	Meshtastic erased; radio out for an afternoon; full re-provision	esptool erase, factory image, re-provision (node number survives: MAC-derived)	Rule: identify every board by its MAC before any upload; never let a tool pick the port (manual 14.2)
6 Config write silently reverted	Closing the CLI's serial port toggles DTR/RTS and resets the ESP32 mid-save	Write 'succeeds'; the next read shows the old value; nothing on screen changes	Hold the port open (Python API); re-run the whole block	Rule: read back every write; the OLED outranks the CLI (manual 16, entry 6)

Meshtastic sends latitude and longitude as 32-bit numbers and the channel's precision setting says how many of those bits to keep. The default keeps 13: every broadcast lands on the centre of a 5.8 km cell, so a moving partner looks frozen. We keep all 32.

Precision 13. Meshtastic sends latitude and longitude as 32-bit integers in units of 1e-7 degree. A channel's `position_precision` says how many of the 32 bits are kept; the rest are zeroed and the position is placed at the centre of the resulting cell. The private-channel default is 13 bits, so the cell is 2^(32-13) × 1e-7 = 0.0524 degree, which is 5.8 km north-south (about 4.9 km east-west at our latitude). A moving partner therefore appeared frozen until it crossed into the next cell. Precision 32 keeps everything: about 1 cm.

GPS jitter. A parked receiver's fix wanders a few metres between readings (satellite geometry, atmosphere, reflections). The receiver converts that wander into a speed, so a parked car reads 1 to 3 mph. The node table ignores any speed under 4.5 km/h. The other three faults: the GPS refresh default of 120 s made positions up to two minutes stale; speed is sent in km/h on the wire, not m/s; and the time zone boundary had to be carried to the New Mexico border.

Failures 5 and 6 are tooling. Radios and displays share the USB ID 303A:1001, so a tool that auto-picks a port can flash the wrong board; it erased Meshtastic from a radio for an afternoon. Rule: identify every board by its MAC before any upload. And closing the CLI's serial port toggles DTR/RTS, which resets the

ESP32 in the middle of a save, so the write "succeeds" and the next read shows the old value. Rule: read back every write, and the radio's own screen outranks the CLI.

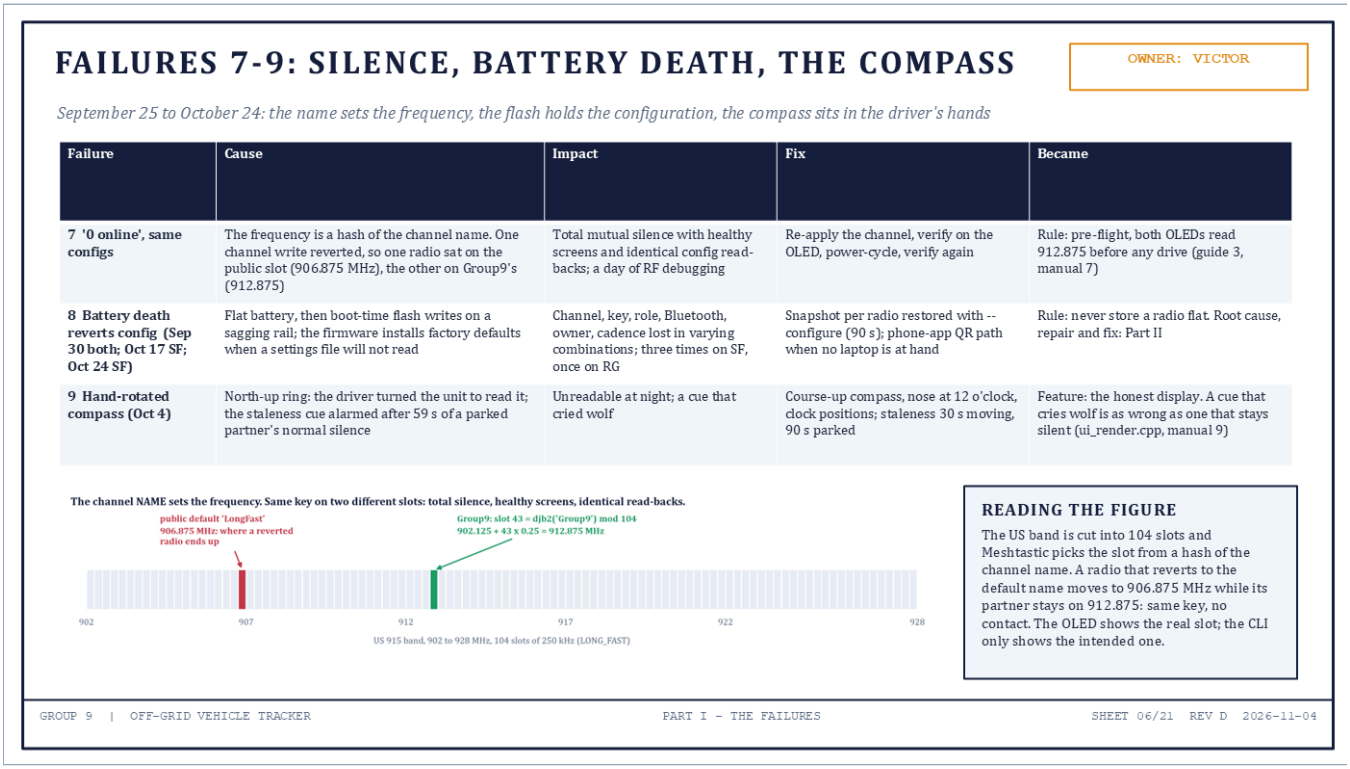
Sheet 6 — Failures 7 to 9: silence, battery death, the compass

The silent frequency revert, the three battery-death incidents summarised in one row, and the hand-rotated compass; under it, the US band drawn as 104 slots with the public default and the Group9 slot marked.

Battery death. 30 September both radios (RG lost channels, SF lost everything), 17 October SF, 24 October SF. Losses were partial and different each time. Mitigations in October: pre-flight, a configuration snapshot per radio restored with `--configure` in 90 s, a phone-app QR path when no laptop is at hand, and never storing a radio flat. The root cause is Part II; do not pre-empt it here.

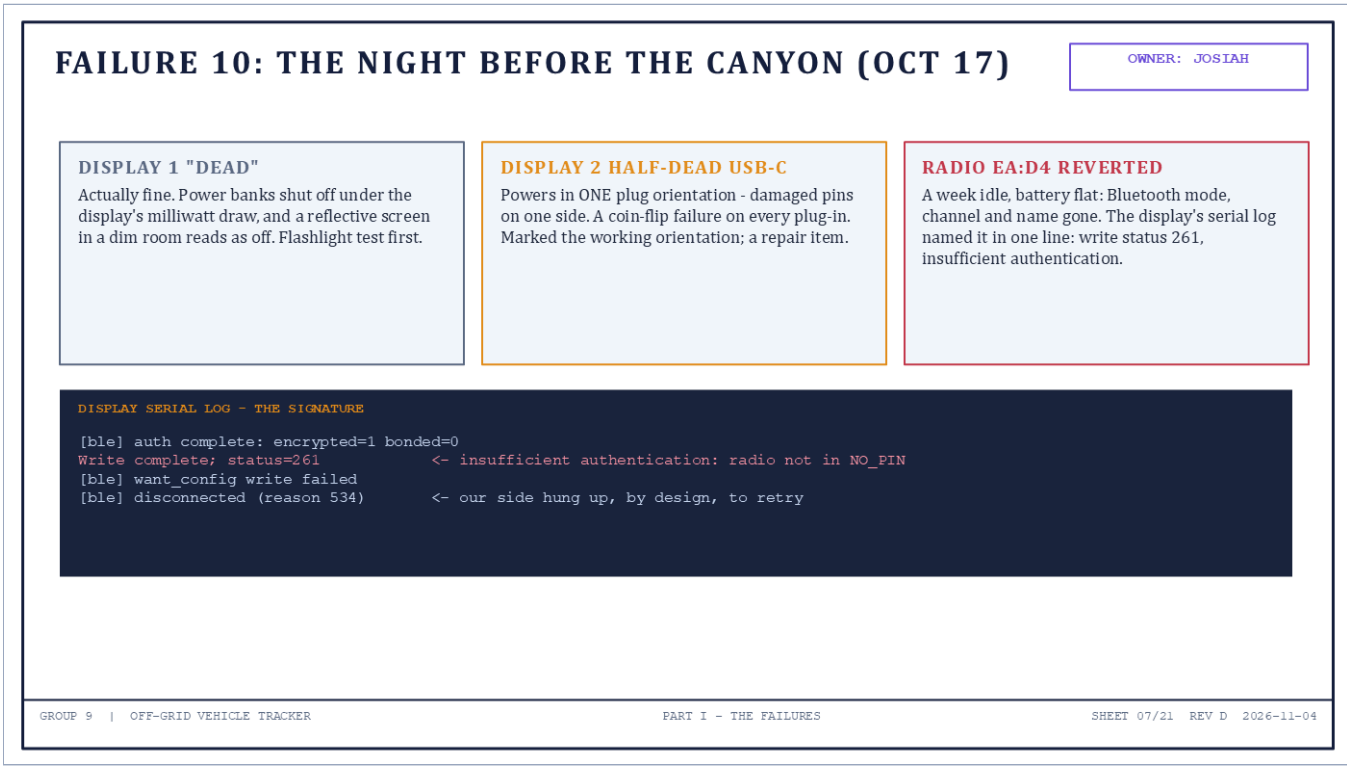
Sheet 7 — Failure 10: the night before the canyon JOSIAH

Three independent faults in one evening, and the display's serial log that named the third one in a single line.

Display 1 looked dead: power banks shut off under a milliwatt load, and a reflective screen in a dim room reads as off. Flashlight test first. Display 2 powers in one USB-C orientation only, damaged pins on one side; the working orientation is marked and it is a repair item. Radio EA:D4 (SF) had been idle a week with a flat battery; its Bluetooth mode, channel and name were gone. The signature is the log excerpt: pairing completes encrypted but not bonded, then a write returns status 261 (insufficient authentication, the radio is no longer in NO_PIN), then our side disconnects by design to retry. Forty minutes for all three, because each had a signature; the test ran the next morning.

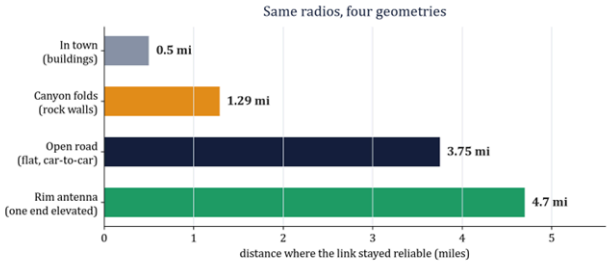
Same radios, four geometries: 0.5 to 4.7 mi. Terrain and antenna height set the range, not the hardware.

The chart is the honest envelope: 0.5 mi in town, 1.29 mi in canyon folds, 3.75 mi car-to-car on flat road, 4.7 mi with one antenna on a canyon rim. Terrain and antenna height set the range, not the hardware. The canyon result is the subtle one: behind rock the link is intermittent at any distance, stale from 1.29 mi yet a packet landed at 4.28 mi through a gap, and a seven-minute outage healed with one packet and no operator action. The New Mexico row is the open-road maximum with roof-top antennas, the one number still missing; the team was on site on 25 October and a National Weather Service flash flood warning stopped the drive. It is rescheduled for the next clear weekend.

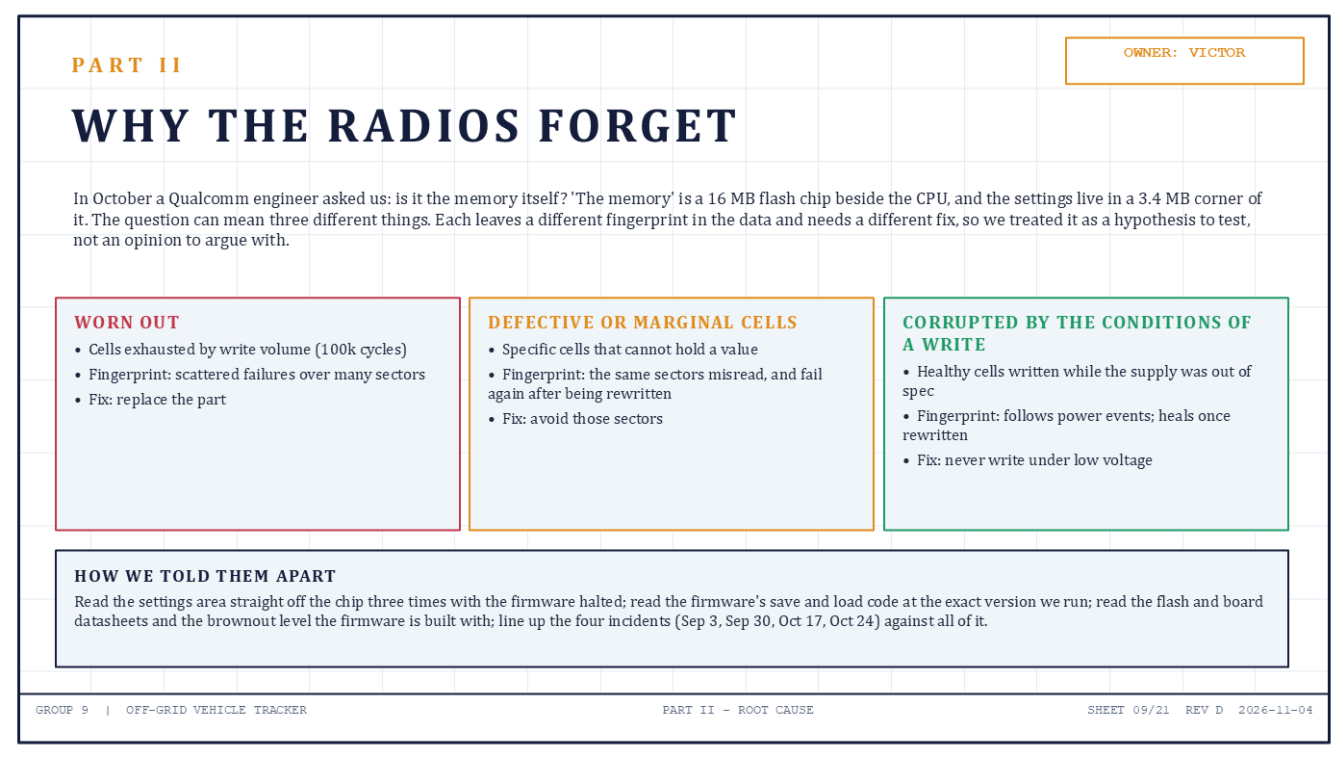
Sheet 9 — Part II: why the radios forget VICTOR

"The memory" is a 16 MB flash chip beside the CPU; the settings live in a 3.4 MB corner of it. "The memory itself is at fault" could mean three different things. **Worn out**: cells exhausted by write volume (100,000 erase cycles); it would look like scattered damage across many sectors and the fix is a new part. **Defective cells**: fixed bad spots that stay bad even after being rewritten; the fix is to avoid them. **Written under bad conditions**: healthy cells left half-written because the supply sagged during a write; fixed bad spots that heal once rewritten; the fix is never to write under low voltage. The three are distinguishable, so the suggestion was treated as a hypothesis to test rather than an opinion to argue with. The bottom card is the method in one sentence: read the chip with the firmware halted, read the firmware source at the exact version we run, read the datasheets, and line up the four incidents.

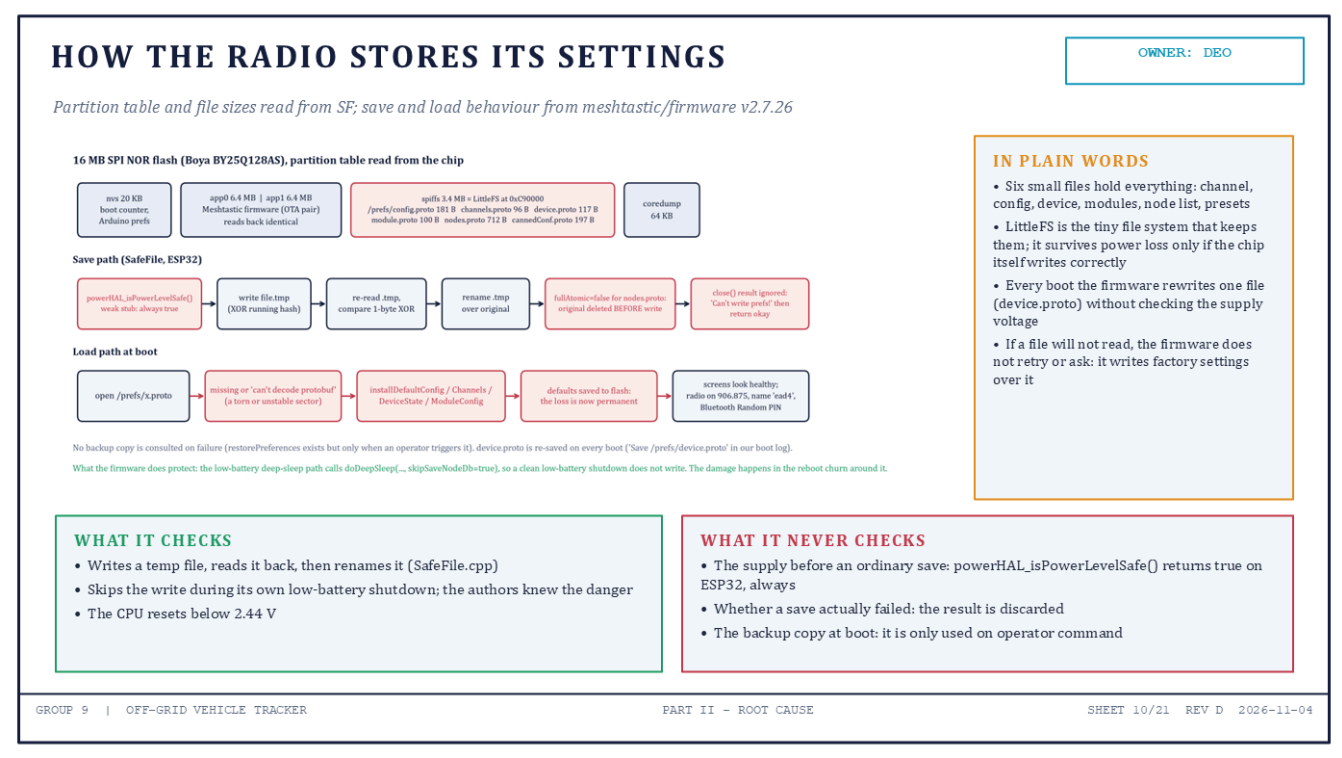
Sheet 10 — How the radio stores its settings DEO

The save path (`SafeFile.cpp`) writes a temporary file, reads it back with a one-byte XOR check, then renames over the original. Two exceptions: `nodes.proto` is written non-atomically (the original is deleted first), and the result of `close()` is discarded, so a failed save logs "Can't write prefs!" and returns okay. The gate every save passes through, `powerHAL_isPowerLevelSafe()`, is a weak default that returns true; no ESP32 override exists in `src/platform/esp32`. The boot log shows `device.proto` re-saved on every boot.

The load path (`NodeDB.cpp`): open the file; if it is missing or will not decode, call `installDefaultConfig()` (or Channels, DeviceState, ModuleConfig), then save the defaults. No retry, and the backup copy is only consulted when an operator runs `restorePreferences`. So one unreadable

file is a permanent, silent factory reset. The one protection that exists: the low-battery deep sleep calls `doDeepSleep(skipSaveNodeDb=true)`, so a clean low-battery shutdown does not write. The damage happens in the reboot churn around it, not in the shutdown itself.

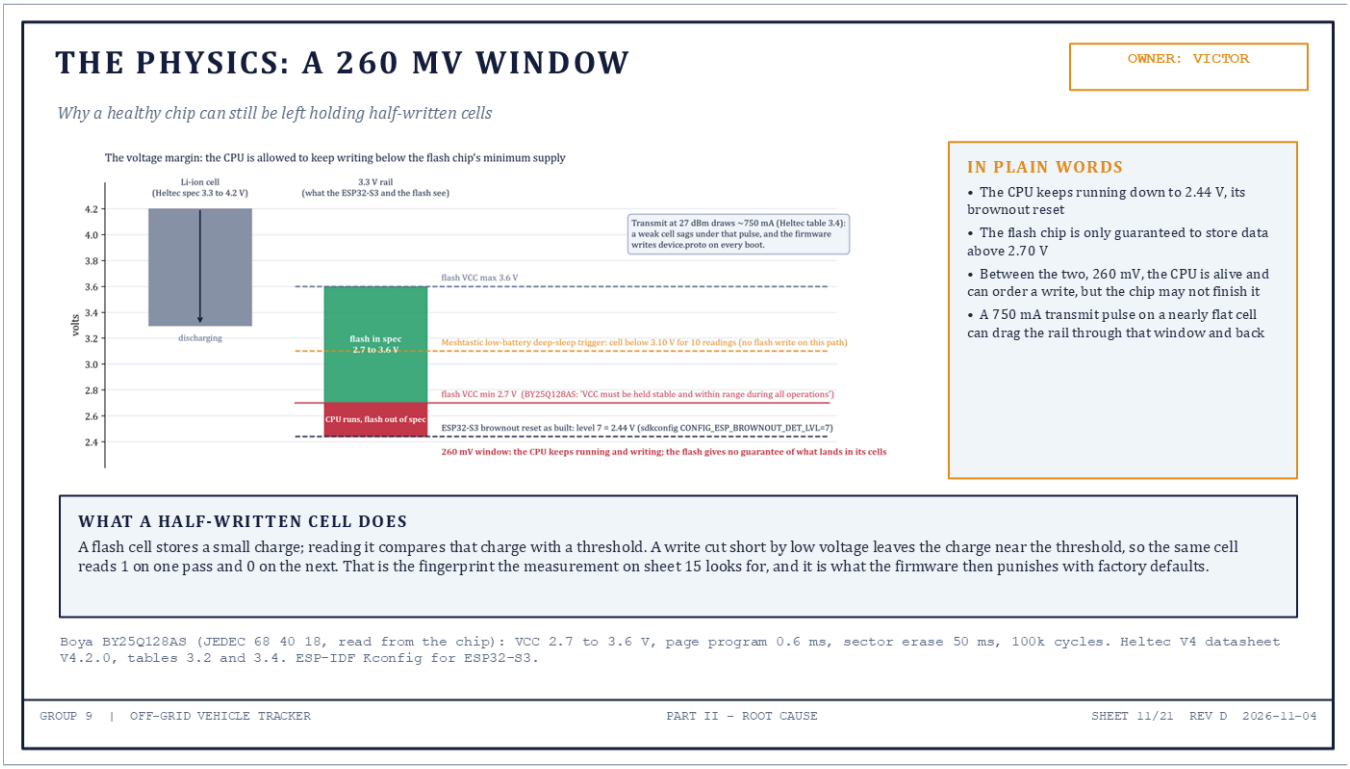
Sheet 11 — The physics: a 260 mV window VICTOR

What a half-written cell is: a flash cell stores a small charge, and reading it compares that charge against a threshold. A write cut short leaves the charge near the threshold, so the same cell reads 1 on one pass and 0 on the next. It is not damage; the cell was never finished. That is the fingerprint the measurement on sheet 15 looks for, and the firmware then turns it into a factory reset.

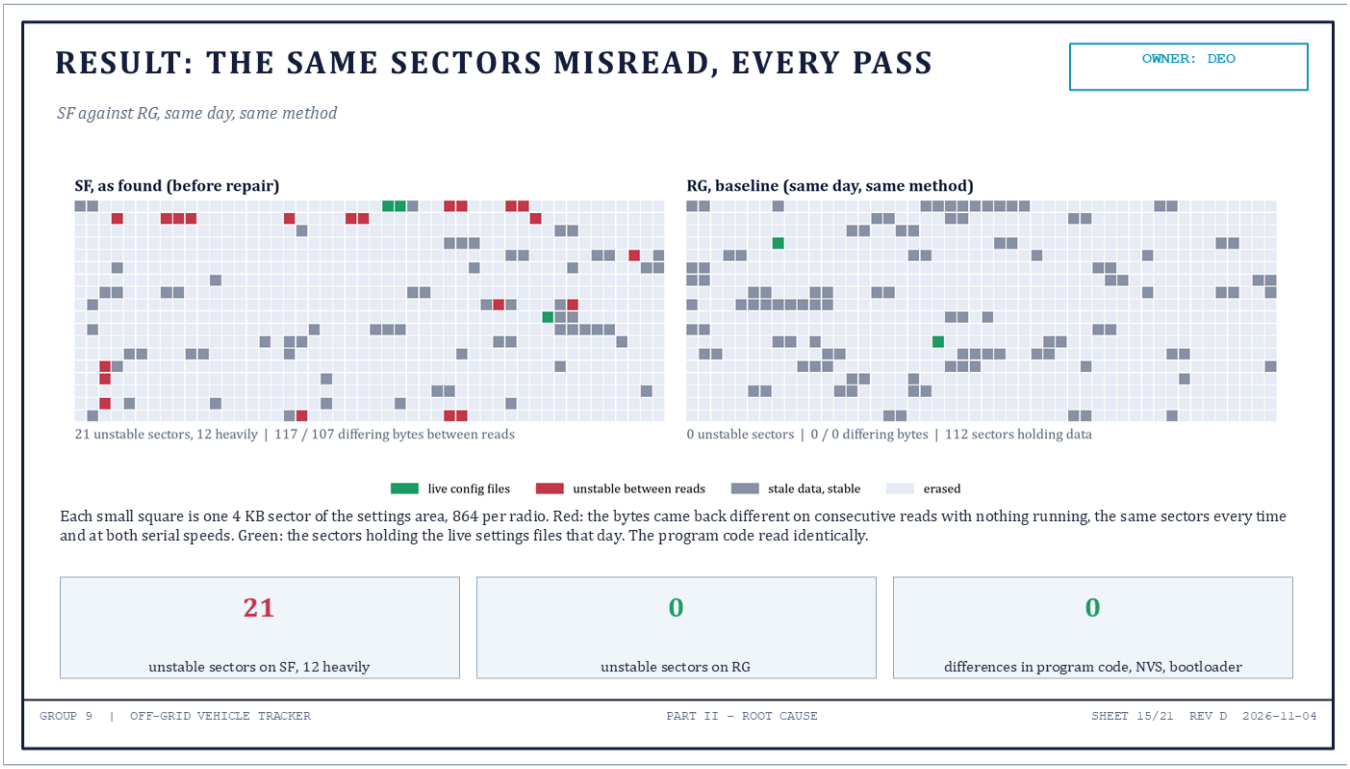
Sheet 15 — Result: the same sectors misread, every pass DEO

Each small square is one 4 KB sector; the settings area has 864. Red sectors returned different bytes on consecutive reads with nothing running: the same sectors every time, at both serial speeds. Green sectors held the live settings files that day (on SF: 25, 26 and 470), which were clean, and that is why SF was still working when measured; LittleFS wear-levelling would eventually have moved a live file onto a red sector. Grey is stale data that read stably; pale is erased. SF: 21 unstable sectors, 12 of them heavily (30, 31, 35, 36, 51, 55, 56, 57, 65, 70, 71, 85), 117 and 107 differing bytes between consecutive reads, 118 bits flipped in both directions, none inside erased areas. RG: zero. Program code, NVS and bootloader: zero differences on both radios.

> **Q: Why was SF still working with 21 bad blocks?** Its live files happened to sit in clean blocks that day (green). The file system moves files around to spread wear, so it was a matter of time.

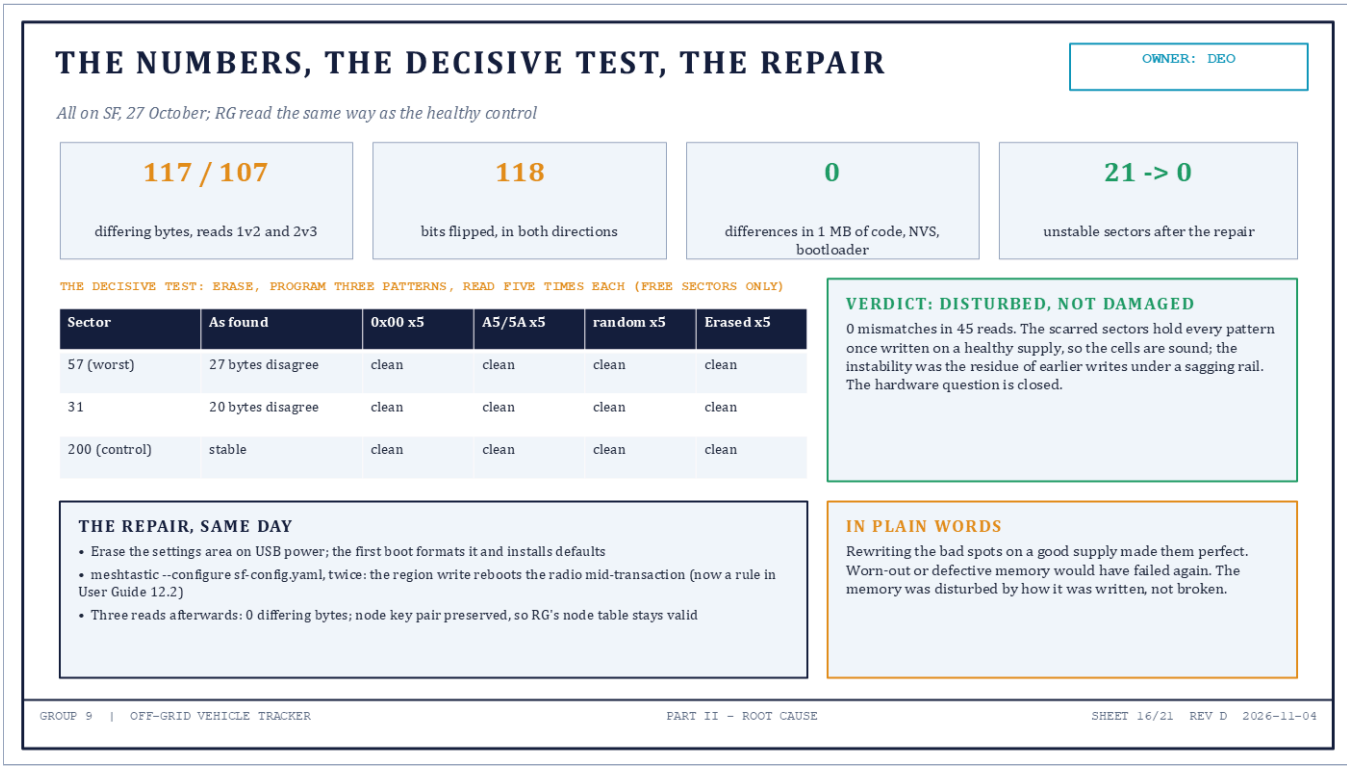
Sheet 16 — The numbers, the decisive test, the repair DEO

Sector	As found	0x00 x5	A5/5A x5	random x5	Erased x5
57 (worst)	27 bytes disagree	clean	clean	clean	clean
31	20 bytes disagree	clean	clean	clean	clean
200 (control)	stable	clean	clean	clean	clean

VERDICT: DISTURBED, NOT DAMAGED

Rewriting the bad spots on a good supply made them perfect. Worn-out or defective memory would have failed again. The memory was disturbed by how it was written, not broken.

Numbers. Fixed sectors, both bit directions, independent of serial speed, code partition stable: that is the fingerprint of cells whose stored charge sits at the read threshold. Not a serial artifact (chunks are verified), not wear (the pattern would be diffuse), not a file-system bug (the image mounts and decodes).

Decisive test (27 October, with authorisation). Sectors 57 and 31, the worst as found (27 and 20 disagreeing bytes), were free in LittleFS, so nothing was lost. Each was erased, then programmed with all zeros, with alternating 0xA5/0x5A, and with a random page, and read five times after each pattern and after a final erase; sector 200, stable as found, was the control. Zero mismatches in 45 reads. Cells that were worn or defective would have failed again; these held every pattern once written under a healthy supply. H2 falls, H3 stands: the silicon is sound and the instability was the residue of earlier writes completed with the supply out of range.

Repair (same day, thirty minutes). Erase the settings partition on USB power; the first boot reports "Failed to initialize LittleFS", formats, and installs defaults; apply the configuration snapshot with `--configure` twice, because the region write reboots the radio mid-transaction and the first pass loses owner, role, channel and cadence (now a rule in User Guide 12.2); read back, reset, read back again; three

reads of the partition: zero differing bytes. The node key pair is carried in the snapshot, so RG's node table stayed valid.

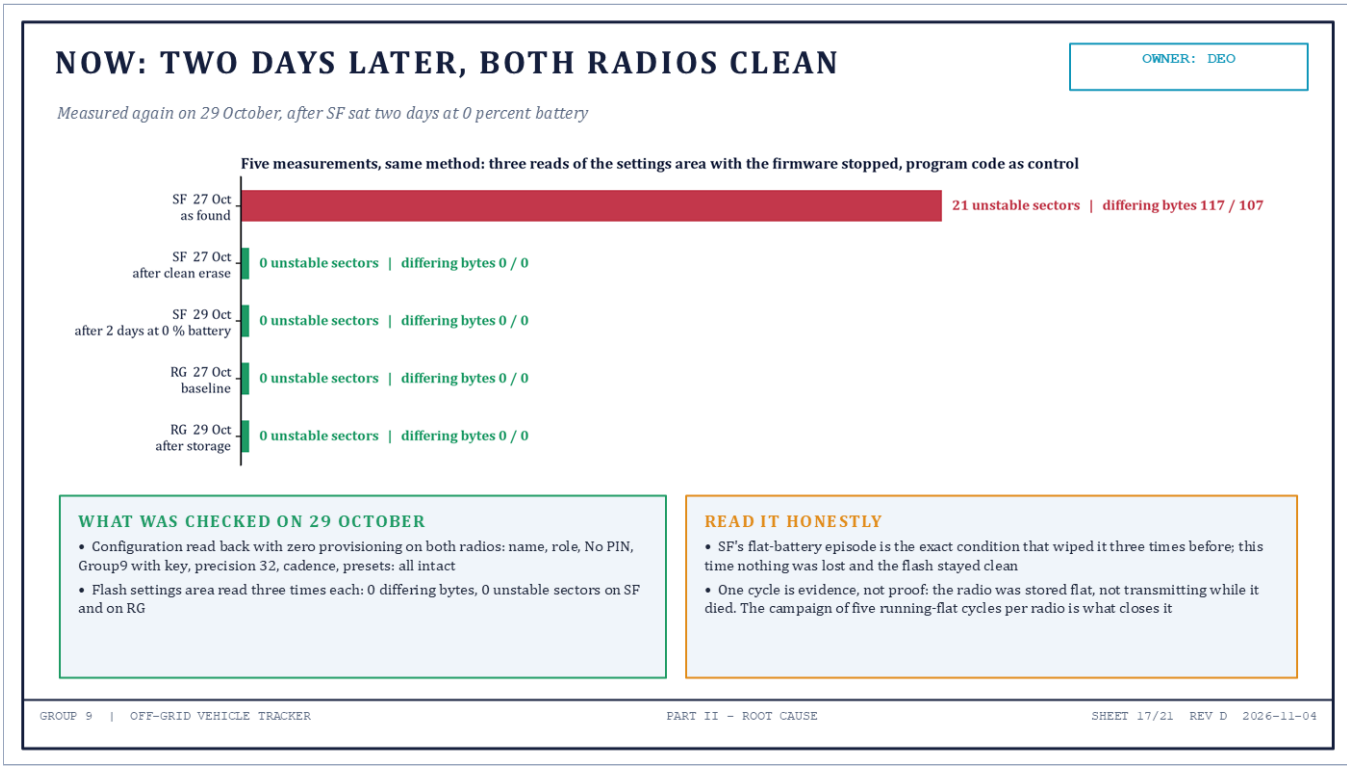
Sheet 17 — Now: two days later, both radios clean DEO

After the 28 October acceptance both radios were unplugged; SF sat two days at zero percent battery, the exact condition that wiped it three times before. On 29 October both were read back with zero provisioning: name, role, No PIN, Group9 with the key, precision 32, cadence, telemetry, 21 presets, all intact; SF reconnected at 18 percent and 3.40 V. The flash was then read three times each: zero differing bytes, zero unstable sectors on both (RG still holds 115 sectors of old data from before, all of it stable). This counts as cycle 1 of the flat-battery campaign for SF.

The honest limit: SF was *stored* flat, not transmitting while it died, so the dangerous write of sheet 11 may simply not have happened this time. Fix 1 makes a revert harmless; it does not remove the cause. The five running-flat cycles per radio, radio on and transmitting until it dies, with the flash map read after each, are what separate "the cause did not fire" from "the cause cannot fire".

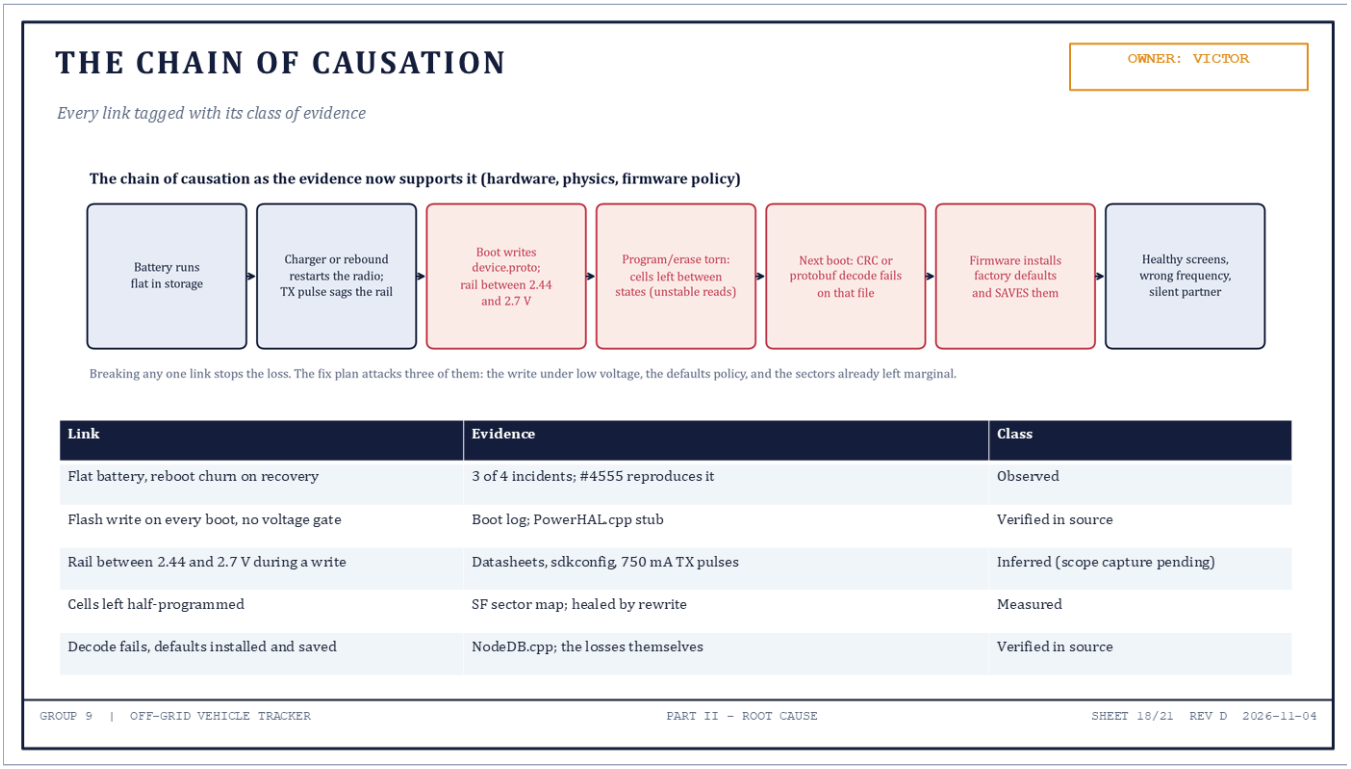
Sheet 18 — The chain of causation VICTOR

The five links from a flat battery to lost settings, each tagged with the class of evidence behind it: observed, verified in source, inferred, measured.

Read it left to right. (1) The battery goes flat and on recovery the radio boots and reboots: observed in three of four incidents and reproduced in upstream issue 4555. (2) Every boot writes a settings file with no voltage check: verified in the boot log and in `PowerHAL.cpp`. (3) The rail sits between 2.44 and 2.7 V during a write: inferred from the datasheets, the brownout configuration and the 750 mA transmit pulses; this is the one link not yet measured, and the oscilloscope capture is what closes it. (4) Cells are left half-programmed: measured on SF and healed by a rewrite. (5) A file fails to decode and the firmware installs and saves factory defaults: verified in `NodeDB.cpp` and in the losses themselves. Tagging the evidence class is what makes the argument defensible: one link is inferred and we say so.
