HOME SODA MACHINE

Printing the Machine

What nine months of printing a kitchen appliance taught us about FDM, one plastic at a time.

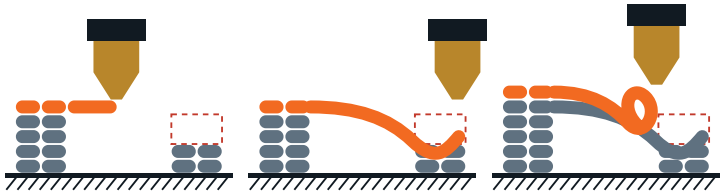
ONE LANDING CUT AWAY

Air is not on the list. A road laid over nothing does not hang there waiting for the next one. It droops, and everything printed onto it afterwards goes with it.

12 NOVEMBER 2026 · PET-GF
A pocket roof laid across a cutout that had taken its landing away.

In the slice, find the first road across every opening and follow each of its ends straight down. If either end is over air it is not a bridge, whatever the slicer calls it. After any cut near an opening, look at the roofs beside it again.

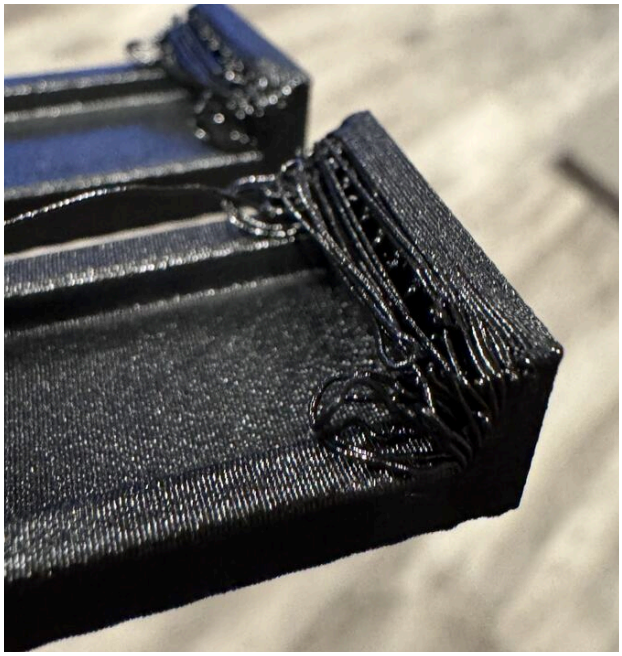
Leaves the first landing. Nothing to press onto. It sags. The next course is laid on the sag.

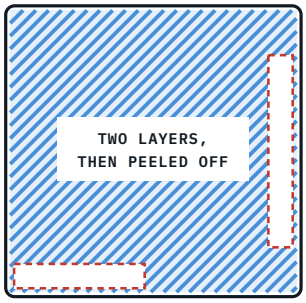
SENDS 1 TO 4
OUR TRIM

20 September 2026: a bench stand as big as the nozzle can reach, 5 mm from the edge. Two clumps on the nozzle, then a peel on a fresh hotend. Pulled in to 15 mm: "It was lifting already."

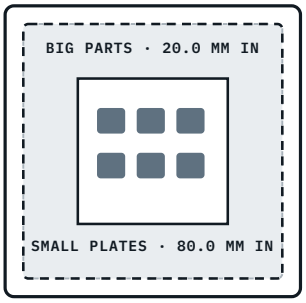
SEND 6
OUR TRIM AGAIN

The file of the third send, on the same hotend. The first layer went down "clean and uniform out to the plate's edge", and the print ran all 917 layers.

The cold-core shell keeps every road 20.0 mm in from the edge. Small test plates are centred 80.0 mm in. Both are measured on the sliced paths, brim and supports included.

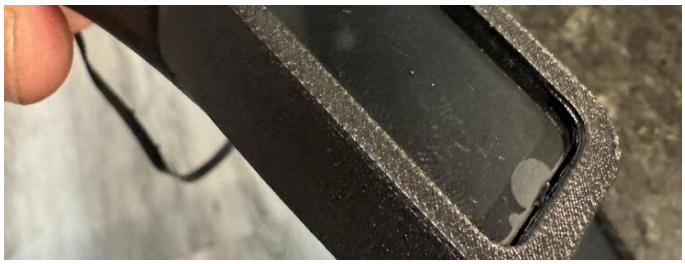
The part fan blows room air at the plastic as it leaves the nozzle. A road laid over air needs that, to set before it sags. A plain wall of PET-GF does not. Printed with the fan on everywhere, thin covers cracked along their layers in the hand.

17 OCTOBER 2026 · MARK2 · WHITE PET-GF · RIGHT NOZZLE
Printed with the fan at 70 percent on every road above the third layer. It split along its layers as the display was pressed in. The cover before it had done the same.

STILL OPEN Why the covers cracked is not established: the fan was the one thing changed between the cover that broke and the one that held, and no strength was measured. The cooling kept above a bridge has been read in each file’s commands since 6 November 2026. No print has yet been judged for it.

One change. That afternoon the cracked cover’s file was printed again with every fan setting at zero. Shape, temperatures, speeds and supports stayed as they were. It took the display and went on. By evening the fan was back, on bridges and overhangs only.

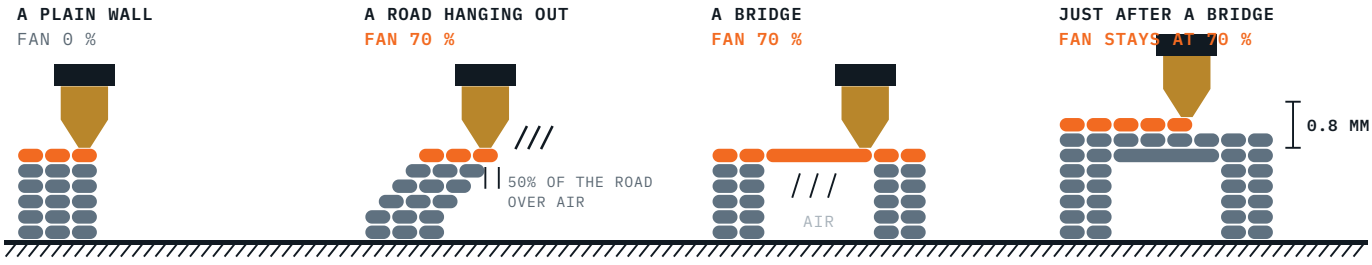
> *“That new printed cover works great. In fact, it worked so well that the other parts of the faucet broke while I was trying to put that cover on, which I think really indicates that we have a brittleness issue with those cooling settings that we need to be aware of.”*
>
> DEREK · 17 OCTOBER 2026 · THE SAME COVER, FAN OFF

The slicer asks how much of a road must hang over air before the fan comes on. Ours is 50%. At zero, Bambu Studio cools every outer wall, overhang or not. The cracked covers’ file carried a zero.

Walls, infill and top faces are laid with the fan at rest. On the first faucet printed this way, 17 October 2026, over 99 percent of the cover’s outer wall was laid with it off.

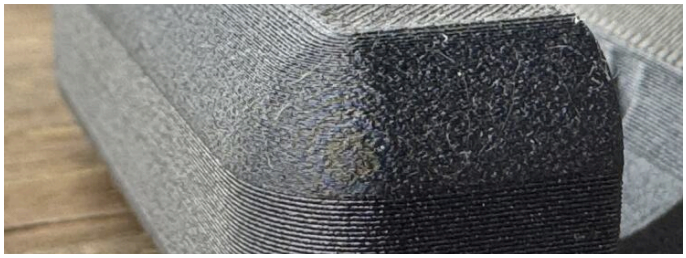
24 SEPTEMBER 2026 · MARK2 · PET-GF
The round at the top of the print, in fine layers. It turns inward as it rises. The band shows: the texture changes where the fine layers begin.

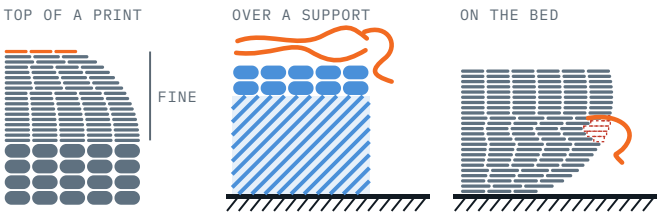
THE SAME PRINT, THE BED SIDE
The same radius in the same fine layers, growing outward off the bed. About twenty courses went down clean. Then the edge lifted and the nozzle dragged through it.

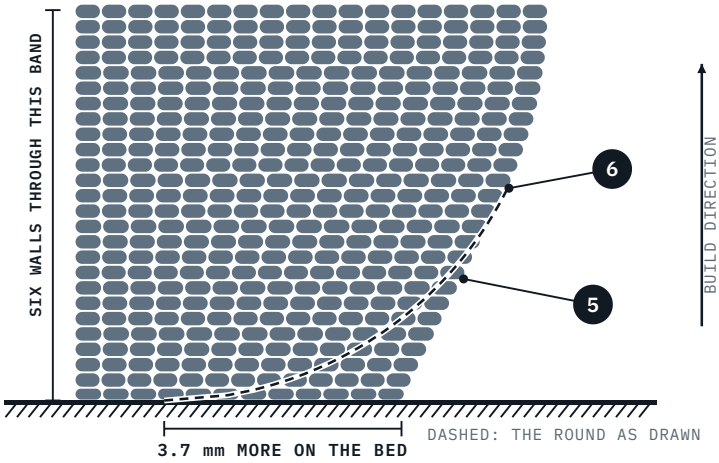
29 SEPTEMBER 2026 · MARK 1 · ORDINARY LAYERS, 0.24 mm

1. About twenty courses go down clean.
2. Edges already laid draw back.
3. The next road out has nothing under it.
4. Higher, where the wall is steeper, the print recovers from the inside.
5. The chamfer starts steep. Each course steps out half its own height.
6. It meets the round here, tangent. Above this the curve is as drawn.

FINE LAYERS	Mark2, 24 September 2026. No supports. The top round clean, the bed round torn part way up.
FAN OFF	Same file, same day. "That turned out worse. Exploded basically."
FAN STEADY	Stopped when the edge failed again. Derek saw where: between the places the infill reached the wall. Where it reached, the edge held.
SIX WALLS	Through the fine band, infill laid before walls. "We have no spaghetti explosion. It's not a great curve, it's not even a chamfer, it actually clearly angles the wrong direction... Still, probably good enough for now."
A CHAMFER	Mark 1, 29 September. Ordinary layers from the bed, six walls through the band, walls before infill, no supports. The record: the bottom curve turned out great.

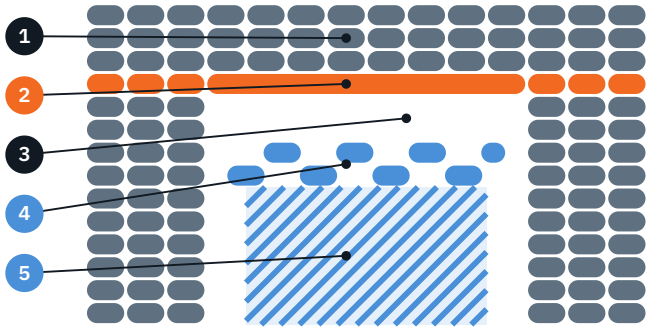
TWO LAYERS OF AIR

ASKED FOR 0.45 MM. THE FILE HAD 0.48.

8 of 8

with two layers did. The support came away and the roof's own strands stayed on the roof.

Even where the support let go, that first course hung loose. On all eight clean coupons it looked and felt loose beside the course above it. A face printed over support is rougher and lower than it was drawn, so every fit beside one is given 0.25 mm more room. The pages on fits show where that goes.

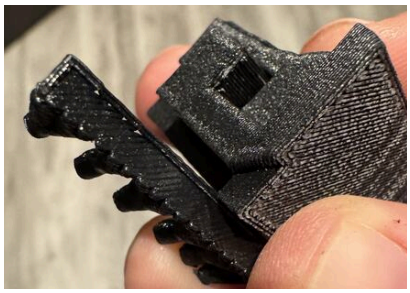
E · 9 NOVEMBER 2026 · MARK 1
Harder to get out than rail supports usually are. It broke up, a tree or two at a time, and one corner had fused pale.

D · 10 NOVEMBER 2026 · MARK 1
The roof and its trees, out as one comb. The mating rail then slid in with room to spare.

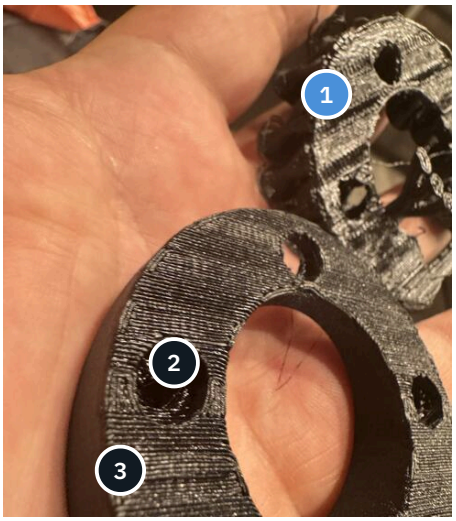
10 NOVEMBER 2026 · MARK 1 · PET-GF
Slim trees, so the roof was there. **1** A stem snapped off inside a pocket meant for a threaded insert. **2** Roof that tore instead of parting. **3** The screwdriver.

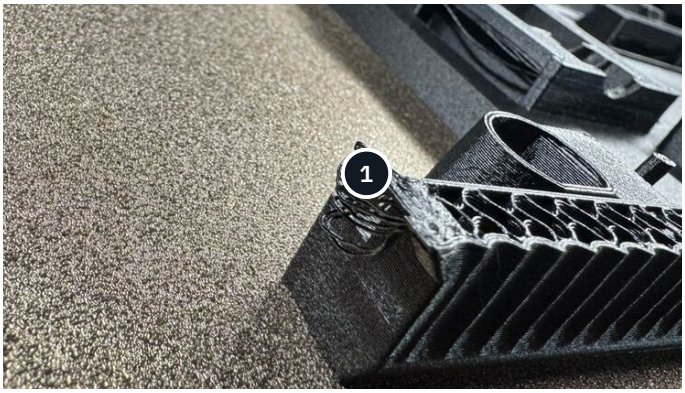
10 NOVEMBER 2026 · MARK 1 · PET-GF
1 A ledge nobody painted, laid over air. **2** Hollow trunks on their way up to something that was painted. They pass the ledge and do not touch it. **3** A second spot.

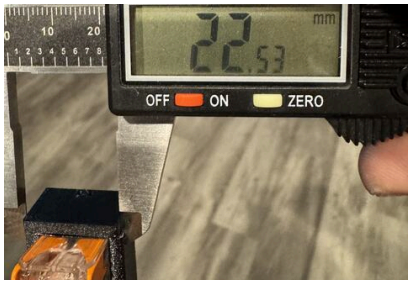
12 NOVEMBER 2026 · MARK 1 · PET-GF
A fit coupon for the two lever connectors in front-top, its pockets drawn narrower than the connectors. Pressed against the edge, a connector split it.

AT REST
21.83 mm across the coupon where nothing pushes on it.

SPREAD
22.53 mm across a pocket with a connector shoved in. Walls three and a half millimetres thick had moved 0.7 mm.

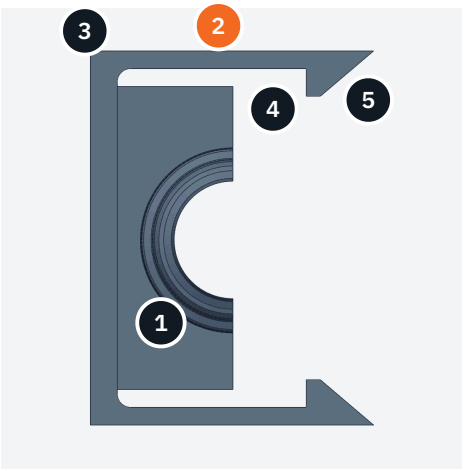
1 NOVEMBER 2026 · MARK2 · PET-GF
A first-round cap, printed as it sits. Its layers run across both leaves. Fitting it over the flow meter tore it.

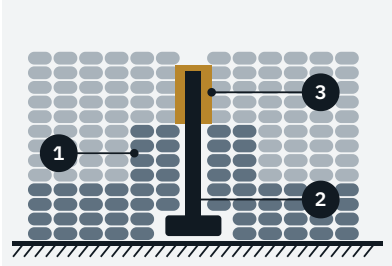
MAY 2026 · A PEG
Two pegs four millimetres across stood on the faucet's plate to press into its shell. One snapped off on the first try.

The second try made the pegs a tenth of a millimetre slimmer, as loose locating pins with nothing to hold. They snapped again. The fault was the direction of the layers, not the fit.

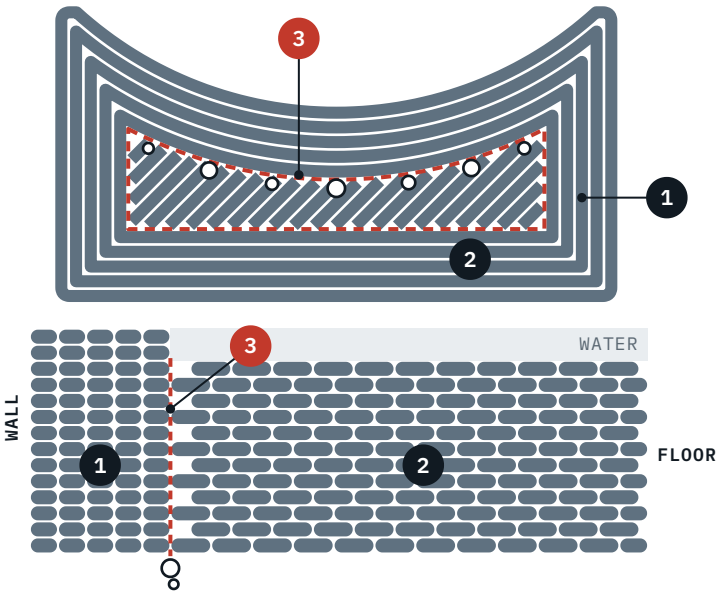
It weeps where the floor meets the wall.

A floor is printed in two parts: loops that follow its outline, then straight fill inside them. Unless the fill is pushed into the loops, the line where the two meet lets water through.

LEAKED **15%, 21 October 2026.** The slicer's own number. Beads in a row: "Leaks between infill and wall."

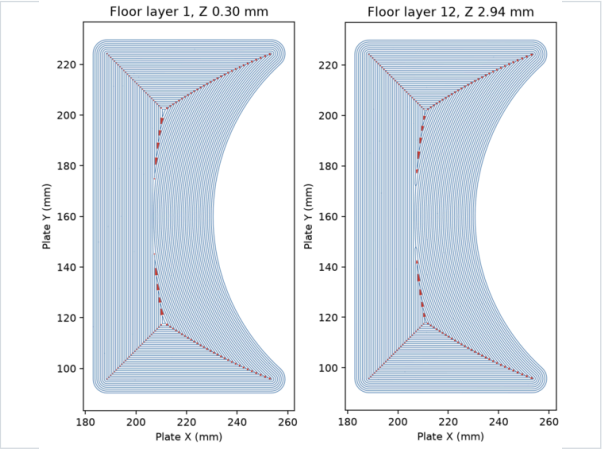
A floor made of loops leaks along its seams.

Loops laid side by side run out of room where they turn a corner and where they meet in the middle. Each of those places is a small gap, and it comes back on every layer.

72% less
uncovered in the slice once a setting added centre roads where loops meet. Printed on 22 October, it leaked in the same place.

> *"Leaks along the seam"*
>
> DEREK · 22 OCTOBER 2026

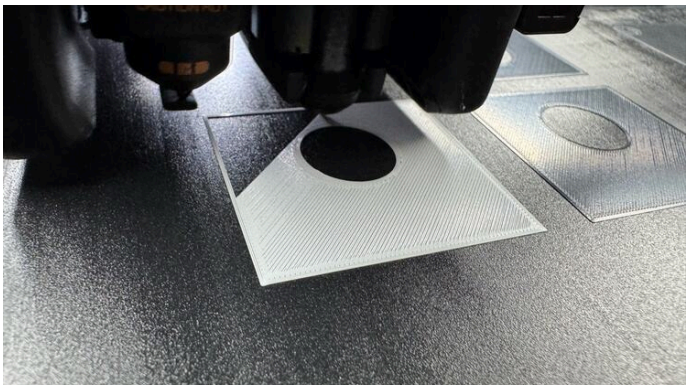
8 NOVEMBER 2026 · MARK 1 · WHITE PETG
The fourth try. By then the spools had been dried twice, the hotend swapped for a spare and the filament rethreaded. It stopped at the same place.

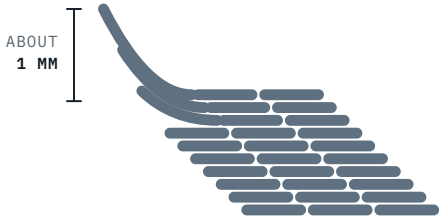
1. **The lip.** About layer 28, a millimetre of the outside edge curled upward on the left.
2. **The nozzle.** The next layers pressed the edge down. It sprang back.
3. **Loose plastic.** Around layer 31 a glob was pulled off the lip and carried elsewhere. A lump lies on the bed here.

> *"Haha, just to test, I dropped part fan from 100 to 50 just now and like instantly we got more curl on that left edge and then the right edge curled too."*
>
> DEREK · DURING THAT PRINT

The left lip had curled with the fan at full. Halving it made that worse and brought the right lip up too.

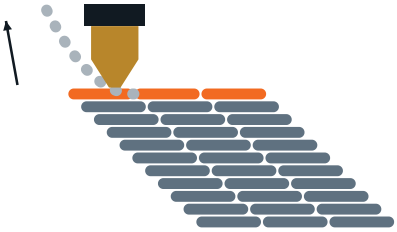
The outer edge of the newest courses lifts.

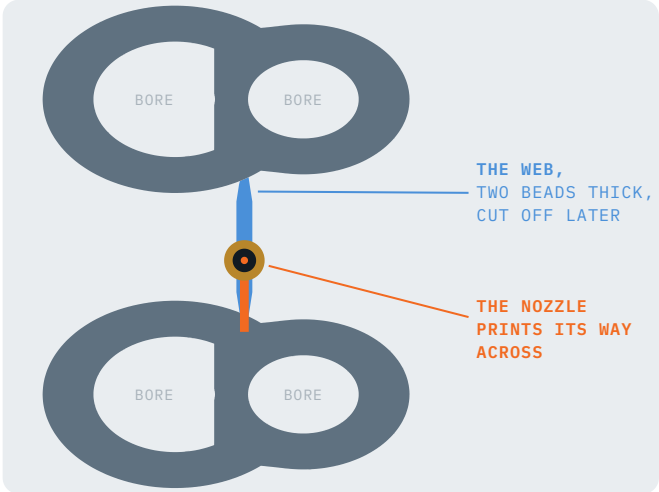
14 OCTOBER 2026 · TWO ELBOWS, TWO ISLANDS
The bed from above, ten millimetres up. The file made 367 hops between the two elbows in 184 layers.

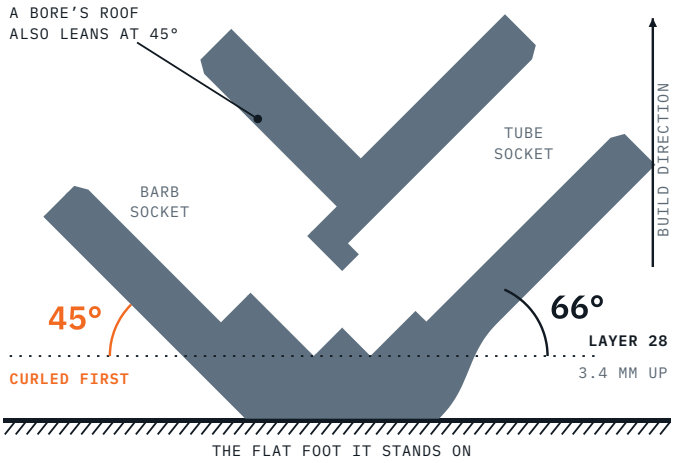
13 OCTOBER 2026 · THE ELBOW ON THE BED
The large socket is on the left. Its outer face leans at 45° from the bed up, and is ragged from the bed up. The right side is smooth low down, where it is steeper, and ragged above.

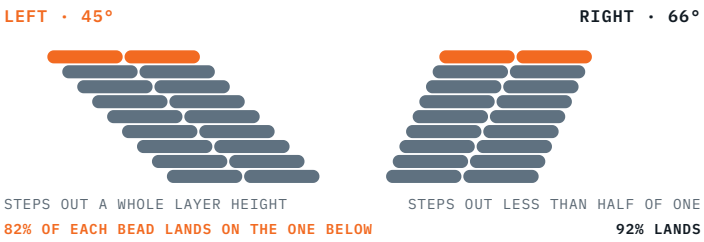
THE SAME ELBOW CUT DOWN ITS MIDDLE
Both legs lean at 45°. The outsides do not: the tube socket begins with a steeper neck.

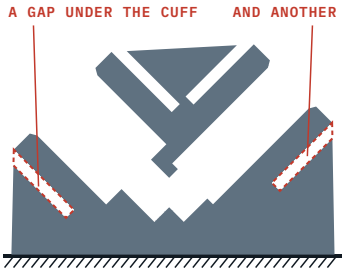
> *"Oh, the left edge is the one that gets the bigger tube. Sure you got the same gradual angle on the underside on left and right?"*
>
> DEREK · 13 OCTOBER 2026

The curl was first noticed at layer 28, on the left. Both legs lean the same. Their outsides, at that height, do not. It was Derek who thought to compare them.

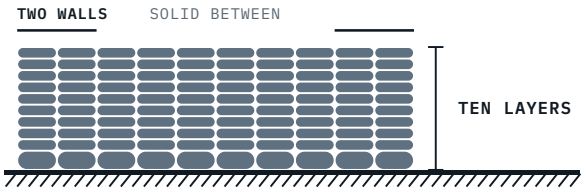
24 May: cap down

The first sleeve was an open ring with a wall 0.375 mm thick. The slicer would not start it: “empty initial layer”. One first-layer line was wider than the wall.

A floor with a hole in it was added to one end and the part was turned to print on it. The first layer is now a flat ring several beads across. It sliced without a raft and printed without trouble, in 95A.

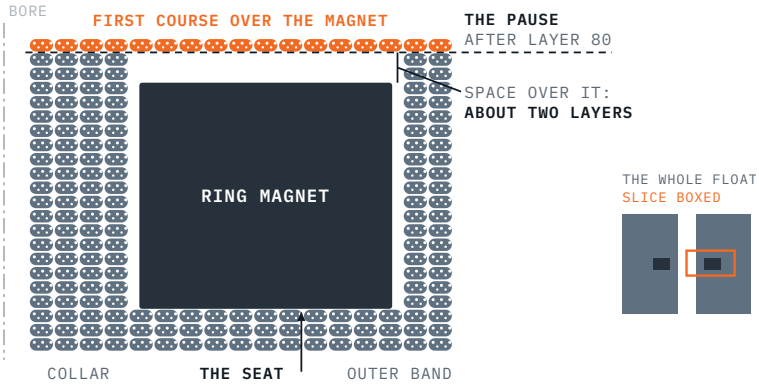
3 OCTOBER 2026 · AS IT PRINTED
The pocket walls stopped about one layer above the top of the magnet, so the first course across had almost no room under it.

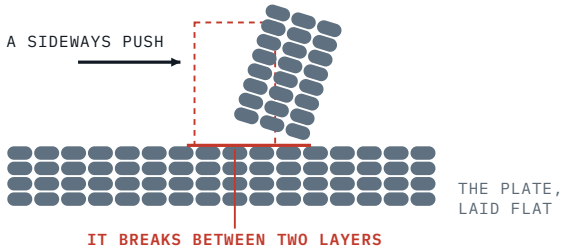
A PEG PRINTED WITH THE PLATE

23 TO 25 MAY 2026 · PET-CF
To save two screws the plate was given two printed pegs. One snapped off as the plate went in. Thinner ones snapped too. "they still don't fit, and they snap so easy because of the orientation of the layer lines. This is just not workable."

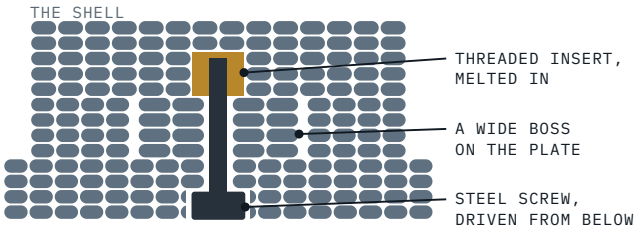
A SCREW THROUGH A WIDE BOSS

10 JUNE 2026 · PET-CF, AND PET-GF TODAY
Three wide bosses, each with a steel screw through it. The faucet is still held to its plate this way. This lesson was about layers, and it moved to PET-GF with nothing to change.
