IN-DEPTH STUDY REPORT: CONTROL TECHNOLOGY FOR CRYSTALLINE SILICA EXPOSURES IN CONSTRUCTION: FIELD EVALUATION OF CONTROL MEASURES FOR TUCK-POINTING

The Farell Building Huntington West Virginia

REPORT DATE August 2001

Report no 20 EPHB NO 247-XXX

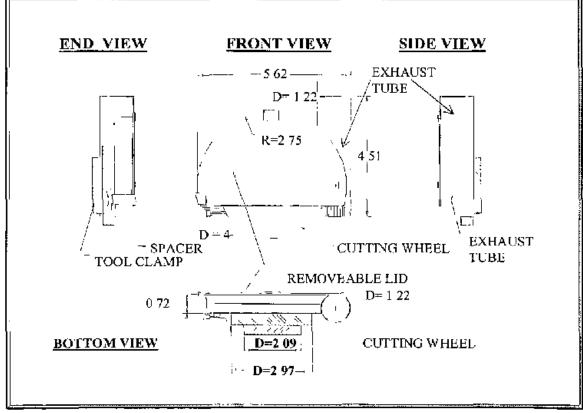
B. LINE DRAWING OF SHROUD

Figure 1 Photograph and detailed line drawing of Dustcontrol shroud. In this figure, all dimensions are in inches and "D=" indicates that the dimension is a diameter "R=" indicates that the dimension is a radius

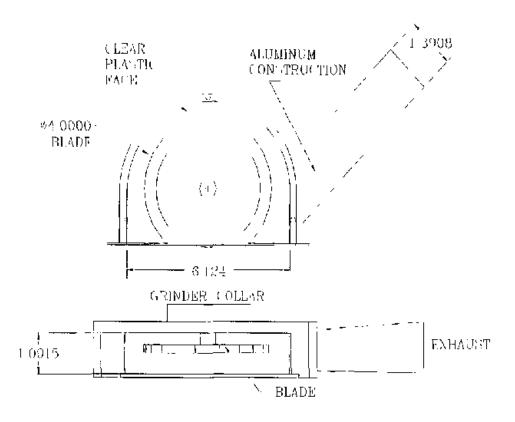
Figure 2 Schematic description of the Joe Due Shroud, dimensions are in inches

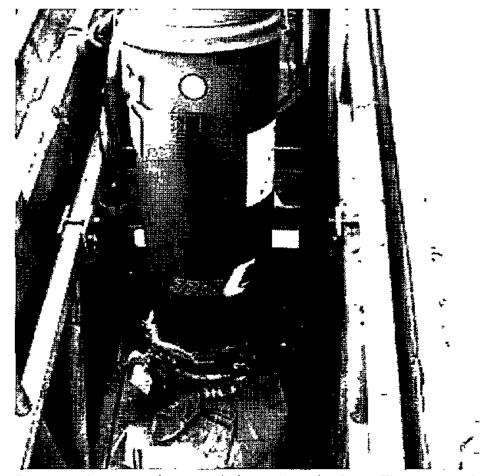
Figure 3 Dustcontrol vacuum cleaner with dust collected in bag. The vacuum cleaner barely fits into the swing stage. The plastic bag used for collecting dust is attached to the vacuum cleaner with a belt. To remove the bags, the worker went through the following motions the belt is unbuckled, the bag is twisted shut to tie it off, and the bag is set aside. This approach appears to minimize dust exposure associated with handling the collected dust

The Dustcontrol vacuum cleaners were awkward to use on the swing stage. These vacuum cleaners were located in the middle of the swing stages and the workers were not able to help one another. In the future, these vacuum cleaners should be hung from the ends of the swing stage. The workers seemed to stay markedly cleaner than other workers who perform the mortar removal tasks associated with tuckpointing. The workers were careful to routinely pulse the filters in order to maintain dust capture efficiency. The workers were pleased to use the control.

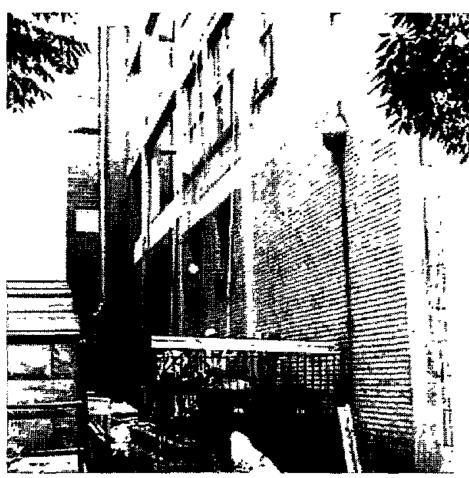
Figure 4 View of West side of Farell Building. This side of the building was being restored Deteriorated bricks and mortar were to be removed as part of a renovation project. Note that this is a very enclosed area.

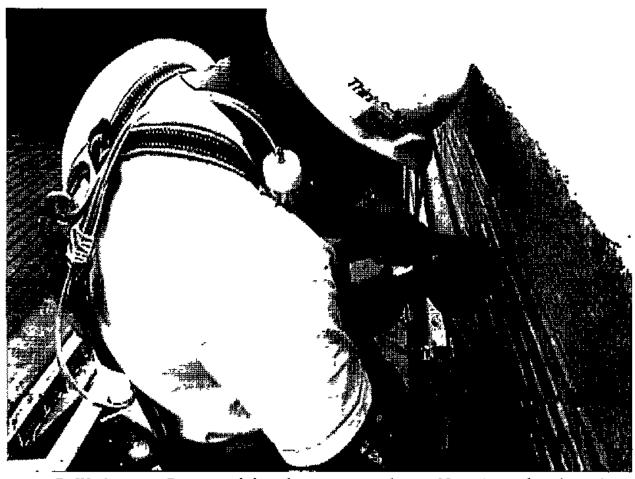
Figure 7 Worker using Dustcontrol shroud to cut a vertical joint. Note, the worker places the exhaust take off on the wall and rotates the grinder wheel into the mortar

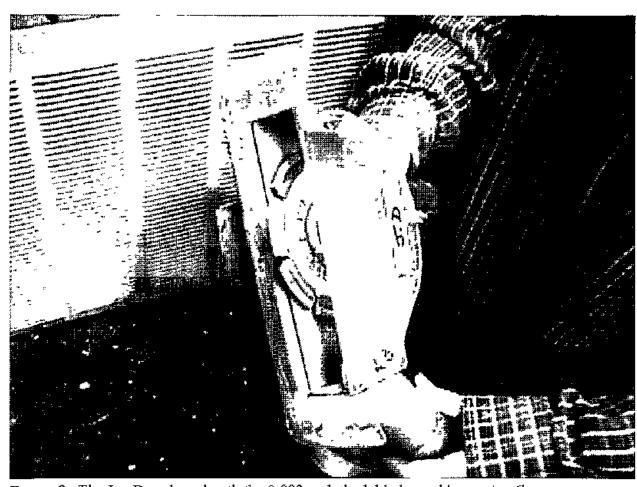
Figure 8 The Joe Due shroud with the 0 093 inch thick blade used by worker S

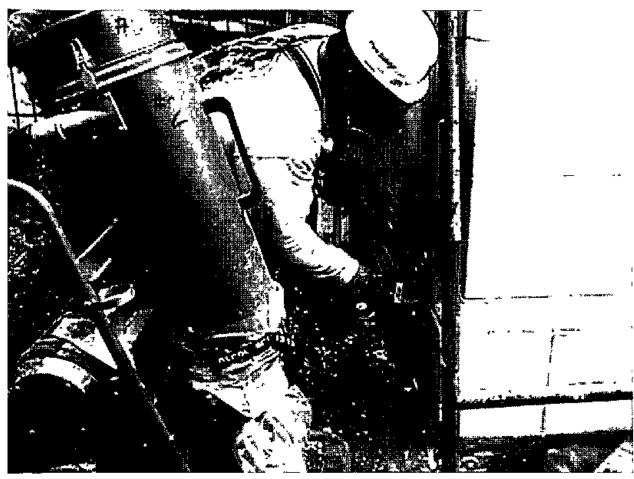
Figure 9 Worker cutting a vertical joint

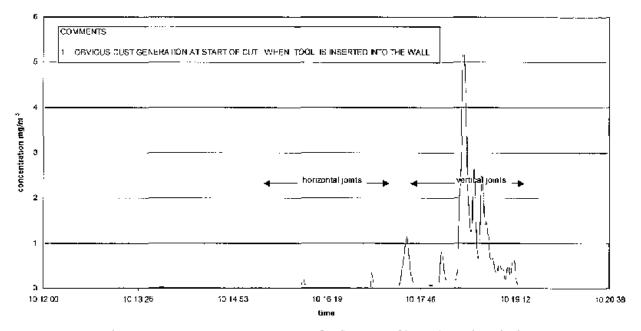
Figure 10 Video exposure monitoring results for Joe Due Shroud used with the Dustcontrol vacuum cleaner

Video exposure monitoring results are presented in Figures 10 -12. These results indicate that the ventilated shrouds do not provide complete dust control. In the video tape, highly visible dust plumes occurred when the shroud failed to capture the dust emitted by the grinding wheel. Shrouds used for capturing generated during grinding operation function as receiving boods. Typically, visible dust plumes occur when the shroud's exhaust take-off does not make physical contact with the wall. This occurs at the start of a horizontal cut on the bed joints and during the cutting of vertical (head) joints. When the shroud's exhaust take-off is not touching the wall, the dust plume flows under the exhaust take-off. The presence of a visible exhaust plume, did not always cause an exposure peak. Sometimes, the dust plume moved away from the worker and at other times, the plume caused an exposure peak. Thus, worker exposure is a function of dust emissions, workpractices that cause dust emissions, and the dispersion of these emissions toward or away from the worker.

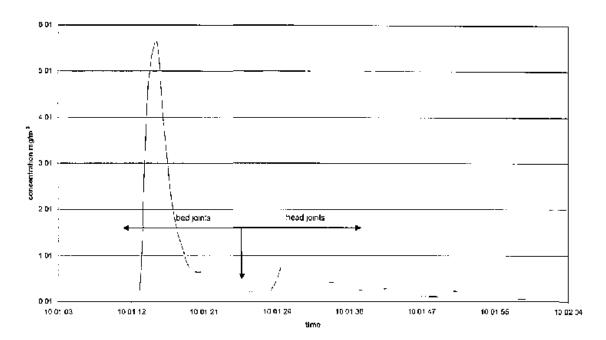
Figure 11 Video exposure monitoring results for Joe Due shroud used with the Portar-Cable vacuum cleaner

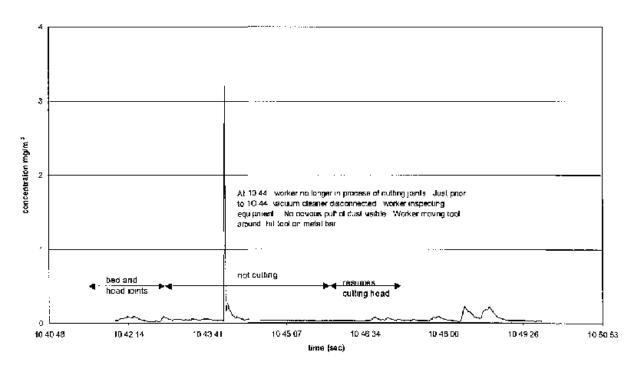
Figure 12 Video exposure monitoring results while worker was using the Dustcontrol shroud with the Dustcontrol vacuum cleaner
