PROJECT OVERVIEW: SUCCESSFUL FIELD-SCALE IN SITU THERMAL NAPL REMEDIATION

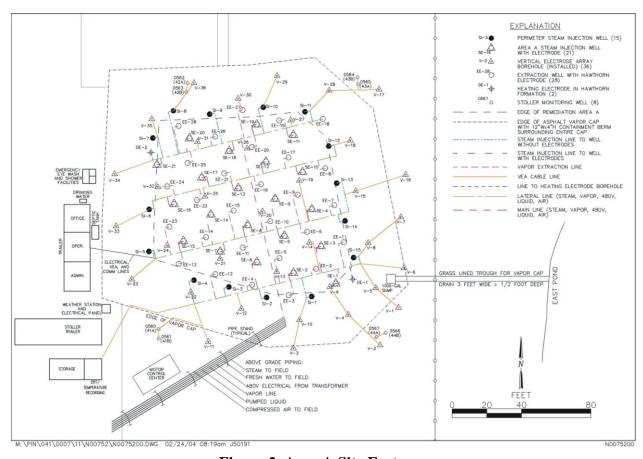
Figure 2. Area A Site Features

- Fifteen steam injection wells around the perimeter of Area A, 28 extraction wells with ET-DSP electrode wells that were spaced throughout Area A, 2 deep ET-DSP electrodes located in the clay layer, and 21 combined steam injection and ET-DSP wells. Figure 2 presents the well distribution.
