***FY 2015 Status Report:
CIRFT Testing of High-Burnup
Used Nuclear Fuel Rods from
Pressurized Water Reactor and
Boiling Water Reactor
Environments***

*September 4, 2015
M2-FCRD-UFD-2015-000101*

Jy-An John Wang, Hong Wang, Hao Jiang, and Y. Yan

Prepared by
OAK RIDGE NATIONAL LABORATORY
Oak Ridge, TN 37831-6283
managed by
UT-BATTELLE, LLC
for the
US DEPARTMENT OF ENERGY
under contract DE-AC05-00OR22725

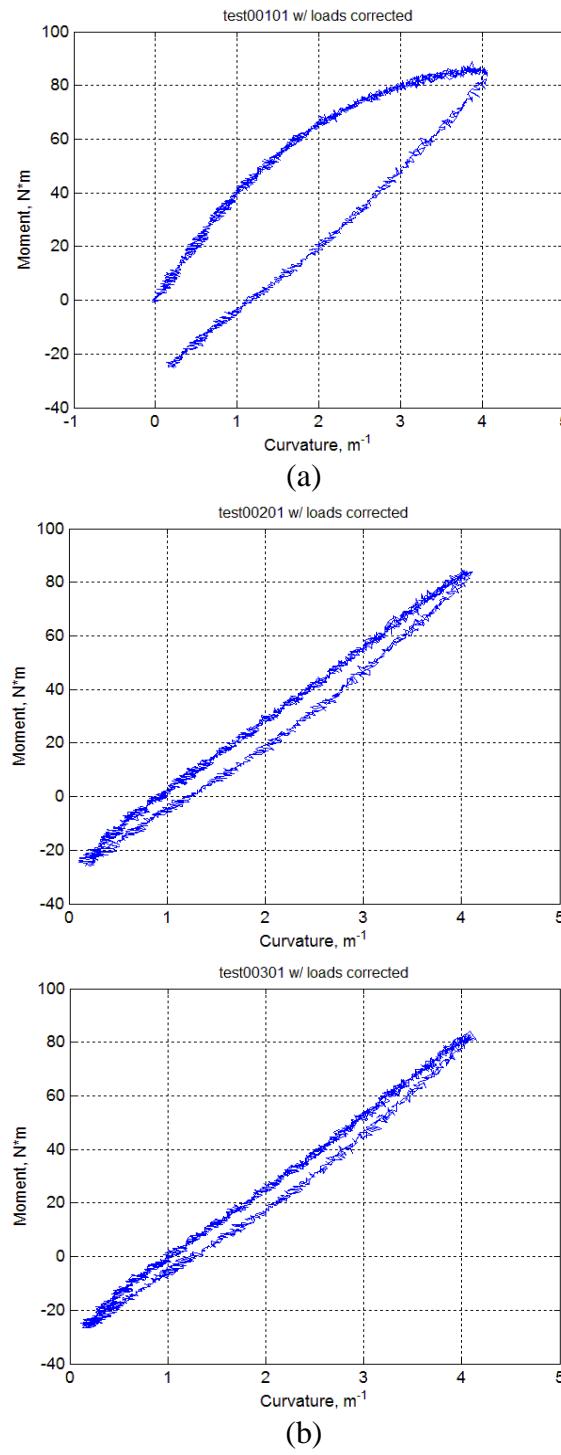
In order to observe the failure mode of the sample, a dynamic test was carried out at $\pm 25.4\text{ N}\cdot\text{m}$, 5 Hz. The lifetime of the rod (N_f) equaled 9.43×10^3 cycles. The rod ultimately failed in the gage section, as shown in Fig. 5.

The segments of tested rod specimens were observed under the hot cell stereomicroscope,¹³ and images were taken, as shown in Fig. 6. The fracture apparently occurred on the pellet-to-pellet interface. The pellets themselves fractured also, which is believed to be due to irradiation. Scratches can be seen as well, particularly along the longitudinal axis. However, the surface integrity of cladding appears to be generally maintained.

Fig. 4. Moment-curvature curves in (a) the first loading cycles and (b) the second and third cycles for the LMK01/574D-A rod.

Fig. 5. Fracture segments for the LMK01/574D-A rod that survived two cycles of loading to relative displacement of 24.0 mm with a maximum moment of around 85 N·m in the initial cycle. A follow-up dynamic test was carried out at ± 25.4 N·m, 5 Hz; $N_f = 9.4 \times 10^3$ cycles.

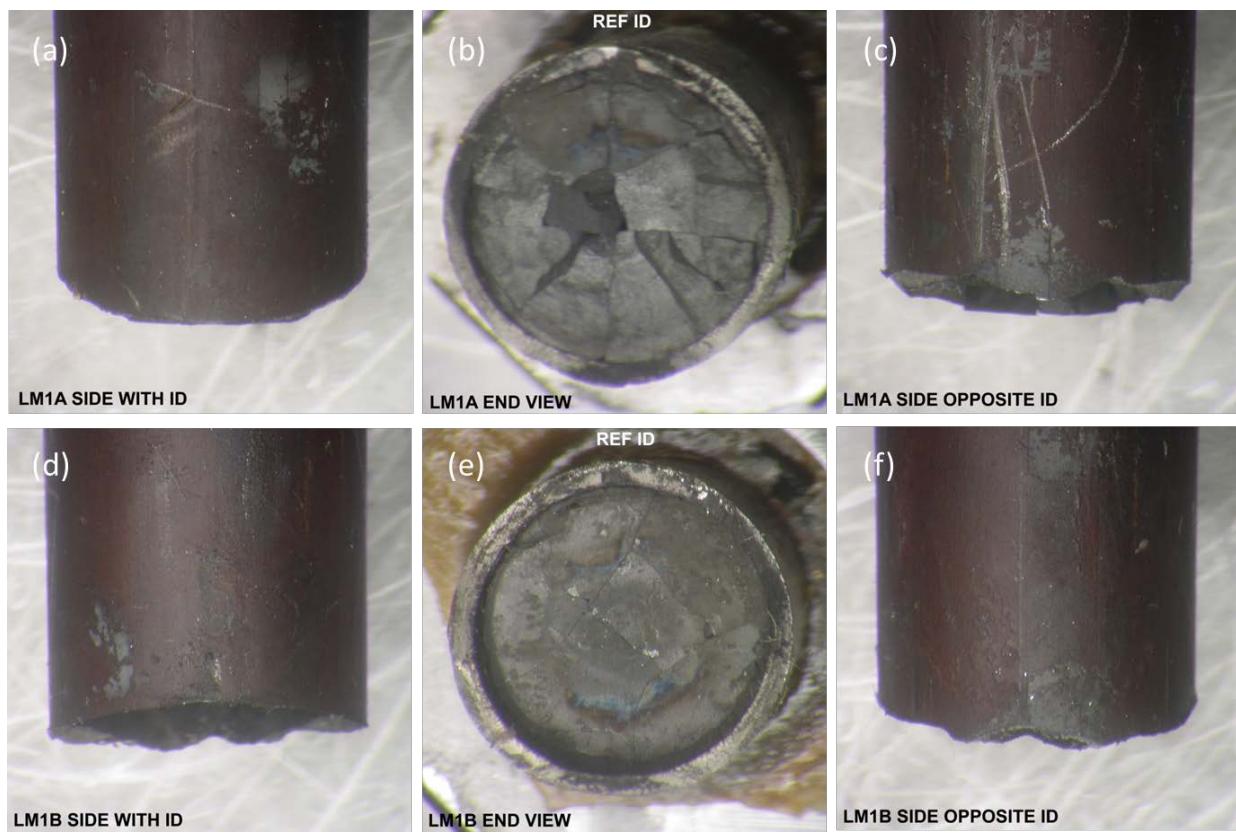
Fig. 6. Fracture segments for LMK01/574D-A. (a) and (d) show the specimen ID side of the segment on end caps A and B; (b) and (e) show the mating fracture surface; and (c) and (f) show the opposite specimen ID side of the segment on end caps A and B.

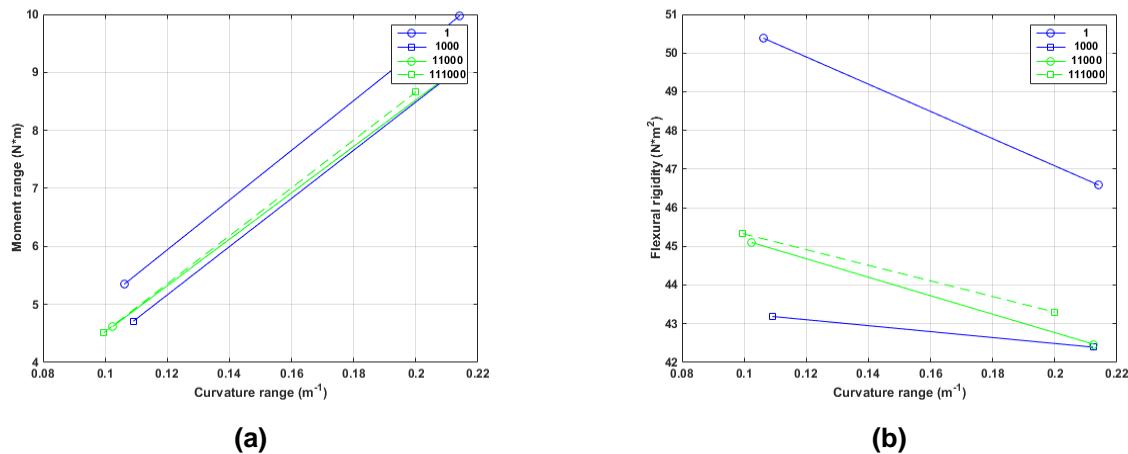
Fig. 7. (a) Moment-curvature range and (b) flexural rigidity-curvature range at various numbers of cycles for LMK02/575D-A. Measurements were made with 0.2 and 0.4 mm relative displacements; $N_f = 1.71 \times 10^5$ cycles at ± 12.70 N·m, 5 Hz.

The test on LMK02/575D-A was conducted at ± 12.70 N·m, 5 Hz. A lifetime of 1.71×10^5 cycles was obtained. Periodic quasistatic measurements of rod deformation were conducted using two relative displacement levels (0.2 and 0.4 mm) at the selected target number of cycles. The curvature range–moment range and flexural rigidity are illustrated in Fig. 7. The variations in these quantities as a function of number of cycles are further given in Fig. 8. The initial rigidity of the measurements at the two displacements was 47 to 50 N·m². The rigidity dropped a little near 10^3 cycles and stayed quite constant after that.

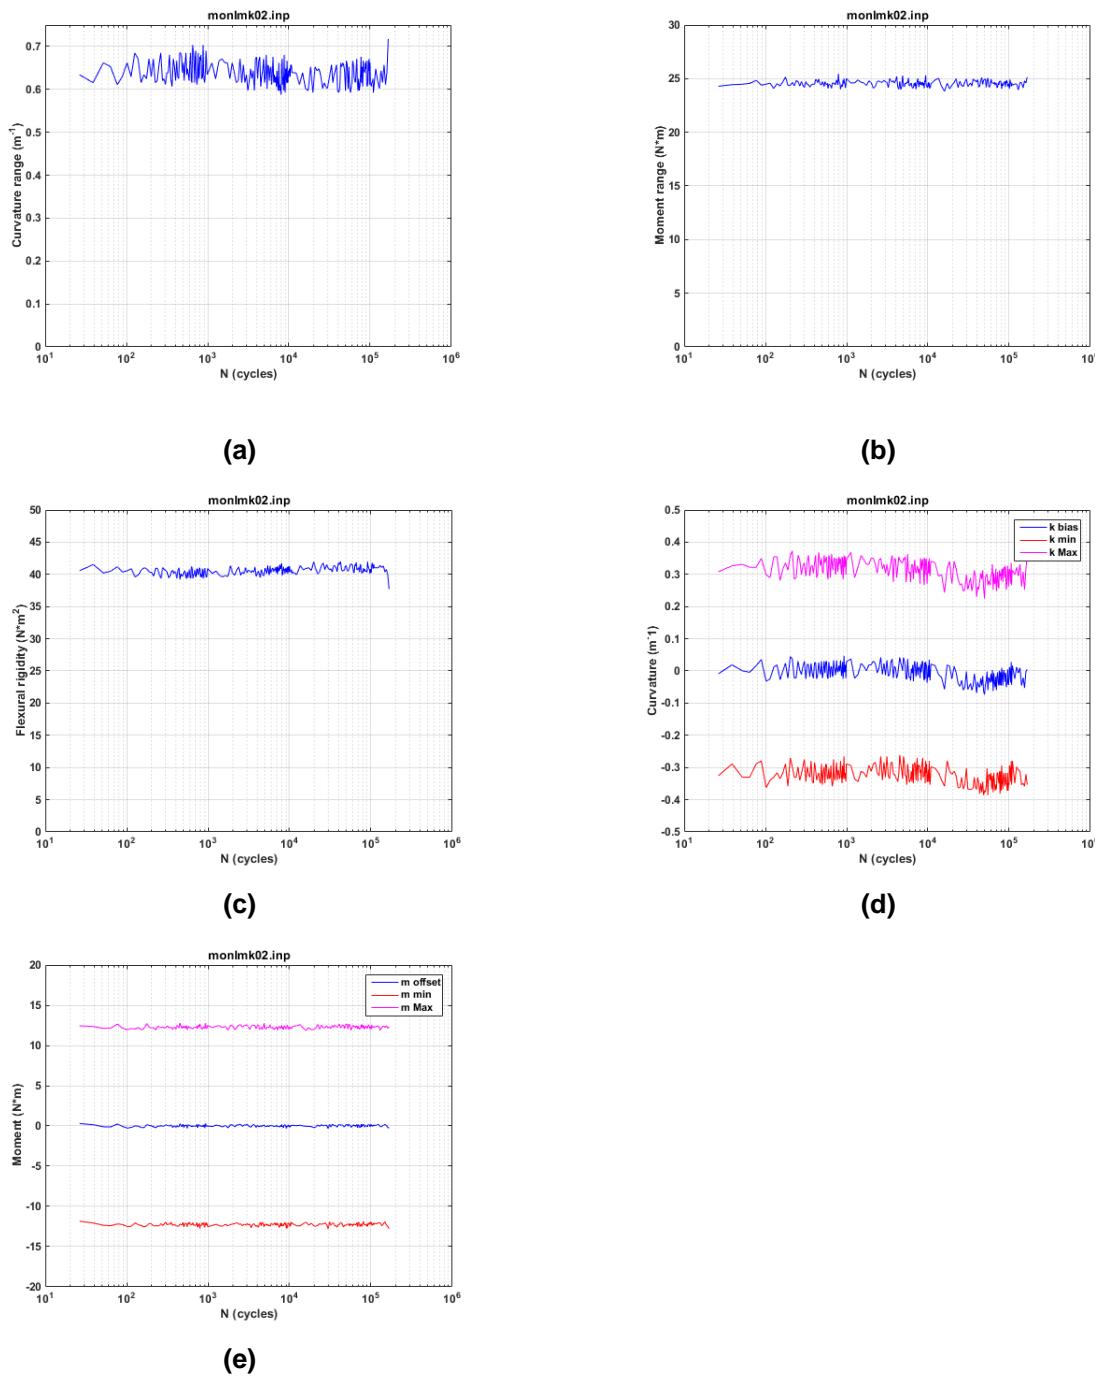
The curvature, moment, and flexural rigidity based on online monitoring data are presented in Fig. 9. The online monitoring showed a flexural rigidity of about 42 N·m², a little lower than that observed in measurements. This is believed to be because different loading conditions were used in measurement and cycling. A sudden drop of flexural rigidity was observed. Overall, a quite stable response was seen before the final failure. The peak and valley of curvature and moment waveforms were also monitored, as shown in the same figure, and it can be seen that there was no significant offset of curvature during whole fatigue testing.

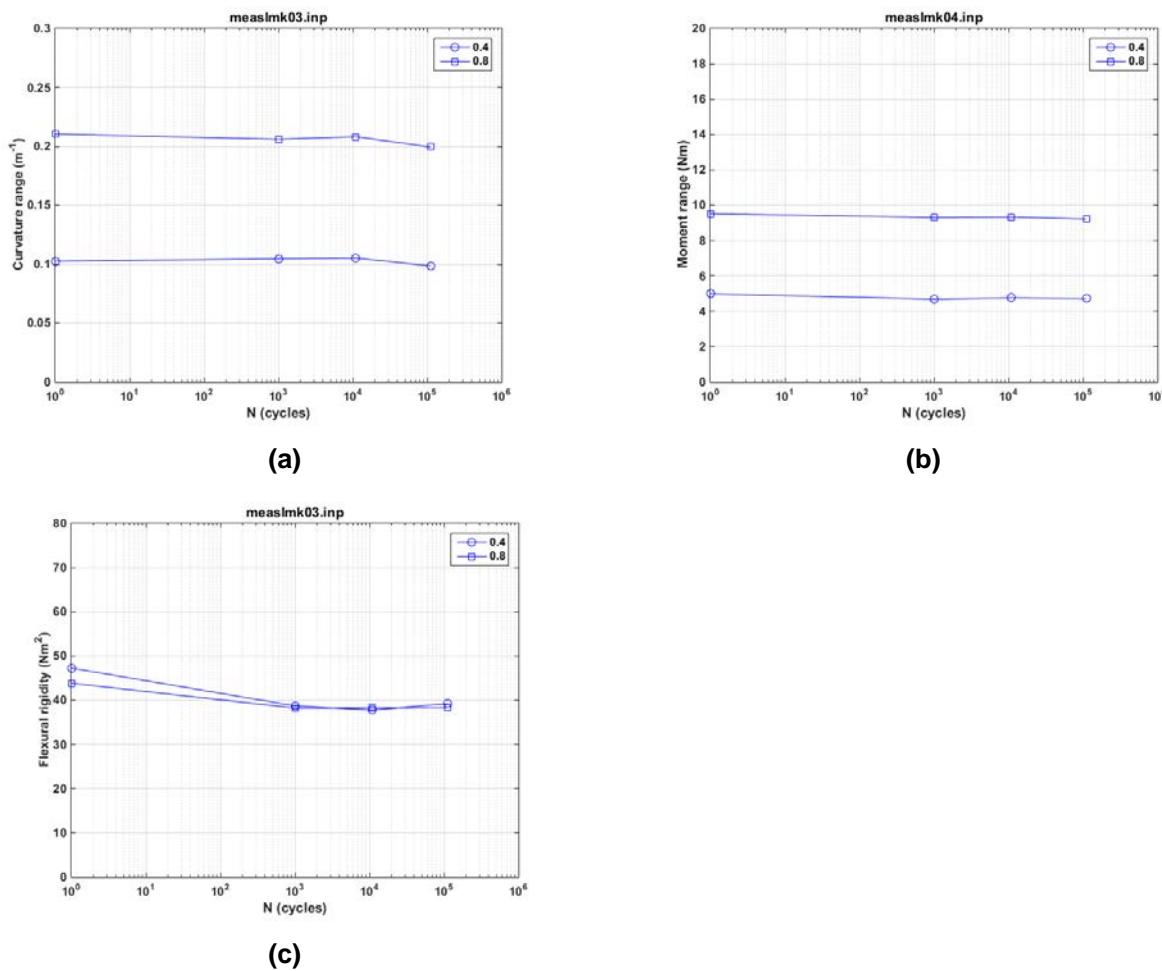
Fig. 11. Variations in (a) curvature range, (b) moment range, and (c) flexural rigidity as a function of the number of cycles for LMK03/575B-A; $N_f = 4.92 \times 10^5$ cycles at ± 10.16 N·m, 5 Hz.

Periodic quasistatic measurements of rod deformation were conducted using two relative displacement levels (0.2 and 0.4 mm) at the selected target number of cycles. The variations in curvature range, moment range, and flexural rigidity as a function of number of cycles are given in Fig. 11. The rigidity of the measurements at the two displacements started with 44 to $48 \text{ N}\cdot\text{m}^2$, dropped to less than $40 \text{ N}\cdot\text{m}^2$ around 10^3 cycles, and remained nearly at a constant level afterwards.

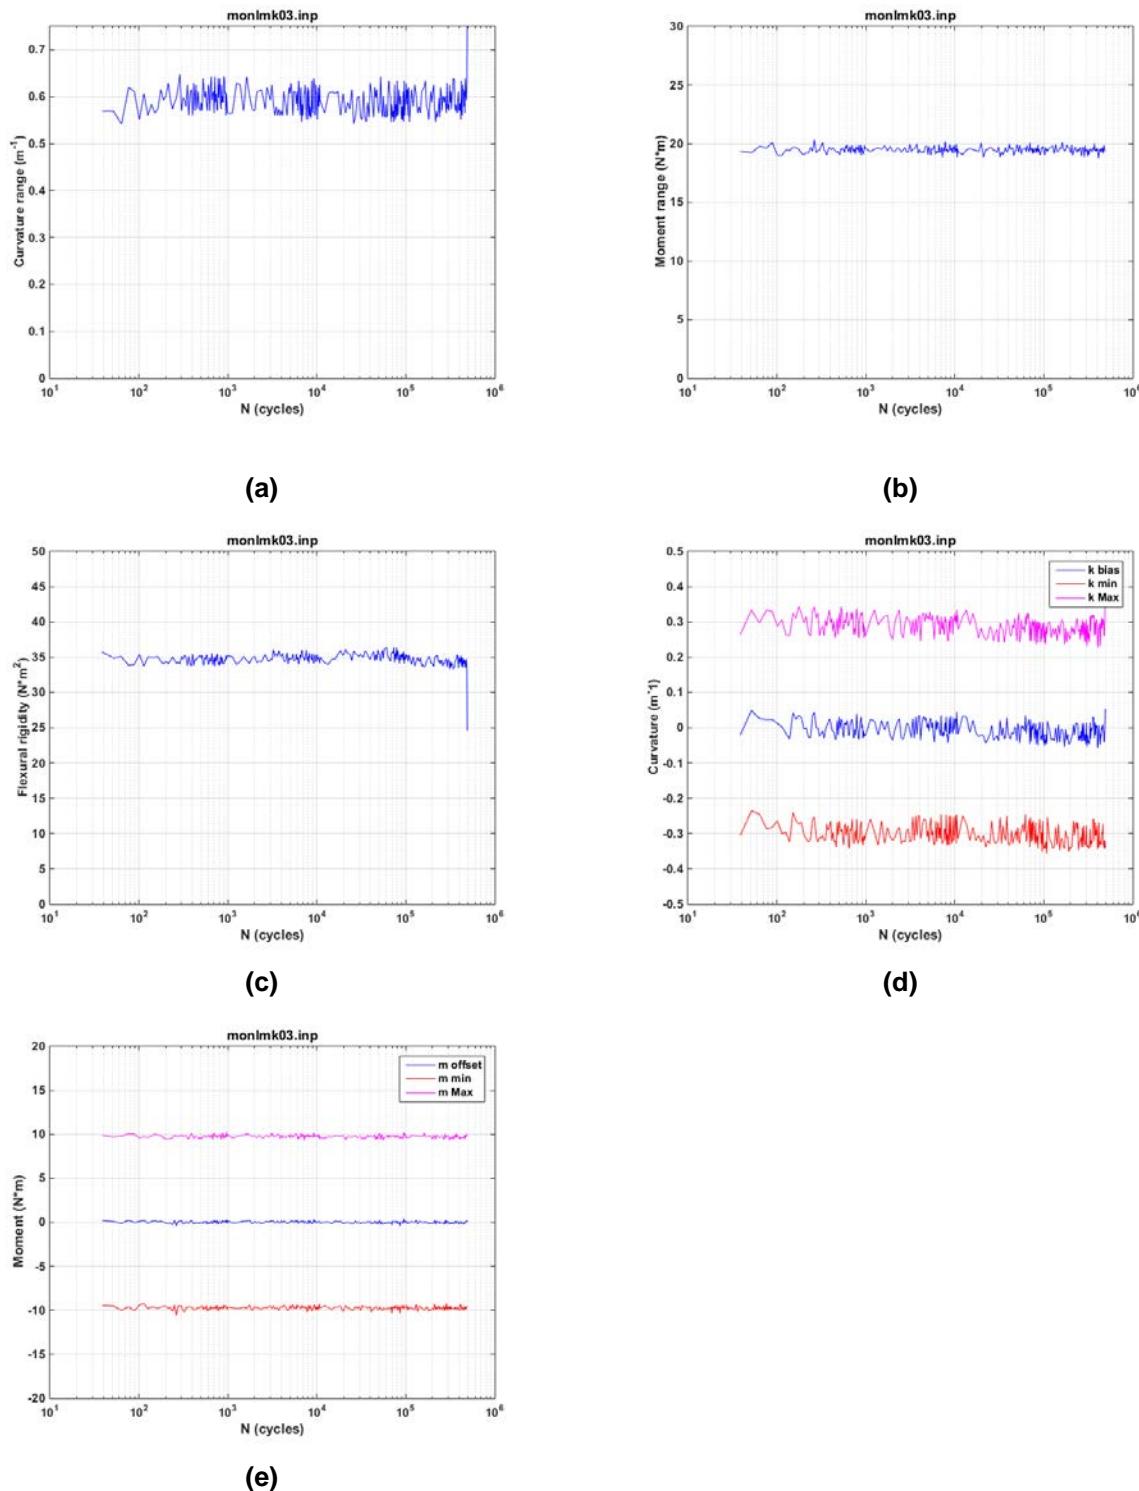
The curvature, moment, and flexural rigidity based on online monitoring data are presented in Fig. 12. The online monitoring showed a flexural rigidity of about $35 \text{ N}\cdot\text{m}^2$, a little lower than that observed in measurements. Again, an abrupt decrease in flexural rigidity was seen before the final failure.

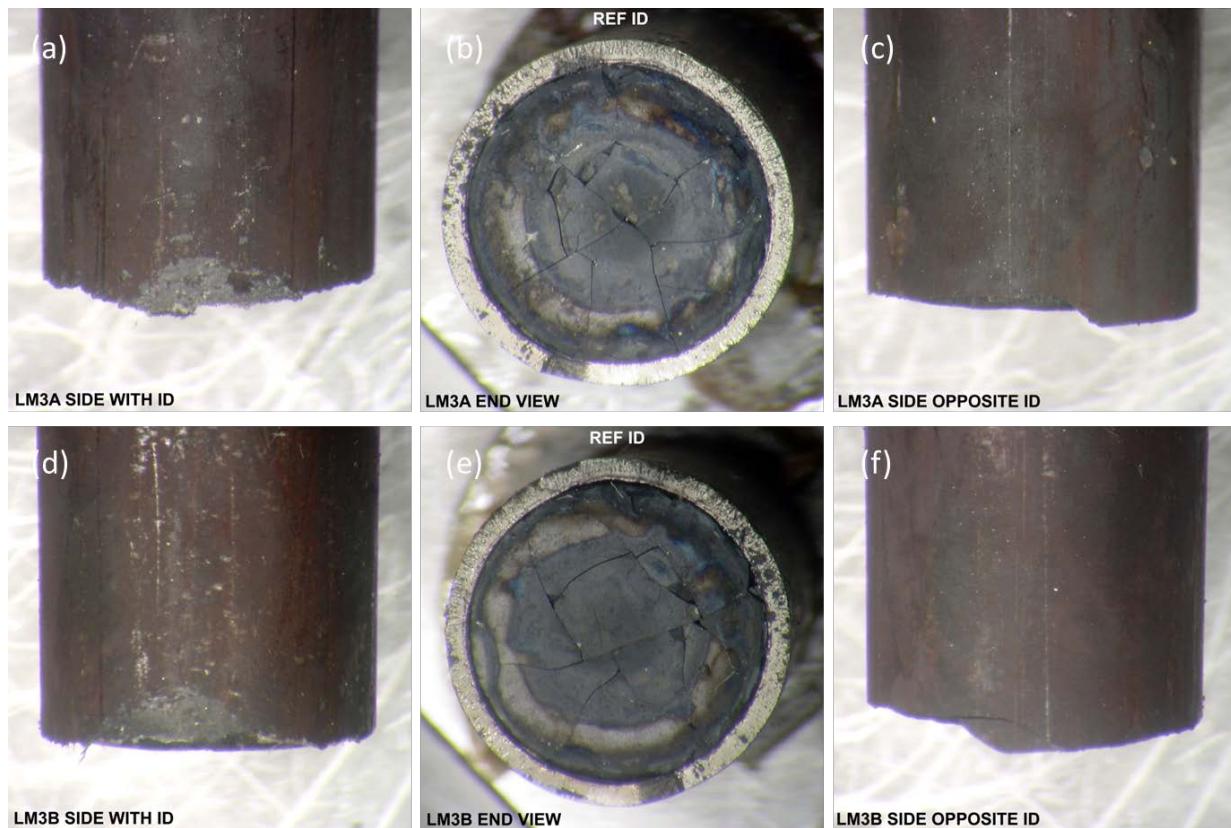
Fig. 14. Fracture segments for LMK03/575B-A. (a) and (d) show the specimen ID side of the segment on end caps A and B; (b) and (e) show the mating fracture surface; and (c) and (f) show the opposite specimen ID side of the segment on end caps A and B.

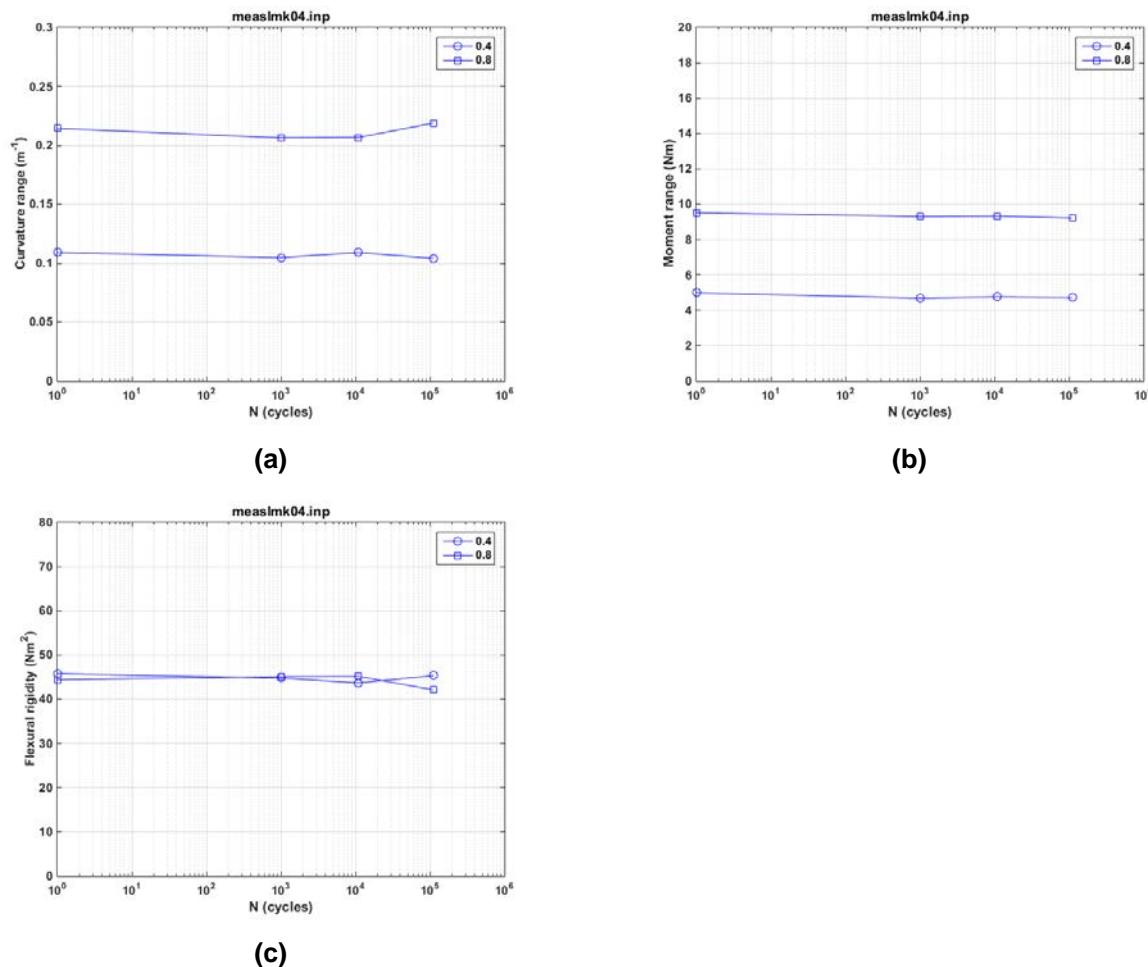
Fig. 15. Variations in (a) curvature range, (b) moment range, and (c) flexural rigidity as a function of the number of cycles for LMK05/574D-B; $N_f = 2.49 \times 10^5$ cycles at $\pm 8.64 \text{ N}\cdot\text{m}$, 5 Hz.

The test on the LMK05/574D-B rod was conducted at $\pm 8.64 \text{ N}\cdot\text{m}$, 5 Hz. The lifetime of the specimen was 2.49×10^5 cycles. Periodic quasistatic measurements of rod deformation were conducted using two relative displacement levels (0.2 and 0.4 mm) at the selected target number of cycles. The variations in curvature range, moment range, and flexural rigidity as a function of number of cycles are given in Fig. 15. With an initial level of $45 \text{ N}\cdot\text{m}^2$, the rigidity of the measurements at the two displacements stayed almost at a constant level over the entire fatigue testing process.

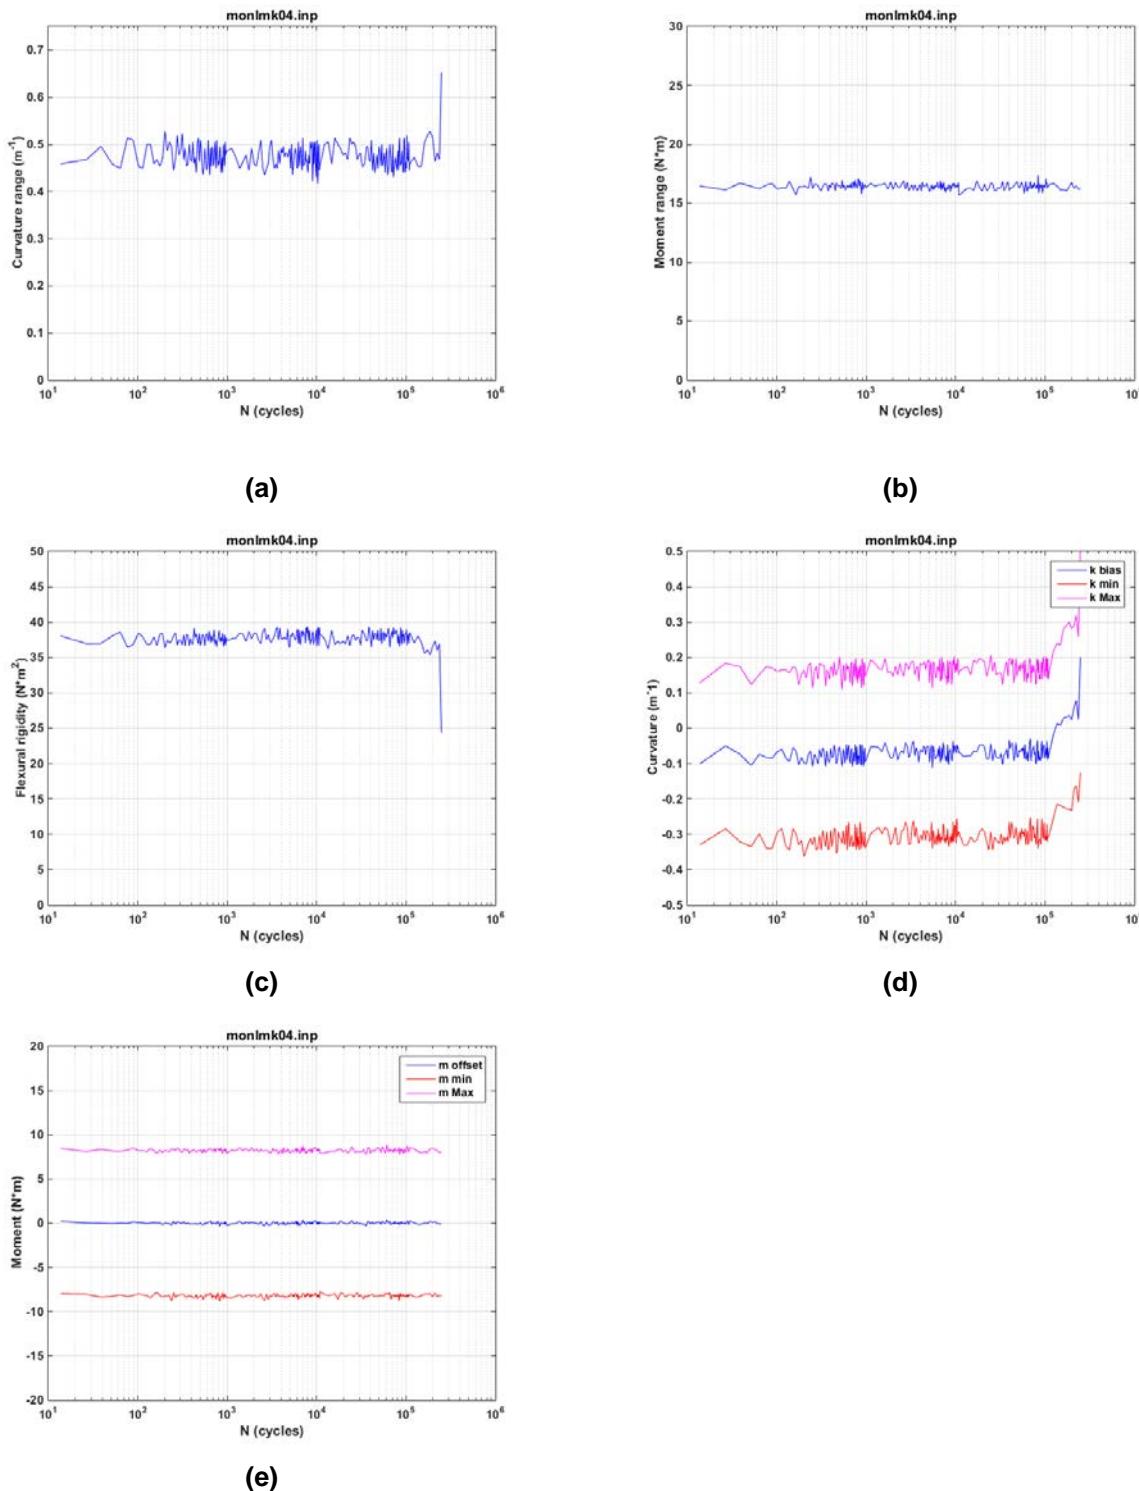
The curvature, moment, and flexural rigidity based on online monitoring data are presented in Fig. 16. The online monitoring showed a flexural rigidity of about $37.5 \text{ N}\cdot\text{m}^2$ in most of the testing. An abrupt drop was observed again before the final failure of the specimen. In addition, curvature waveform demonstrated a negative curvature offset of about -0.075 m^{-1} and drifting at 10^5 cycles. The drift may be related to the tightening of bolts in specimen grips. Compared to LMK03, a shorter lifetime was obtained even though a lower moment amplitude was used. Whether the uncertainty of the testing result is caused by variation in the initial condition of the segment remains to be investigated.

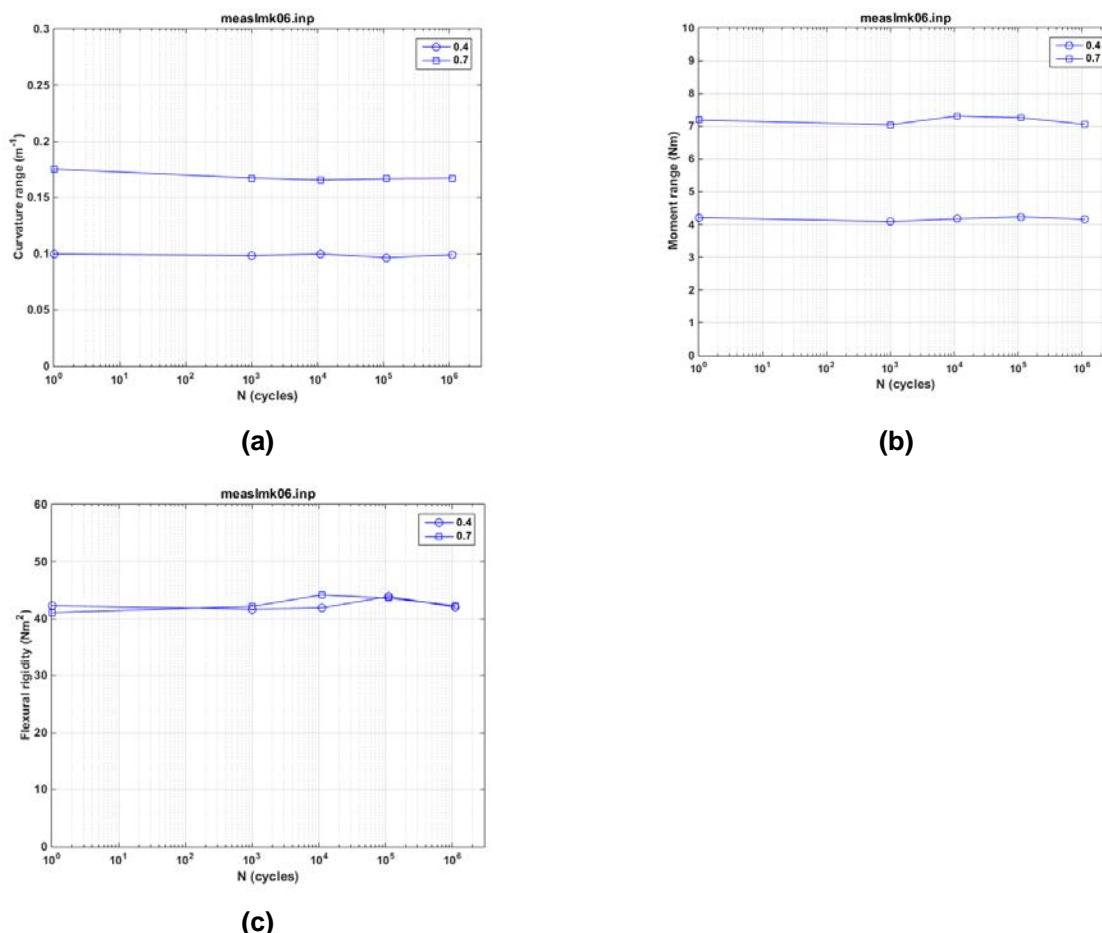
Fig. 17. Variations in (a) curvature range, (b) moment range, and (c) flexural rigidity as a function of the number of cycles for LMK06/575D-E; $N_f = 1.79 \times 10^6$ cycles at $\pm 7.62 \text{ N}\cdot\text{m}$, 5 Hz.

The test on the LMK06/575D-E rod was conducted at $\pm 7.62 \text{ N}\cdot\text{m}$, 5 Hz. The lifetime of the specimen was 1.79×10^6 cycles. Periodic quasistatic measurements of rod deformation were conducted using two relative displacement levels (0.2 and 0.35 mm) at the selected target number of cycles. The variations in curvature range, moment range, and flexural rigidity as a function of the number of cycles are given in Fig. 17. The rigidity of the measurements was observed to fluctuate slightly, but it essentially stayed around $42 \text{ N}\cdot\text{m}^2$ during the cyclic testing.

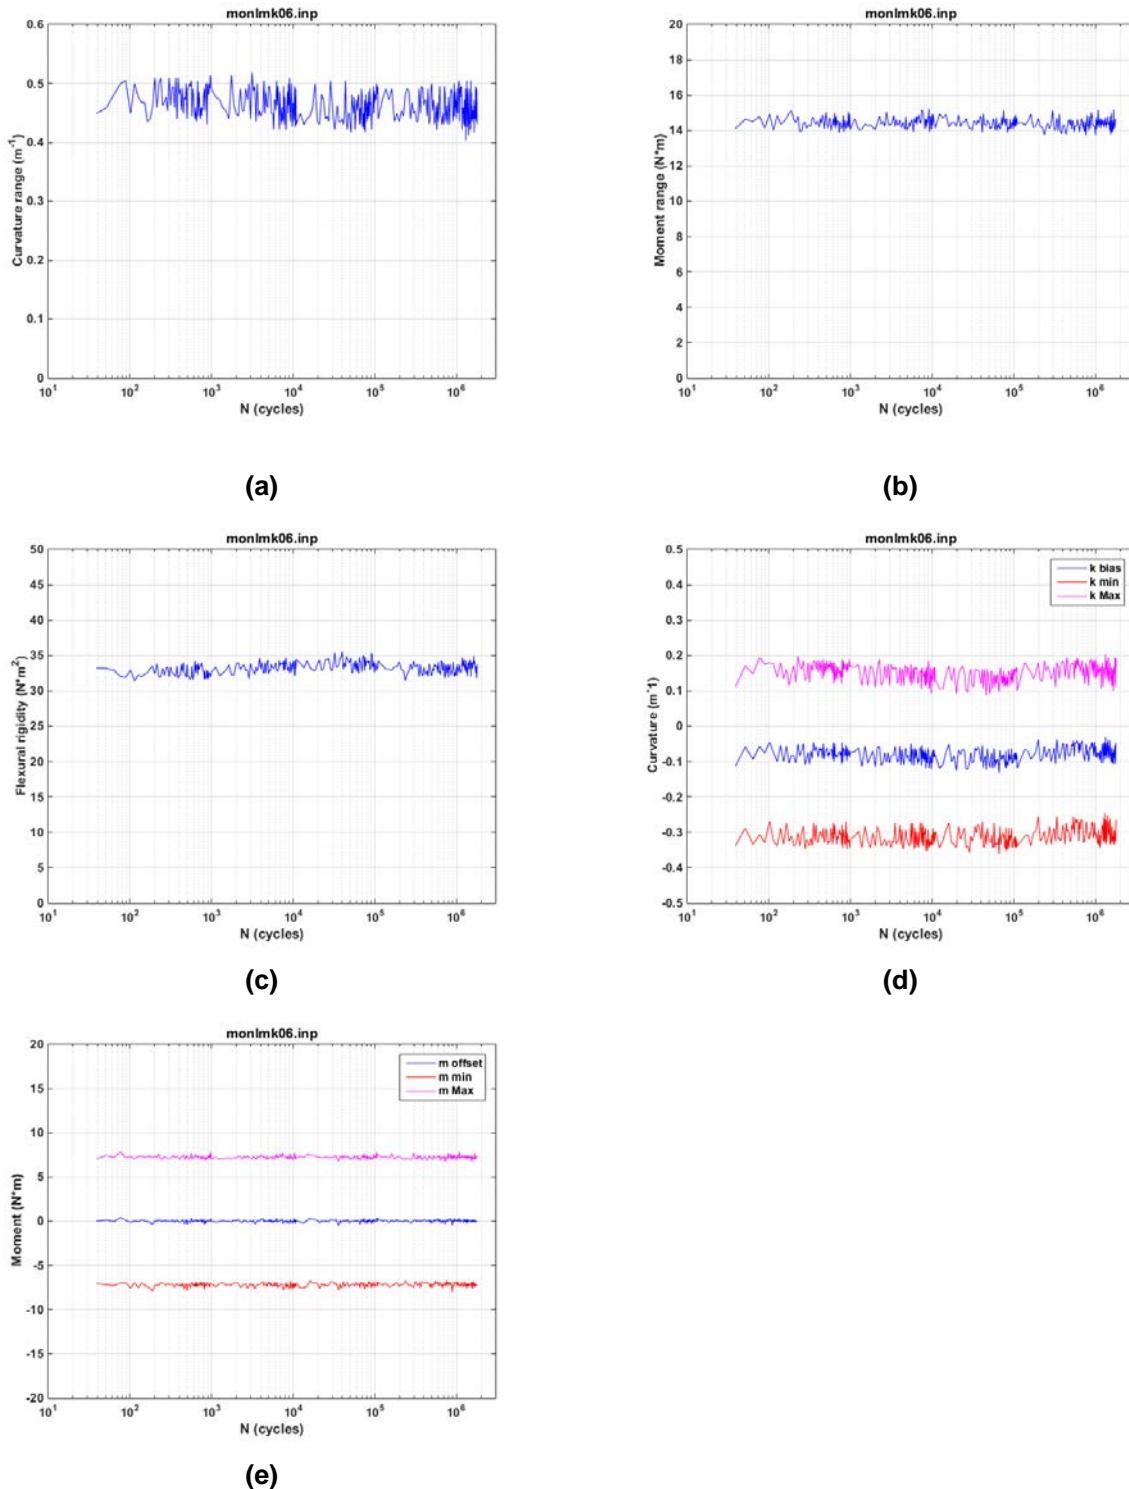
The curvature, moment, and flexural rigidity based on online monitoring data are presented in Fig. 18. The online monitoring showed a flexural rigidity of about $33 \text{ N}\cdot\text{m}^2$, slightly lower than that observed in measurements. Overall, a quite stable rod response was exhibited before the final failure. At the same time, a negative curvature offset of approximately -0.075 m^{-1} was observed from the peak and valley monitoring of waveform.

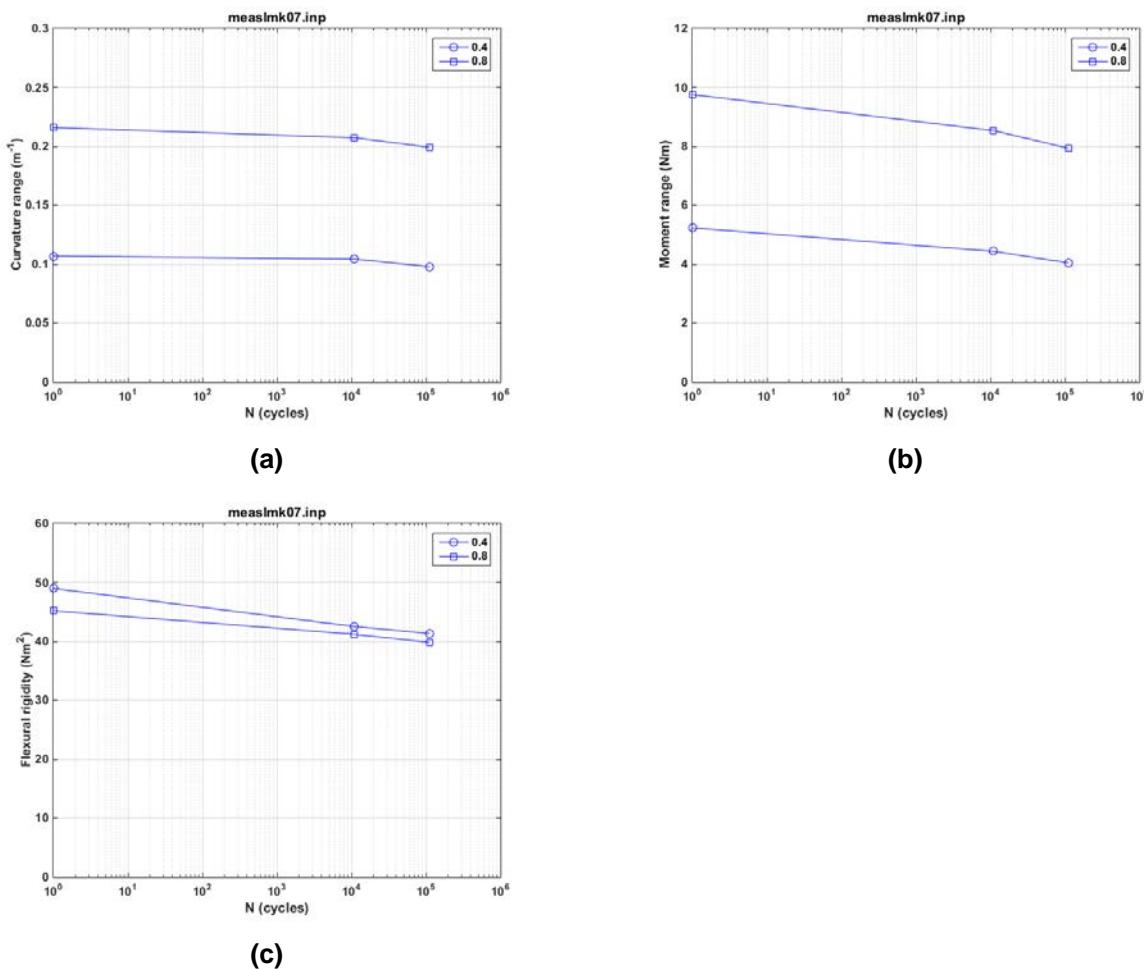
Fig. 19. Variations in (a) curvature range, (b) moment range, and (c) flexural rigidity as a function of the number of cycles for LMK07/575C-A; $N_f = 1.22 \times 10^5$ cycles at ±15.24 N·m, 5 Hz.

The test on the LMK07/575C-A rod was conducted at $\pm 15.24 \text{ N}\cdot\text{m}$, 5 Hz. The lifetime of the specimen was 1.22×10^5 cycles. Periodic quasistatic measurements of rod deformation were conducted using two relative displacement levels (0.2 and 0.4 mm) at the selected target number of cycles. The variations in curvature range, moment range, and flexural rigidity as a function of number of cycles are given in Fig. 19. As can be seen, there was a significant decrease in rigidity near 10^5 cycles from 45–50 to $\sim 40 \text{ N}\cdot\text{m}^2$, corresponding to the high moment cycling.

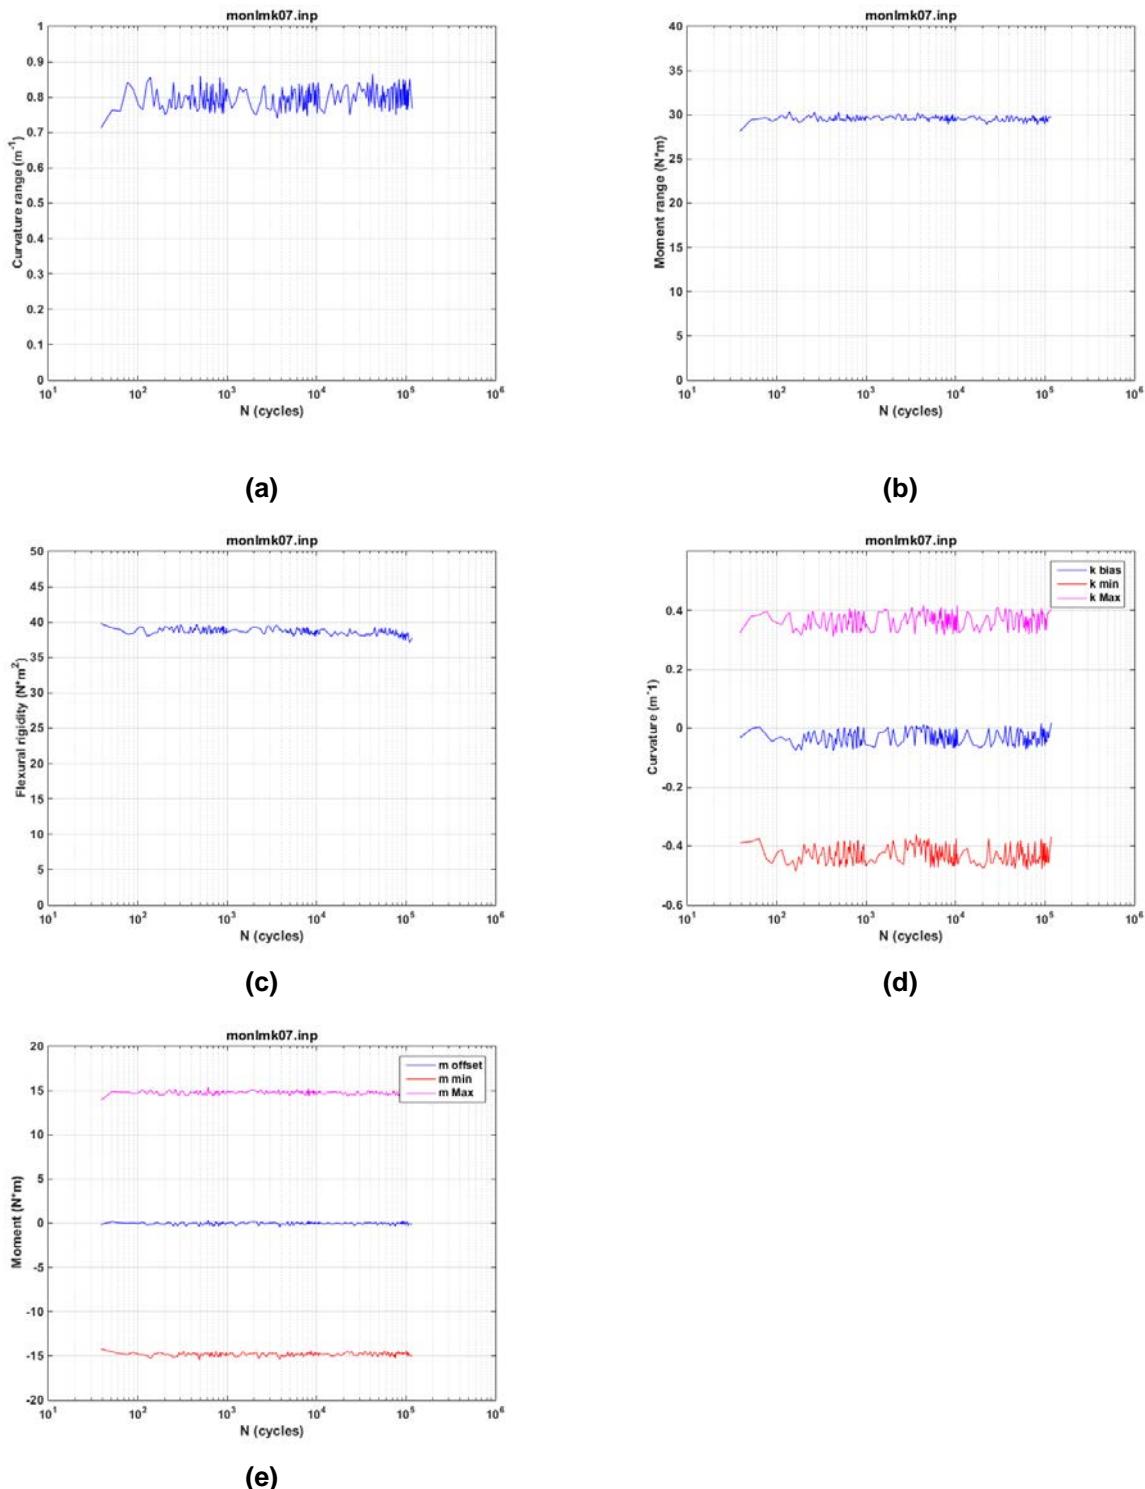
The curvature, moment, and flexural rigidity based on online monitoring data are presented in Fig. 20. The online monitoring showed a flexural rigidity of about $38 \text{ N}\cdot\text{m}^2$, a little lower than that observed in measurements. Essentially, no significant change can be observed with the monitored flexural rigidity over the cyclic testing process, except a slight downward bend of the curve near 7×10^4 cycles. At the same time, a little negative curvature offset (-0.05 m^{-1}) was observed.

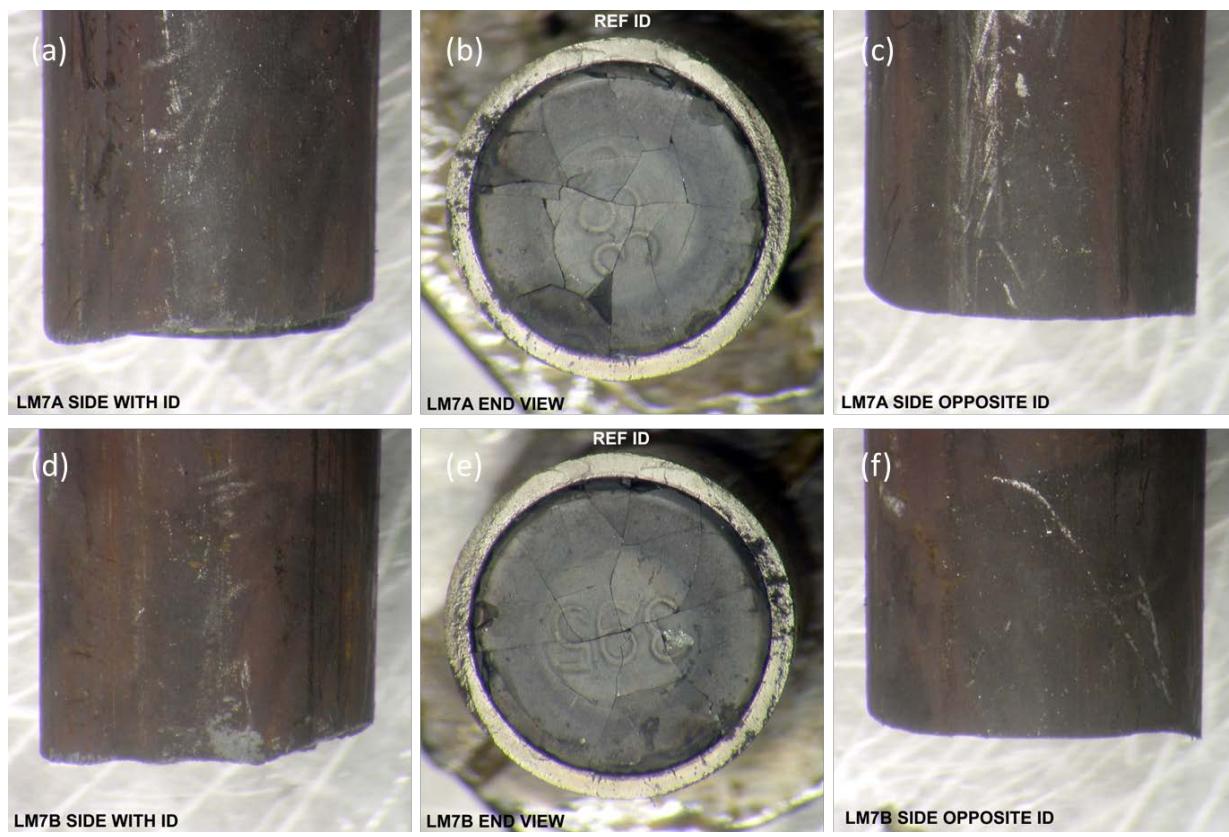
Fig. 21. Fracture segments for LMK07/575C-A. (a) and (d) show the specimen ID side of the segments on end caps A and B; (b) and (e) show the mating fracture surface; and (c) and (f) show the opposite specimen ID side of the segment on end caps A and B.

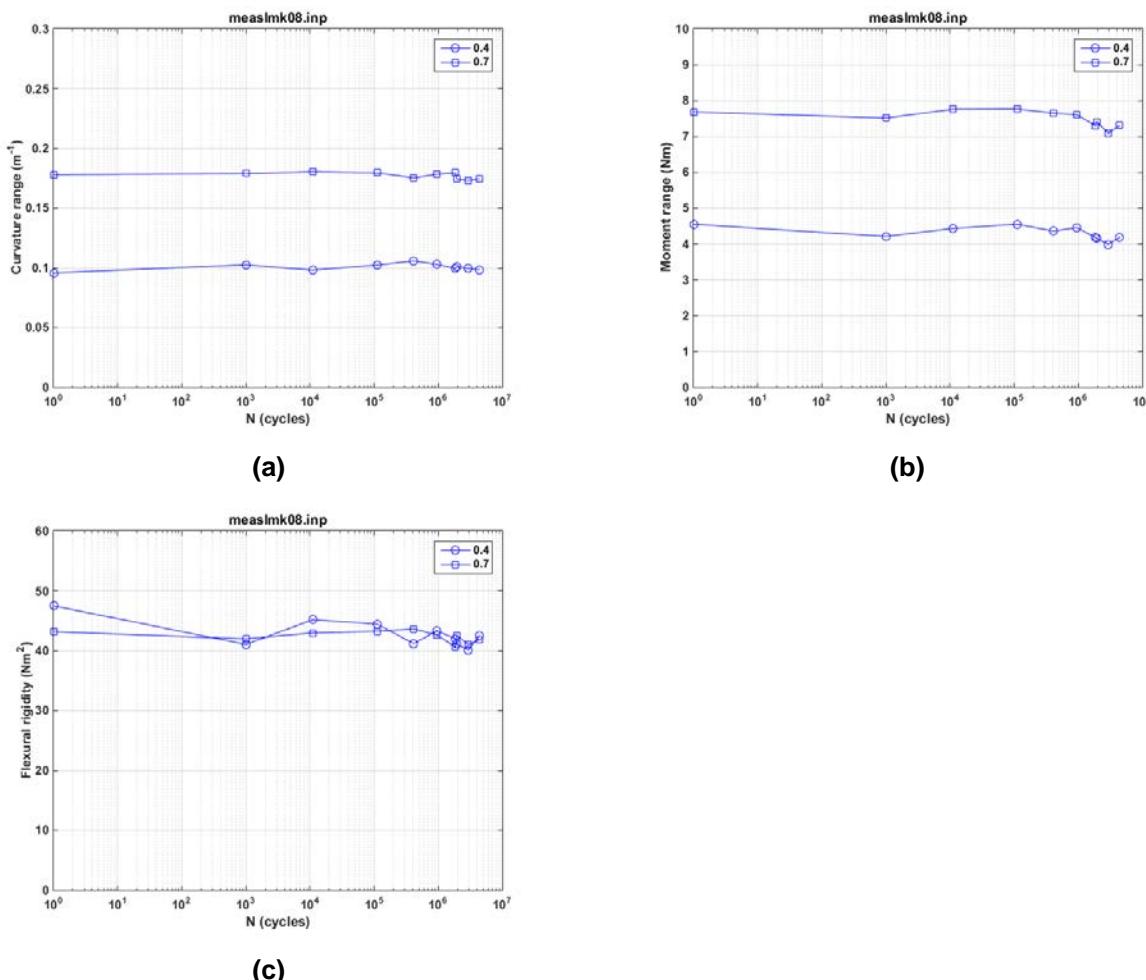
Fig. 22. Variations in (a) curvature range, (b) moment range, and (c) flexural rigidity as a function of the number of cycles for LMK08/575B-D. Measurements were made with 0.2 and 0.35 mm relative displacements; $N_f = 4.70 \times 10^6$ cycles at ± 7.62 N·m, 5 Hz.

The test on the LMK08/575B-D rod was conducted at ± 7.62 N·m, 5 Hz. The specimen failed at 4.70×10^6 cycles. Periodic quasistatic measurements of rod deformation were conducted using two relative displacement levels (0.2 and 0.35 mm) at the selected target number of cycles. The variations in curvature range, moment range, and flexural rigidity as a function of the number of cycles are given in Fig. 22. The rigidity of the measurements at two displacements started with 43 to 47 N·m² and demonstrated a slight decreasing trend.

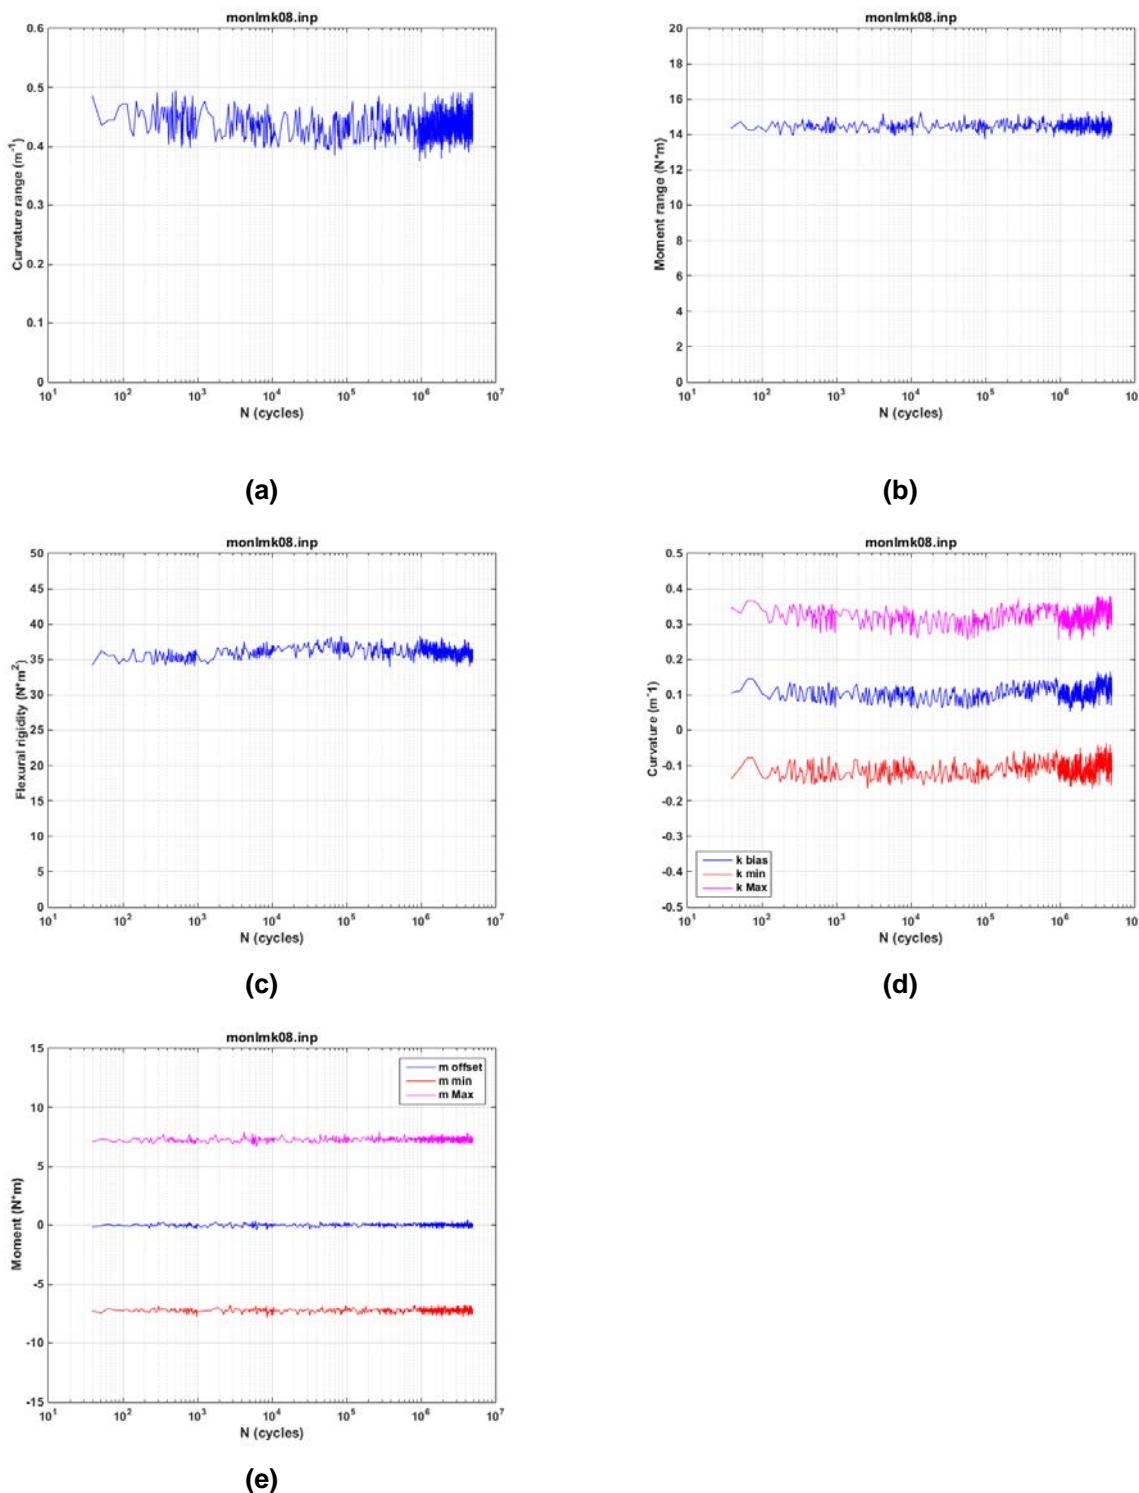
The curvature, moment, and flexural rigidity based on online monitoring data are presented in Fig. 23. The online monitoring showed a flexural rigidity of about 36.5 N·m², slightly lower than that observed in the measurements. This was mainly because different loading conditions were used in the measurement and cycling. Overall, a quite steady response was exhibited over the entire cyclic testing period. Meanwhile, a positive curvature offset of 0.1 m^{-1} was seen during the cyclic fatigue process.

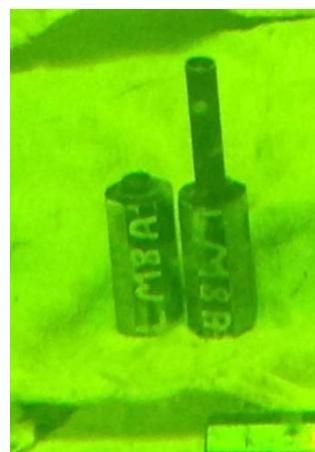
Fig. 24. Fracture segments for LMK08/575B-D; $N_f = 4.70 \times 10^6$ cycles at $\pm 7.62 \text{ N}\cdot\text{m}$, 5 Hz.

Failure of the specimen occurred in the gage section, as shown in Fig. 24.
