***FY 2015 Status Report:
CIRFT Testing of High-Burnup
Used Nuclear Fuel Rods from
Pressurized Water Reactor and
Boiling Water Reactor
Environments***

*September 4, 2015
M2-FCRD-UFD-2015-000101*

Jy-An John Wang, Hong Wang, Hao Jiang, and Y. Yan

Prepared by
OAK RIDGE NATIONAL LABORATORY
Oak Ridge, TN 37831-6283
managed by
UT-BATTELLE, LLC
for the
US DEPARTMENT OF ENERGY
under contract DE-AC05-00OR22725

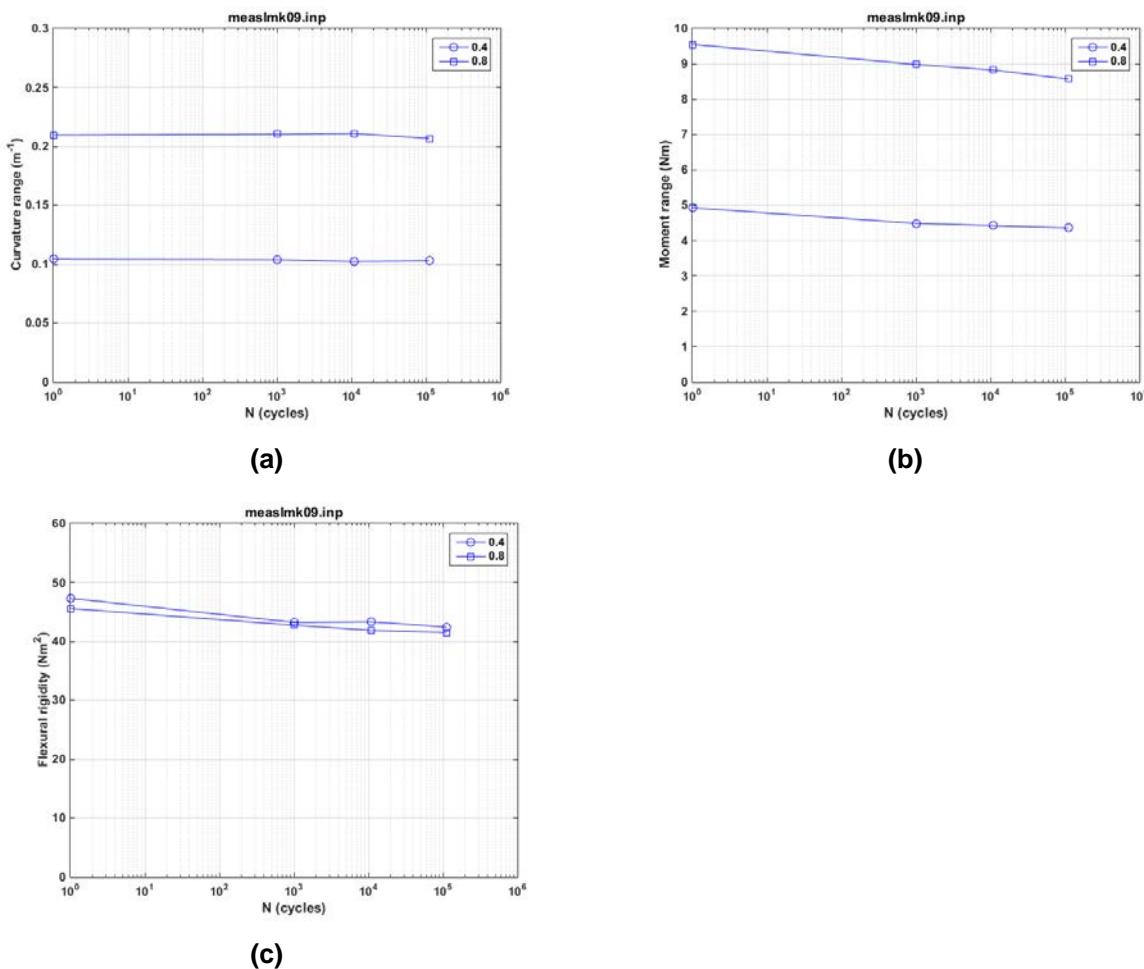
Fig. 25. Variations in (a) curvature range, (b) moment range, (c) flexural rigidity as a function of the number of cycles for LMK09/574D-D. Measurements were made with 0.2 and 0.4 mm relative displacements; $N_f = 7.31 \times 10^5$ cycles at ± 10.16 N·m, 5 Hz.

The test on the LMK09/574D-D rod was conducted at $\pm 10.16 \text{ N}\cdot\text{m}$, 5 Hz. The specimen failed at 7.31×10^5 cycles. Periodic quasistatic measurements of rod deformation were conducted using two relative displacement levels (0.2 and 0.4 mm) at the selected target number of cycles. The variations in curvature range, moment range, and flexural rigidity as a function of the number of cycles are given in Fig. 25. The rigidity of the measurements at two displacements started with 45 to 47 $\text{N}\cdot\text{m}^2$ and demonstrated a slight decreasing trend.

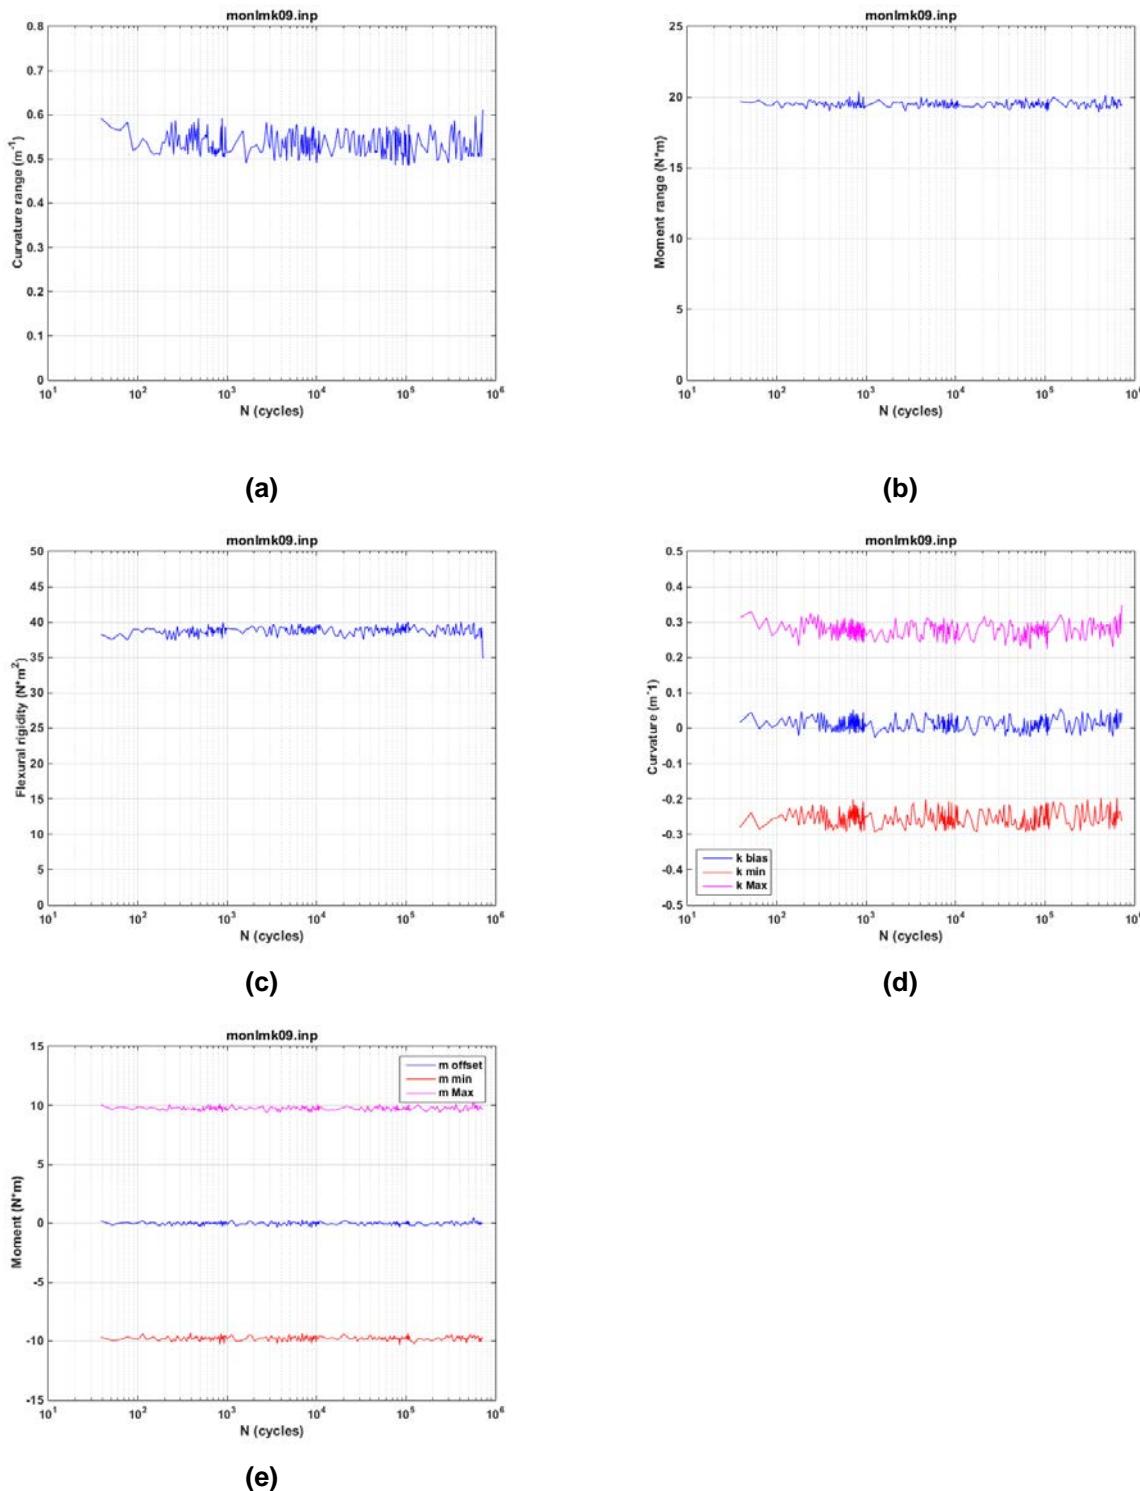
The curvature, moment, and flexural rigidity based on online monitoring data are presented in Fig. 26. The online monitoring showed a flexural rigidity of about $39 \text{ N}\cdot\text{m}^2$, slightly lower than that observed in measurements. This is believed to be because different loading conditions were used in measurement and cycling. Overall, a quite steady response was exhibited over the entire cyclic testing period. Meanwhile, a positive curvature offset of 0.02 m^{-1} was seen during the cyclic fatigue process.

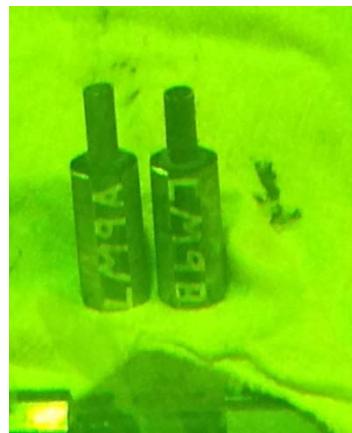
Fig. 27. Fracture segments for LMK09/574D-D; $N_f = 7.31 \times 10^5$ cycles at $\pm 10.16 \text{ N}\cdot\text{m}$, 5 Hz.

The failure occurred again in the middle of gage section of the specimen, as shown in Fig. 27. A fractographic study was conducted using a stereo-optical microscope. Images of the lateral surface and fracture surfaces are presented in Fig. 28. Overall surface integrity was maintained to a certain extent. Again, the fracture clearly occurred at the pellet-to-pellet interface. The pellets developed cracks and fractured into several large size of fragments, and they held in place. No apparent gap can be seen between the pellet and cladding.

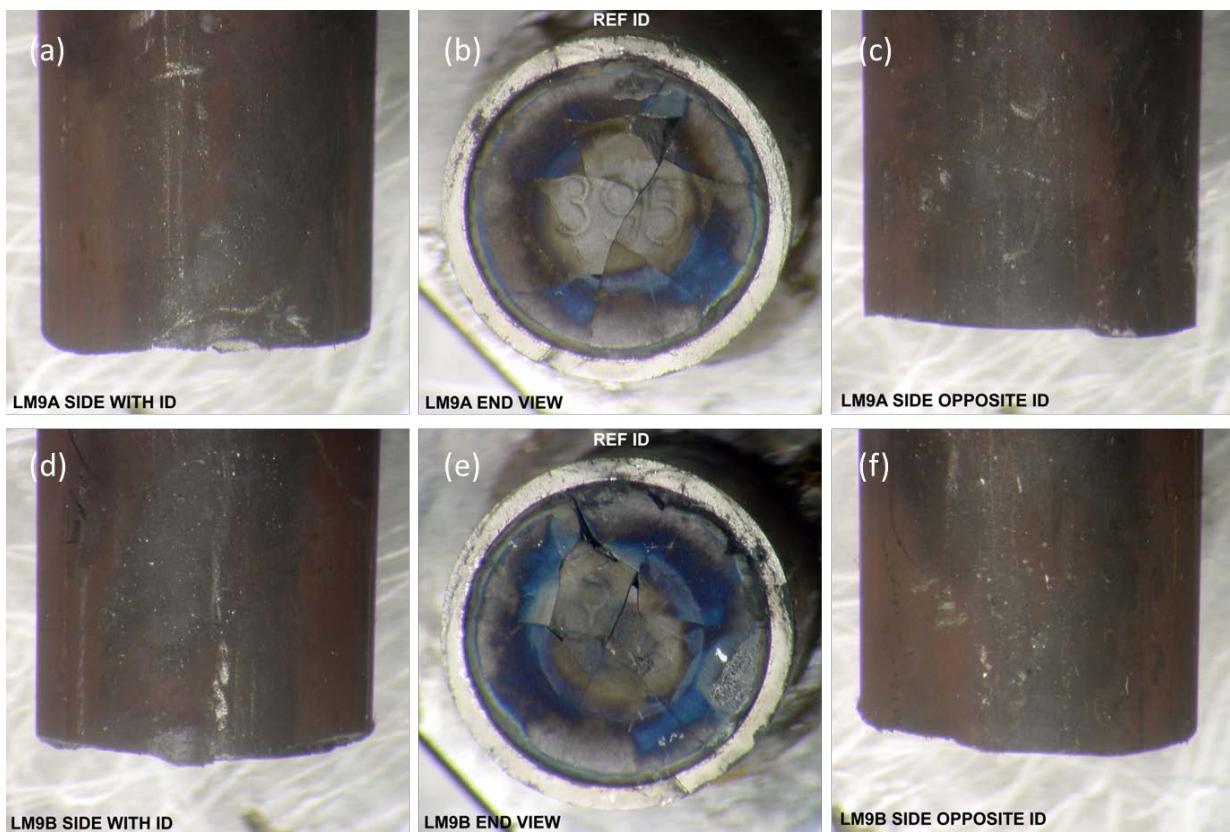
Fig. 28. Fracture segments for LMK09/574D-D. (a) and (d) show the specimen ID side of the segment on end caps A and B; (b) and (e) show the mating fracture surface; and (c) and (f) show the opposite specimen ID side of segment on end caps A and B.

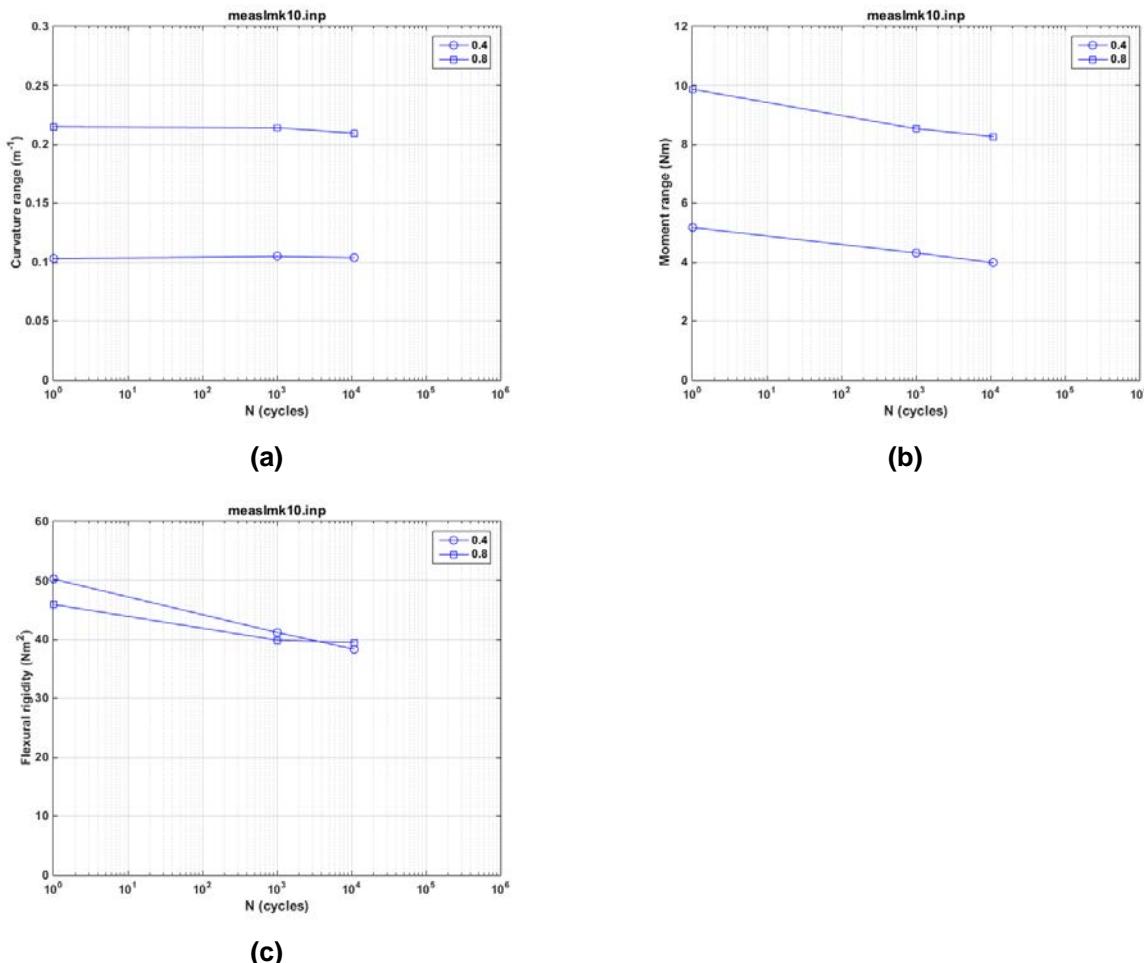
Fig. 29. Variations in (a) curvature range, (b) moment range, and (c) flexural rigidity as a function of the number of cycles for LMK10/575B-E. Measurements were made with 0.2, and 0.4 mm relative displacements; $N_f = 5.20 \times 10^4$ cycles at $\pm 20.32 \text{ N}\cdot\text{m}$, 5 Hz.

The test on the LMK10/575B-E rod was conducted at $\pm 20.32 \text{ N}\cdot\text{m}$, 5 Hz. The specimen failed at 5.20×10^4 cycles. Periodic quasistatic measurements of rod deformation were conducted using two relative displacement levels (0.2 and 0.4 mm) at the selected target number of cycles. The variations in curvature range, moment range, and flexural rigidity as a function of number of cycles are given in Fig. 29. The rigidity of the measurements at two displacements started with 45 to 50 $\text{N}\cdot\text{m}^2$ and demonstrated a clear decreasing trend.

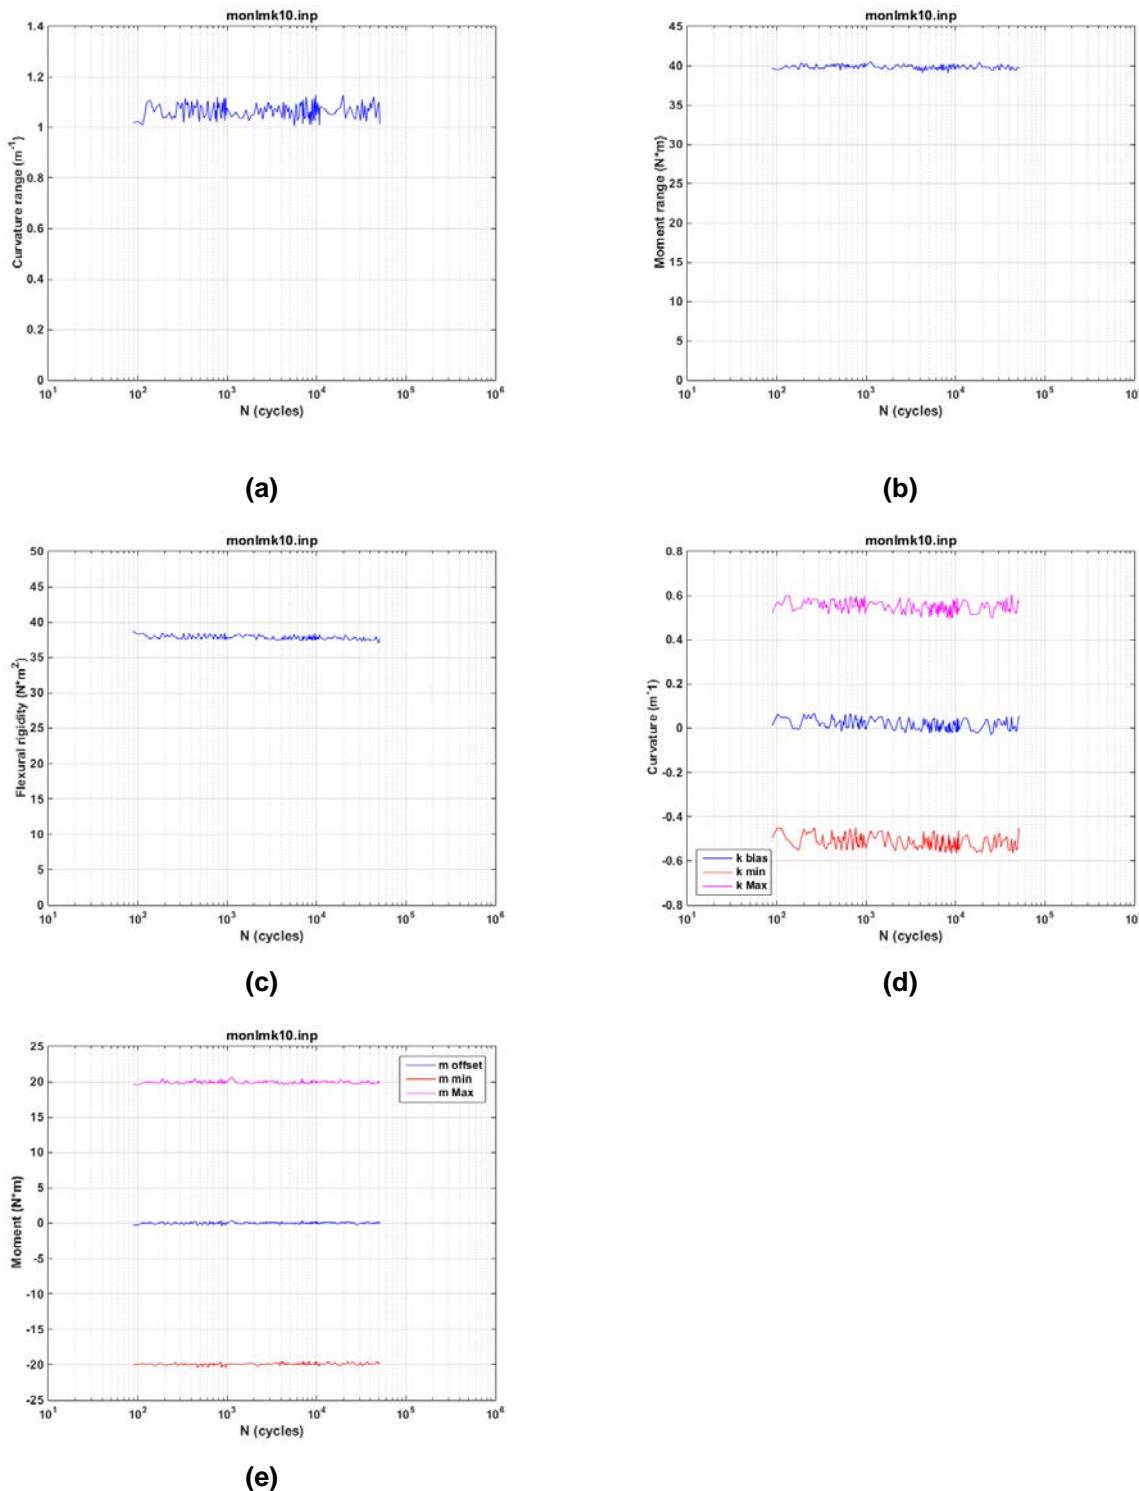
The curvature, moment, and flexural rigidity based on online monitoring data are presented in Fig. 30. The online monitoring showed a flexural rigidity of about 38 $\text{N}\cdot\text{m}^2$, slightly lower than that observed in the measurements. This is mainly because different loading conditions were used in measurement and cycling. Overall, a quite steady response was exhibited over the entire cyclic testing period. Meanwhile, a positive curvature offset of 0.05 m^{-1} was seen during the cyclic fatigue process.

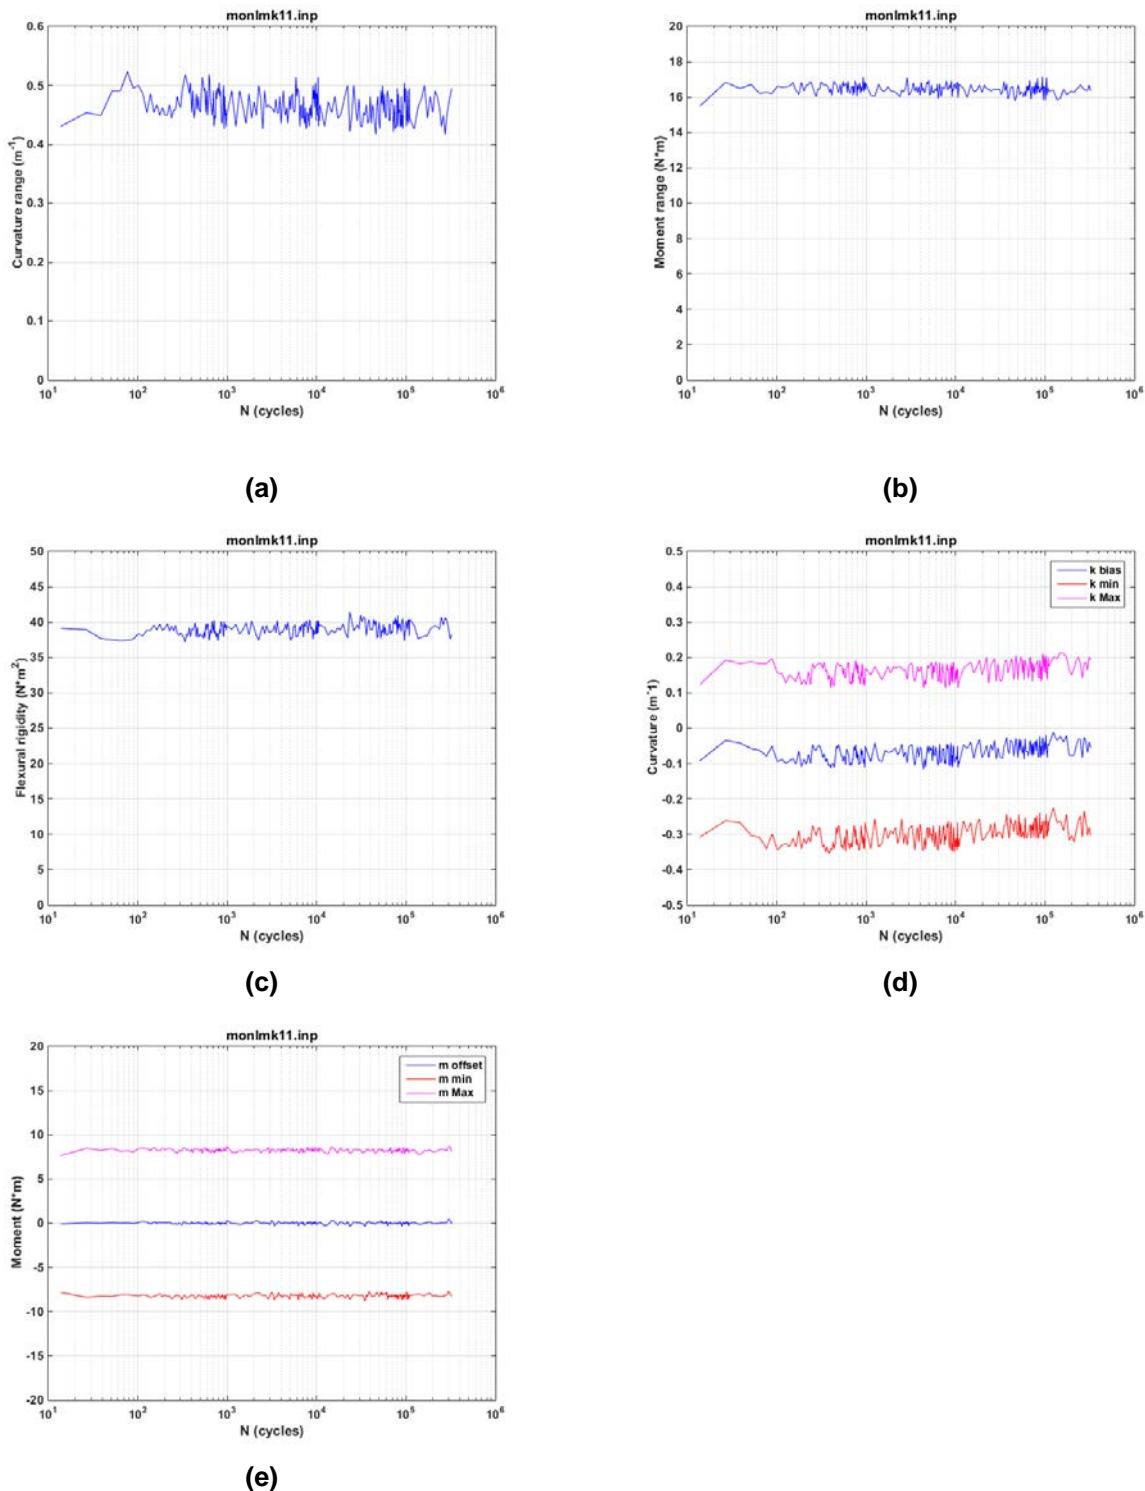
The curvature, moment, and flexural rigidity based on online monitoring data are presented in Fig. 32. The online monitoring showed a flexural rigidity of about $39\text{ N}\cdot\text{m}^2$, slightly lower than that observed in the measurements. This is mainly because different loading conditions were used in the measurements and cycling. Overall, a steady response was exhibited over the entire cyclic testing period. Meanwhile, a negative curvature offset, -0.06 m^{-1} , was seen during the cyclic fatigue process.

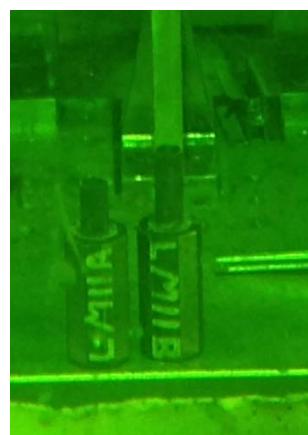
Fig. 33. Fracture segments for LMK11/574D-D; $N_f = 3.55 \times 10^5$ cycles at $\pm 8.64 \text{ N}\cdot\text{m}$, 5 Hz.

Fig. 33 illustrates the failure position of the specimen. A fractographic study was conducted using a stereo-optical microscope. The images of the lateral surface and fracture surfaces are presented in Fig. 34. Although some scratches are seen over the lateral surface, overall surface integrity was maintained to a certain extent. The fracture clearly occurred on the pellet-to-pellet interface. Mosaic cracks developed in the pellets. No apparent gap can be seen between the pellet and cladding.

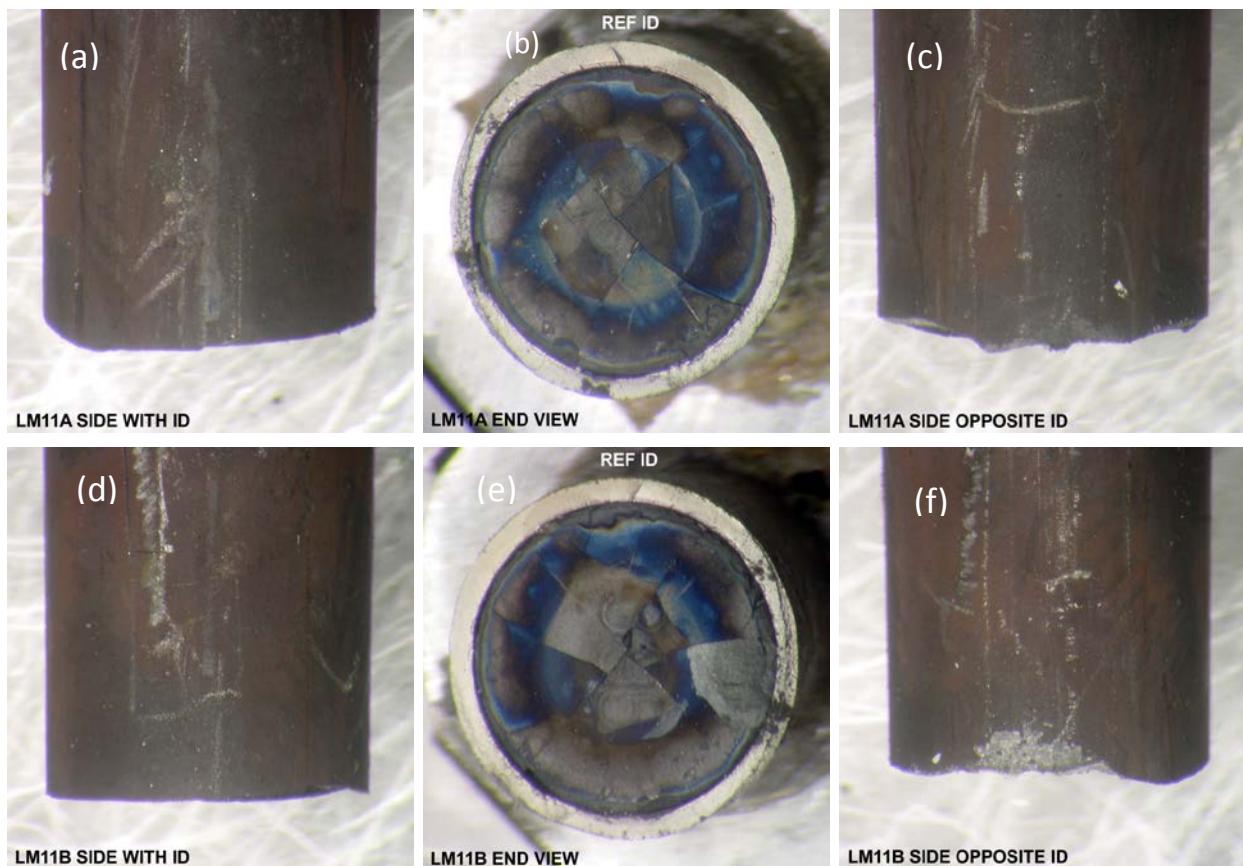
Fig. 34. Fracture segments for LMK11/575B-D. (a) and (d) show the specimen ID side of the segment on end caps A and B; (b) and (e) show the mating fracture surface; and (c) and (f) show the opposite specimen ID side of segment on end caps A and B.

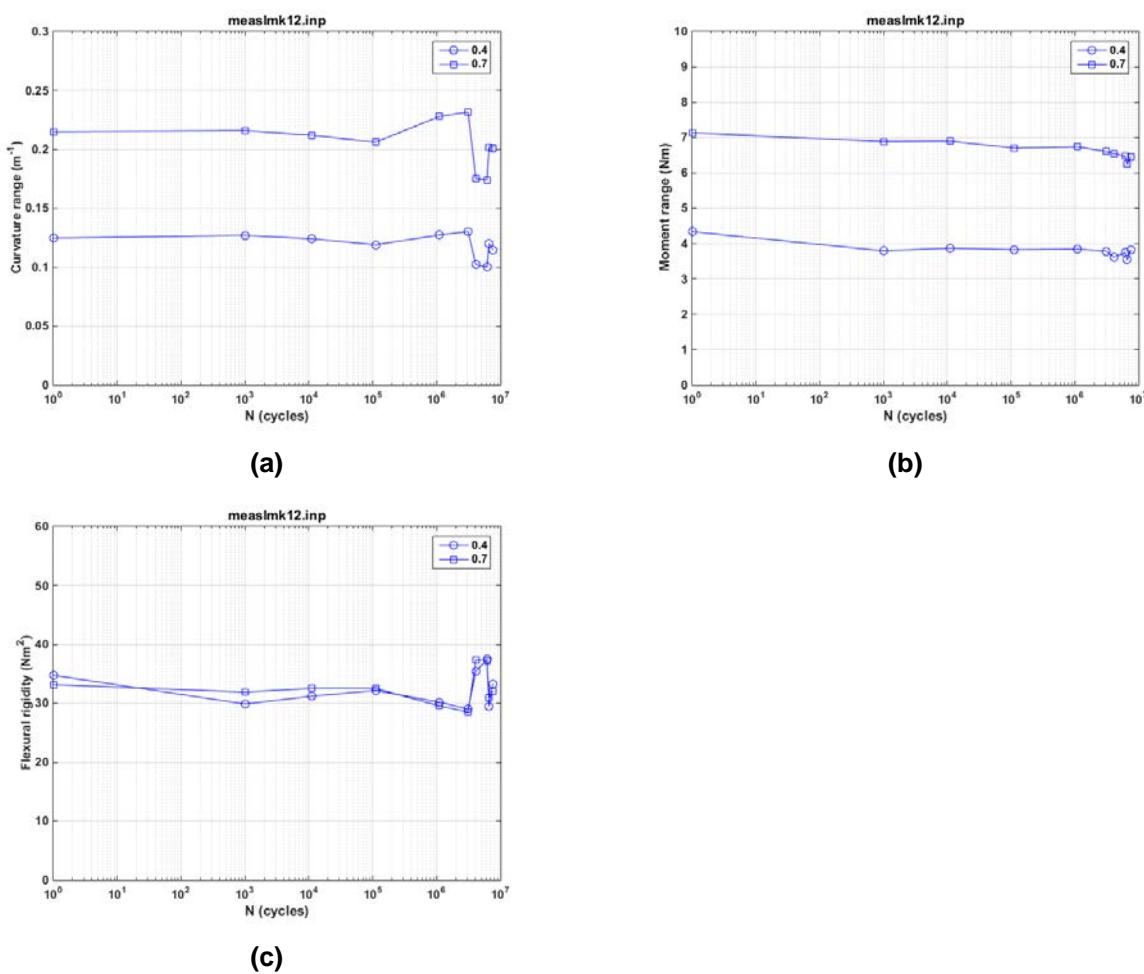
Fig. 35. Variations in (a) curvature range, (b) moment range, and (c) flexural rigidity as a function of the number of cycles for LMK12/575B-A. Measurements were made with 0.2 and 0.35 mm relative displacements; $N = 7.58 \times 10^6$ cycles at $\pm 7.11 \text{ N}\cdot\text{m}$, 5 Hz.

The test on the LMK12/575B-A rod was conducted at $\pm 7.11 \text{ N}\cdot\text{m}$, 5 Hz and stopped at the cycle number 7.58×10^6 . The quasistatic measurements were conducted using two relative displacement levels (0.2 and 0.35 mm) at the selected number of cycles, and results are illustrated in Fig. 35. A small fluctuation occurred near 4×10^6 cycles. The reason for such fluctuation is not clear. However, the overall rigidity stayed around 30 to 38 $\text{N}\cdot\text{m}^2$.

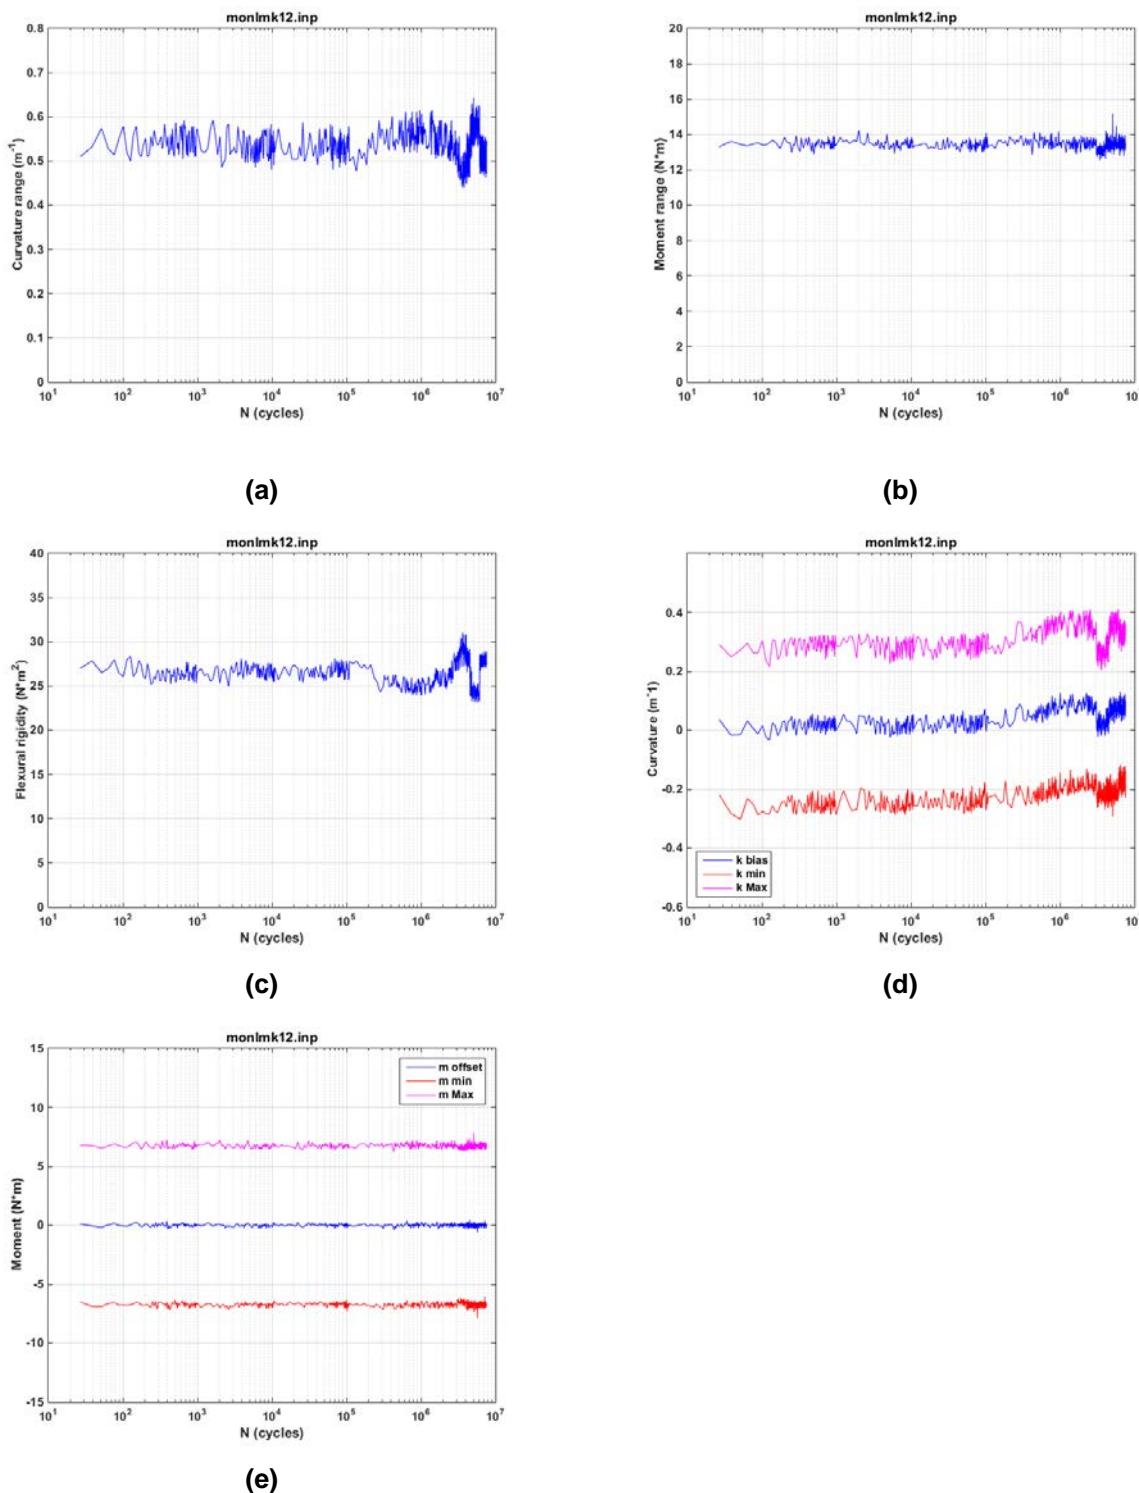
Fig. 36. Variations in (a) curvature range, (b) applied moment range, (c) flexural rigidity, (d) maximum and minimum values of curvature, and (e) maximum and minimum values of moment as a function of the number of cycles for LMK12/575B-A; $N = 7.58 \times 10^6$ cycles at $\pm 7.11 N \cdot m$, 5 Hz.

The curvature, moment, and flexural rigidity based on online monitoring data are presented in Fig. 36. The online monitoring showed a flexural rigidity variation of 24 to 29 $\text{N}\cdot\text{m}^2$. At the same time, the curvature exhibited a slight upward drift at the end of cycling of around 0.05 m^{-1} . The rigidity of this rod specimen is relatively lower compared to other LMK rods.

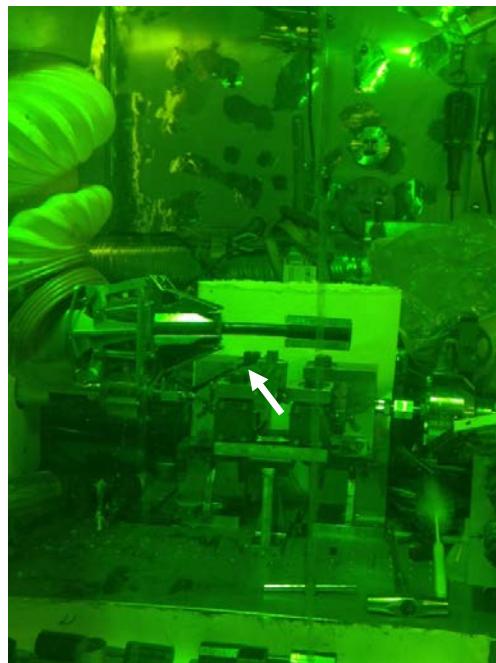
Fig. 45. Image of specimen NA3 (651D3) after testing; the rod sustained four cycles of loading to 24.00 mm relative displacement; the maximum moment of 47 N·m was reached during the initial loading cycle.

Subsequent loading cycles did not produce additional deformation, but they did introduce a closed hysteresis loop. The maximum curvature at a relative displacement of 24.00 mm at the loading points of the U-frame (i.e., 12.00 mm at each motor) was 4.1 m^{-1} . The maximum equivalent stress and strain obtained were 522 MPa and 2%, respectively. The rod appeared to be bent with significant plastic deformation after the static tests, as shown in Fig. 45.

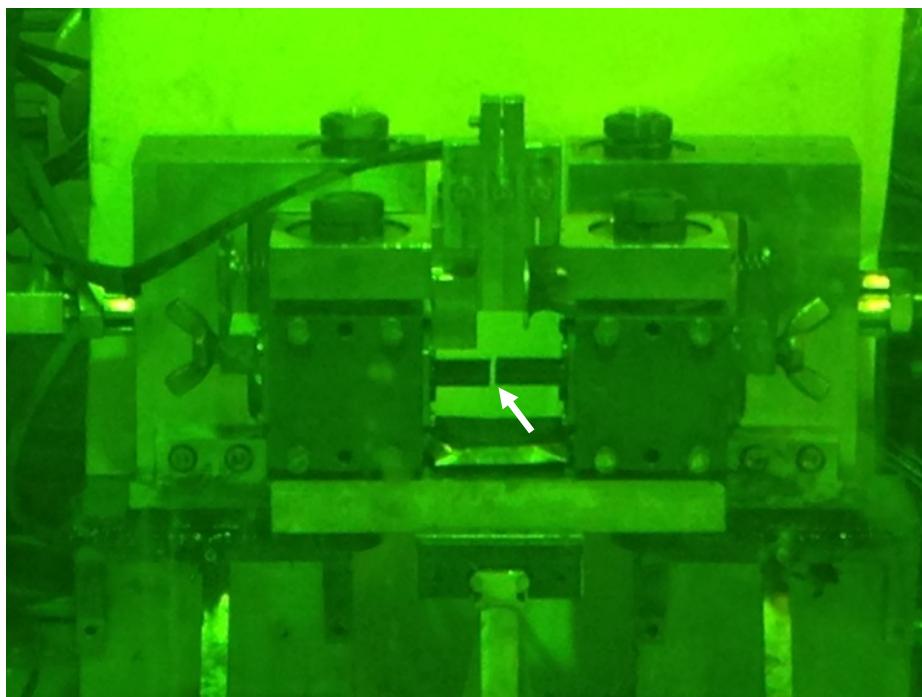
Fig. 54. Fracture location of NA2 (651C5), $N_f = 2.2 \times 10^4$ cycles at $\pm 10.16 \text{ N}\cdot\text{m}$, 5 Hz.

Periodic quasistatic measurements of rod deformation were conducted using two relative displacement levels—1.0 and 2.0 mm—at the target intervals as described in Wang and Wang.⁹ Variations in the curvature, moment, and flexural rigidity as a function of the number of cycles are given in Fig. 52. The flexural rigidity of the rod stayed between 22 and 25 N·m² during most of the cycle testing period. This value of rigidity is slightly lower than but still close to that of NA2. The results from online monitoring are given in Fig. 53, and the image showing the failure location of the rod specimen is given in Fig. 54.

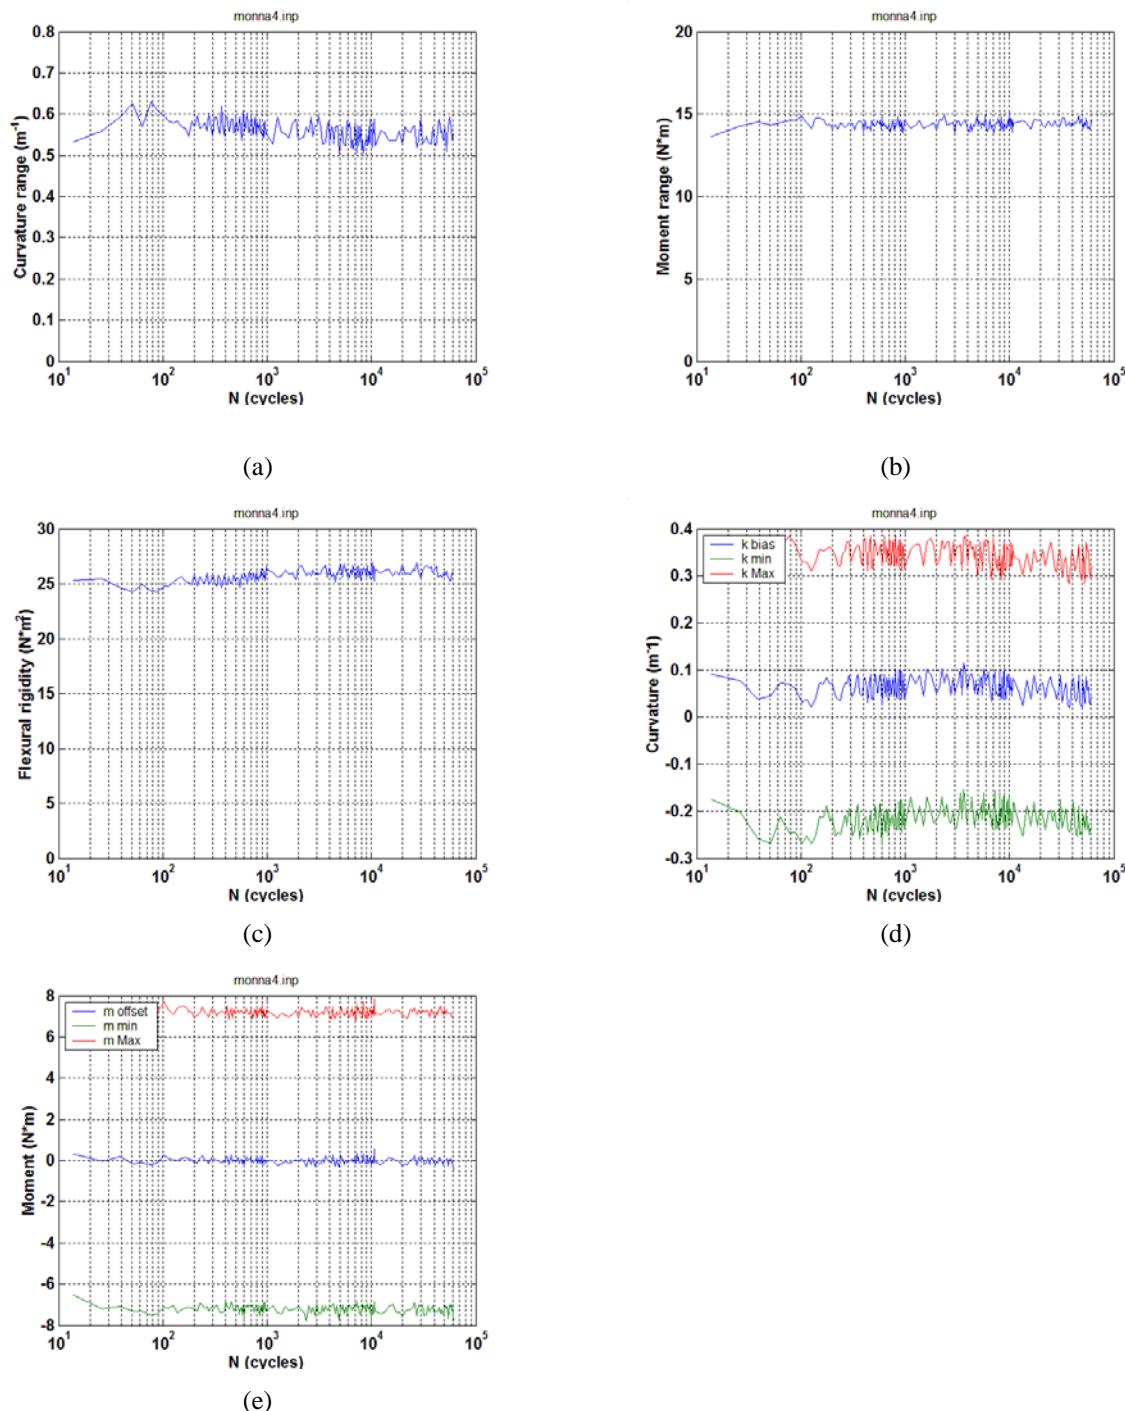
Again, periodic quasistatic measurements of rod deformation were conducted using two relative displacement levels—0.8 and 1.6 mm—at the target intervals. Variations in the curvature, moment, and flexural rigidity as a function of the number of cycles are given in Fig. 55. The initial values of flexural rigidity ranged between 24.5 and 28 N·m². The level of rigidity is apparently close to the values observed for NA1 and NA2. The flexural rigidity of NA4 exhibited an increasing trend during the period of the test cycle, especially in the case of the 0.8 mm measurement. This increasing trend was also observed in the variation in flexural rigidity (Fig. 56). At the same time, a positive offset of curvature was found for the rod under reverse bending. The mean value of curvature was around 0.05 m⁻¹.

Fig. 56. Variations in (a) curvature range, (b) applied moment range, (c) flexural rigidity, (d) maximum and minimum values of curvature, and (e) maximum and minimum values of moment as a function of the number of cycles for NA4 (652B1B); $N_f = 6.1 \times 10^4$ cycles at $\pm 7.62 \text{ N}\cdot\text{m}$, 5 Hz.

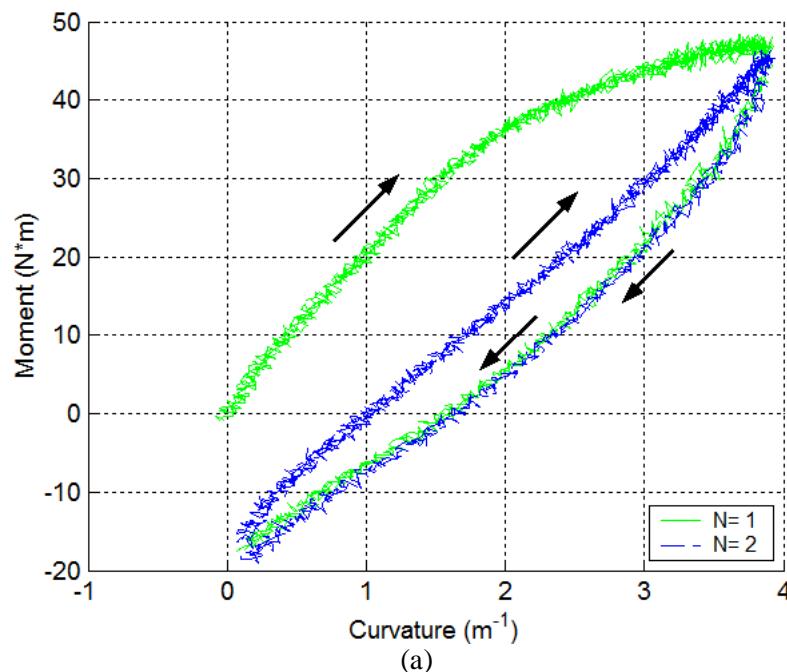
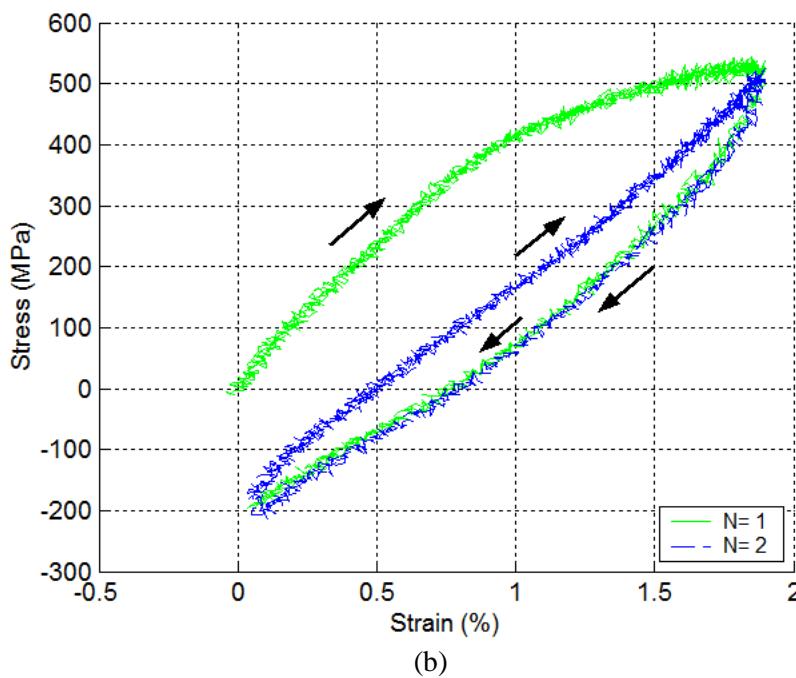
The moment-curvature curves and equivalent stress-strain curves based on the first four loading cycles for MOX1 (specimen MOX-A-11) are shown in Fig. 57. There was a significant nonlinear deformation after 30 N·m; the maximum moment of 47 N·m was reached during the initial loading cycle. A deflection point appeared at approximately 8 N·m in the initial loading cycle. Subsequent loading cycles did not produce additional deformation, but loadings generated a closed hysteresis loop. The maximum curvature under a relative displacement of 24.00 mm at the loading points of the U-frame (i.e., 12.00 mm at each motor) was 3.85 m^{-1} . The maximum equivalent stress and strain were 520 MPa and 1.8%, respectively.

Fig. 57. (a) Moment-curvature curves and (b) equivalent stress-strain curves based on the first four loading cycles for MOX1 (specimen MOX-A-11).

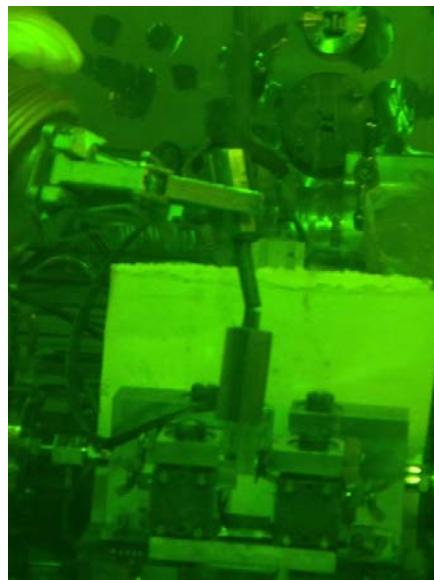
A dynamic test was carried out at $\pm 15.24 \text{ N}\cdot\text{m}$, 5 Hz to observe the failure mode of the rod. The fatigue life of the rod was $N_f = 4.0 \times 10^3$ cycles. The rod finally failed in the gage section, as shown in Fig. 58.

Fig. 58. Fracture segments for MOX1 (specimen MOX-A-11); the rod survived two cycles of loading to a relative displacement of 24.00 mm with a maximum moment of 47 N·m in the initial cycle. A follow-up dynamic test was carried out at ± 15.24 N·m, 5 Hz; $N_f = 4.0 \times 10^3$ cycles.

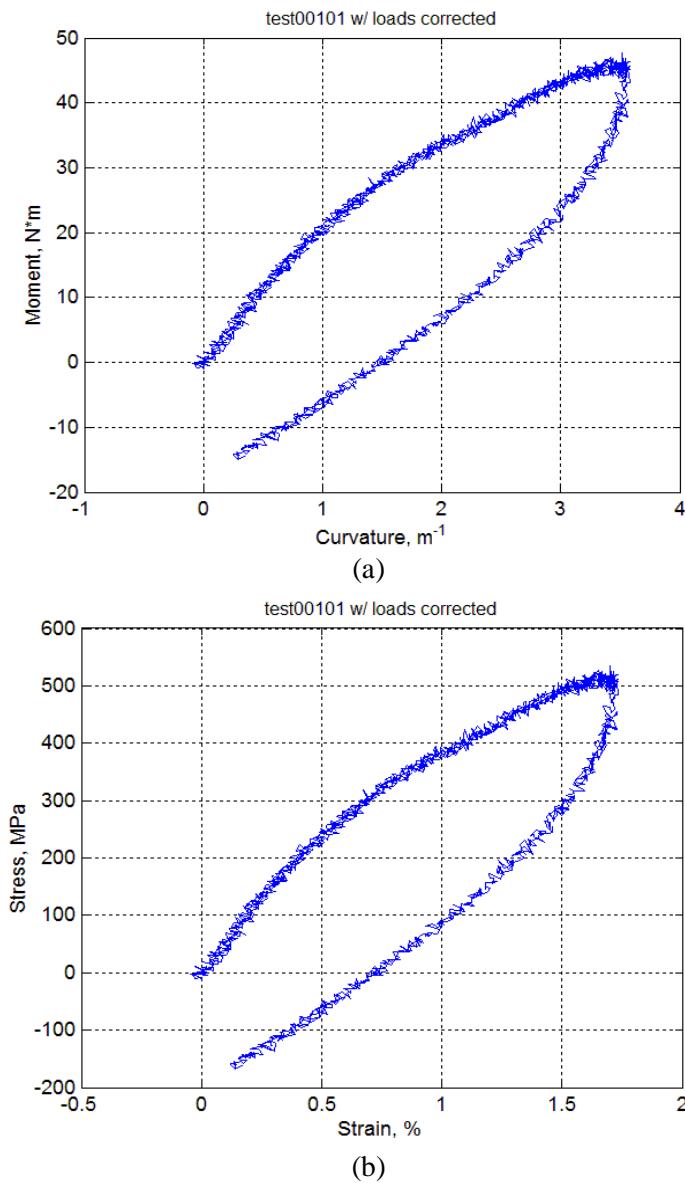
The moment-curvature curves and equivalent stress-strain curves are shown in Fig. 59. The second stage as seen in MOX1 and other HBR fuel specimens is hard to identify because the moment-curvature curve turned out to be nonlinear starting at approximately 9 N·m. The maximum moment was 45 N·m. The maximum curvature under a relative displacement of 24.00 mm at the loading points of the U-frame (i.e., 12.00 mm at each motor) was 3.53 m^{-1} . The maximum equivalent stress and strain were 510 MPa and 1.7%, respectively.

Fig. 59 (a) Moment-curvature curves and (b) equivalent stress-strain curves based on the first four loading cycles for MOX3 (MOX-A-13).

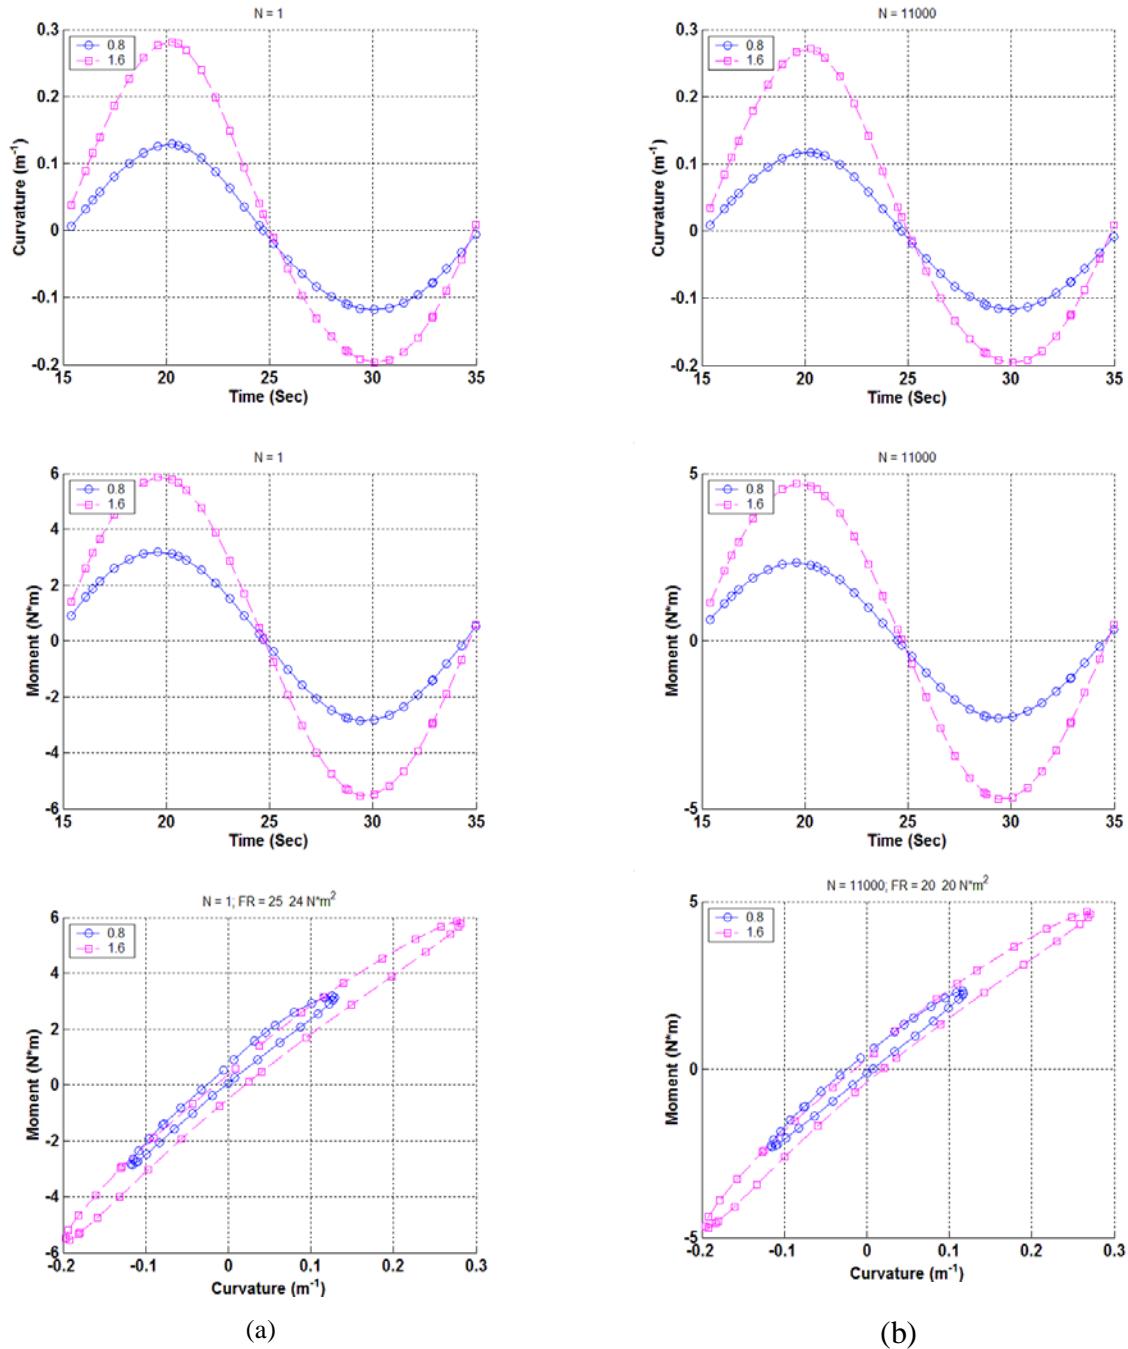
Periodic quasistatic measurements of rod deformation were conducted using two relative displacement levels—0.8 and 1.6 mm—at the selected target number of cycles, as described above. Investigation into the distorted moment-curvature loop indicated that the distortion may result from a reduced sample rate. Therefore, the sampling rate was adjusted to that used for dynamic tests of HBR fuel. Time histories of moment and curvature and curvature-moment loops obtained at the first cycle and 11,000 cycles are shown in Fig. 60. The regular curvature-moment loops were obtained with the modified data acquisition setting.

Fig. 60. Moment and curvature as a function of time and moment-curvature loops based on measurements when (a) $N=1$ and (b) $N = 111,000$ cycles for MOX2 (MOX-A-12). Measurements were made with 0.8 and 1.6 mm relative displacements; $N_f = 3.7 \times 10^4$ cycles at $\pm 10.16 \text{ N}\cdot\text{m}$, 5 Hz.

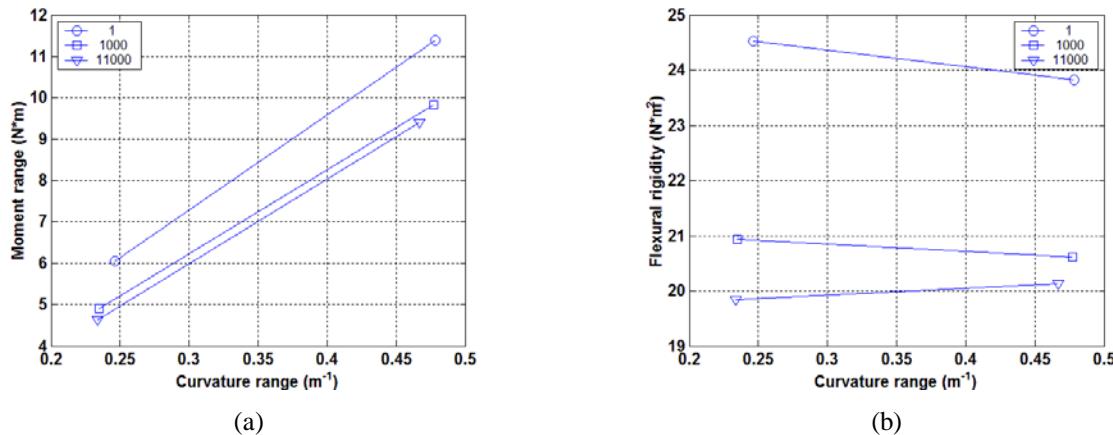
The curvature range–moment range and flexural rigidity are illustrated in Fig. 61. The variations in these quantities as a function of the number of cycles are given in Fig. 62. The rigidity of the measurements clearly showed a decreasing trend starting with $24 \text{ N}\cdot\text{m}^2$ and then dropping to $20 \text{ N}\cdot\text{m}^2$ at 1.1×10^4 cycles.

Fig. 61 (a) Moment-curvature relation and (b) moment-flexural-rigidity relation at various numbers of cycles for MOX (MOX-A-12). Measurements were made with 0.8 and 1.6 mm relative displacements; $N_f = 3.7 \times 10^4$ cycles at ± 10.16 N·m, 5 Hz.
