***FY 2015 Status Report:
CIRFT Testing of High-Burnup
Used Nuclear Fuel Rods from
Pressurized Water Reactor and
Boiling Water Reactor
Environments***

*September 4, 2015
M2-FCRD-UFD-2015-000101*

Jy-An John Wang, Hong Wang, Hao Jiang, and Y. Yan

Prepared by
OAK RIDGE NATIONAL LABORATORY
Oak Ridge, TN 37831-6283
managed by
UT-BATTELLE, LLC
for the
US DEPARTMENT OF ENERGY
under contract DE-AC05-00OR22725

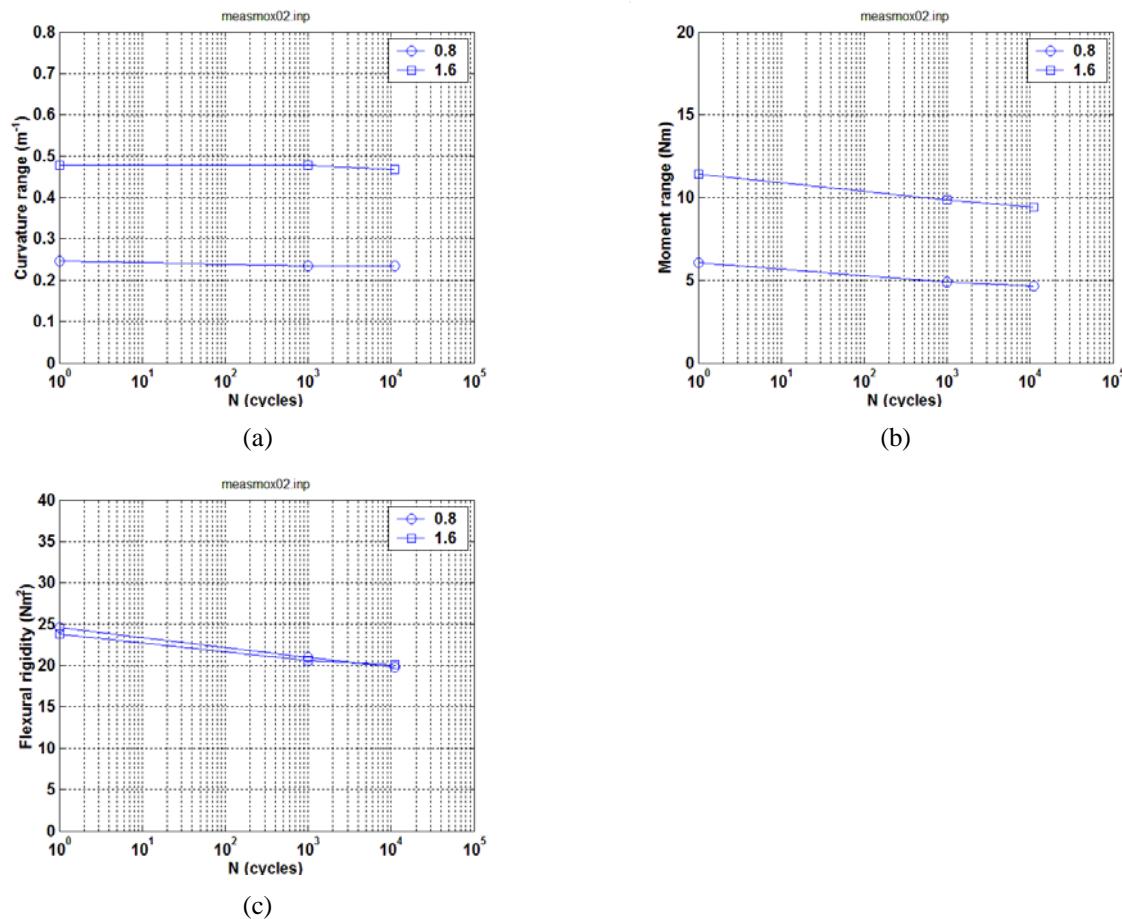
The curvature range–moment range and flexural rigidity are illustrated in Fig. 61. The variations in these quantities as a function of the number of cycles are given in Fig. 62. The rigidity of the measurements clearly showed a decreasing trend starting with $24 \text{ N}\cdot\text{m}^2$ and then dropping to $20 \text{ N}\cdot\text{m}^2$ at 1.1×10^4 cycles.

Fig. 62. Variations in (a) curvature range, (b) moment range, and (c) flexural rigidity as a function of the number of cycles for MOX (MOX-A-12). Measurements were made with 0.8 and 1.6 mm relative displacements; $N_f = 3.7 \times 10^4$ cycles at ± 10.16 N·m, 5 Hz.

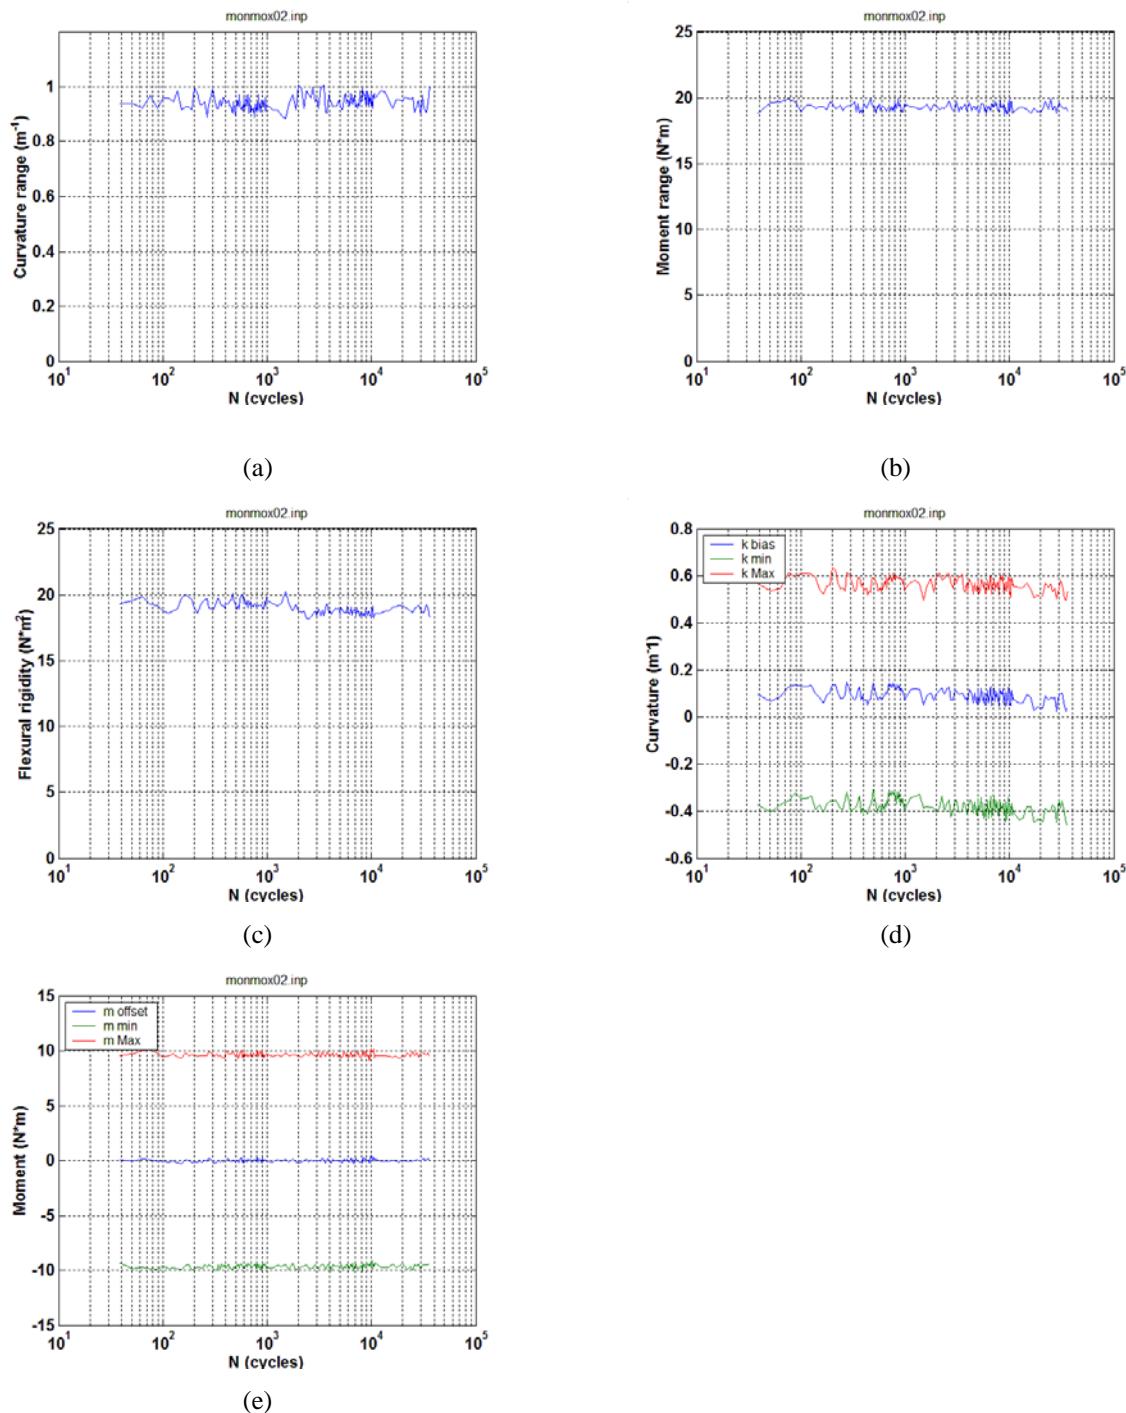
The curvature range, moment range, and flexural rigidity based on online monitoring data are presented in Fig. 63, along with the maxima and minima. Online monitoring showed that flexural rigidity was essentially stable with a small amount of decrease (19 to $18 \text{ N}\cdot\text{m}^2$) prior to the failure. The degree of decrease is lower than the value seen in the measurement. At the same time, the positive offset of curvature with an initial level of 0.1 m^{-1} tended to decrease during the cycle test. Moment and curvature time history and moment-curvature loops based on online monitoring at early and late stages of dynamic testing are illustrated in Fig. 64. It can be seen that moment-curvature loops based on online monitoring were actually well defined. Except for slightly drifting toward the left, no significant change can be observed between loops measured in the two points of the cycle process.

Fig. 63. Variations in (a) curvature range, (b) applied moment range, (c) flexural rigidity, (d) maximum and minimum values of curvature, and (e) maximum and minimum values of moment as a function of the number of cycles for MOX2 (MOX-A-12); $N_f = 3.7 \times 10^4$ cycles at ± 10.16 N·m, 5 Hz.

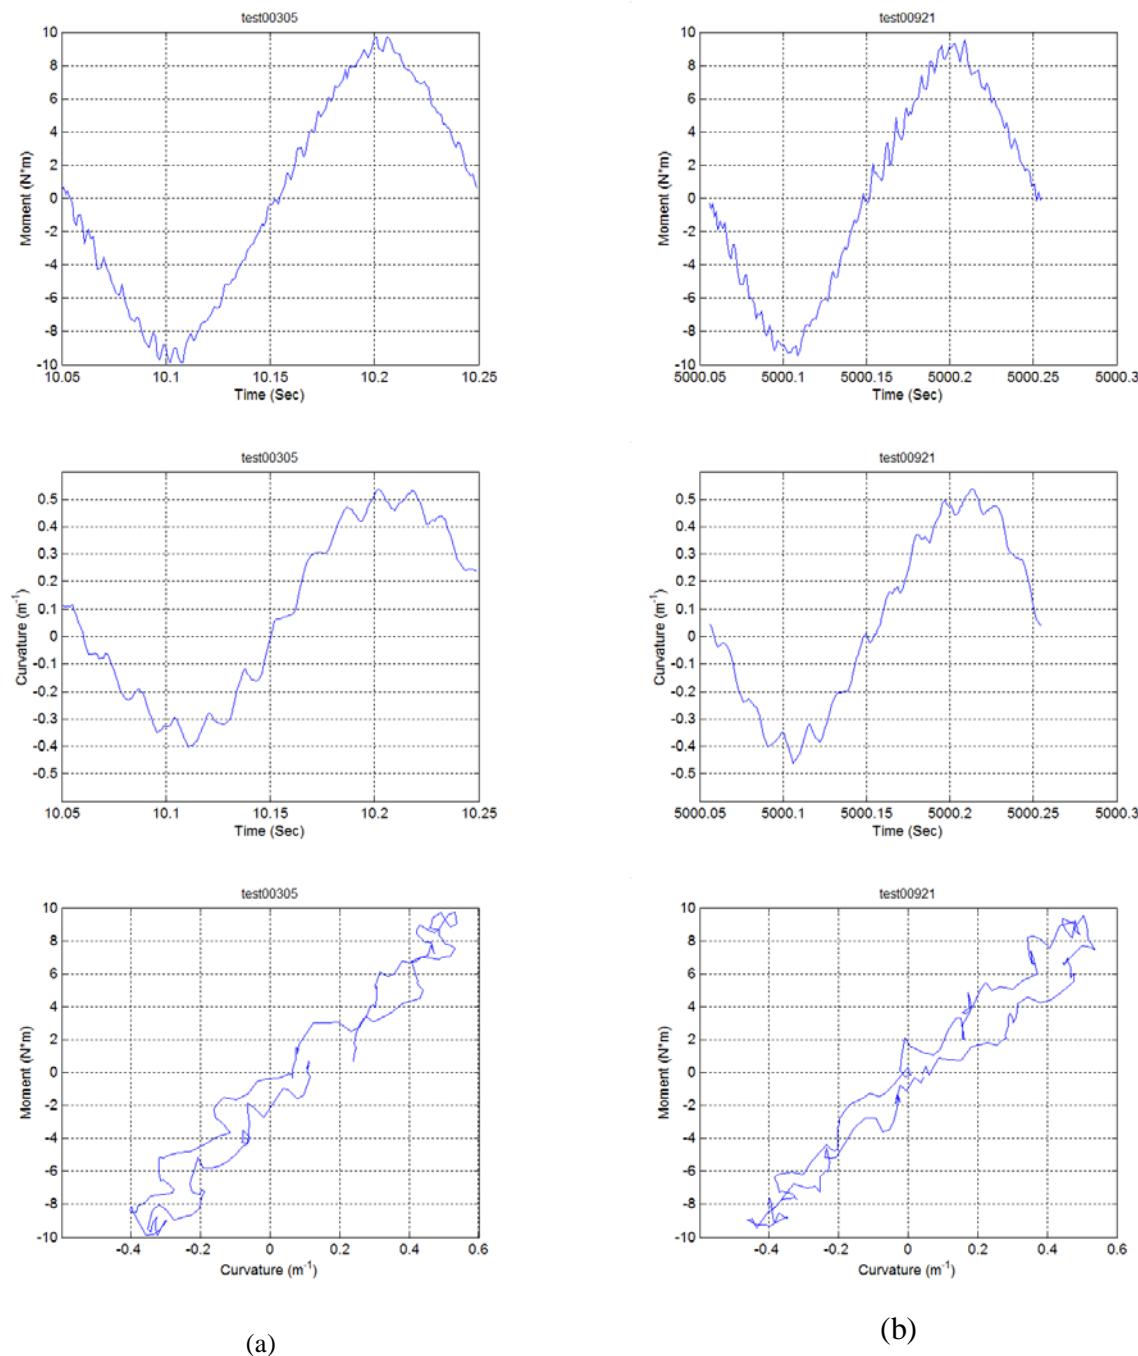
Fig. 64. Moment and curvature as a function of time and moment-curvature loops at (a) 50 cycles and (b) 3.6×10^4 cycles; results are based on online monitoring of MOX2 (MOX-A-12); $N_f = 3.7 \times 10^4$ cycles at ± 10.16 N·m, 5 Hz.

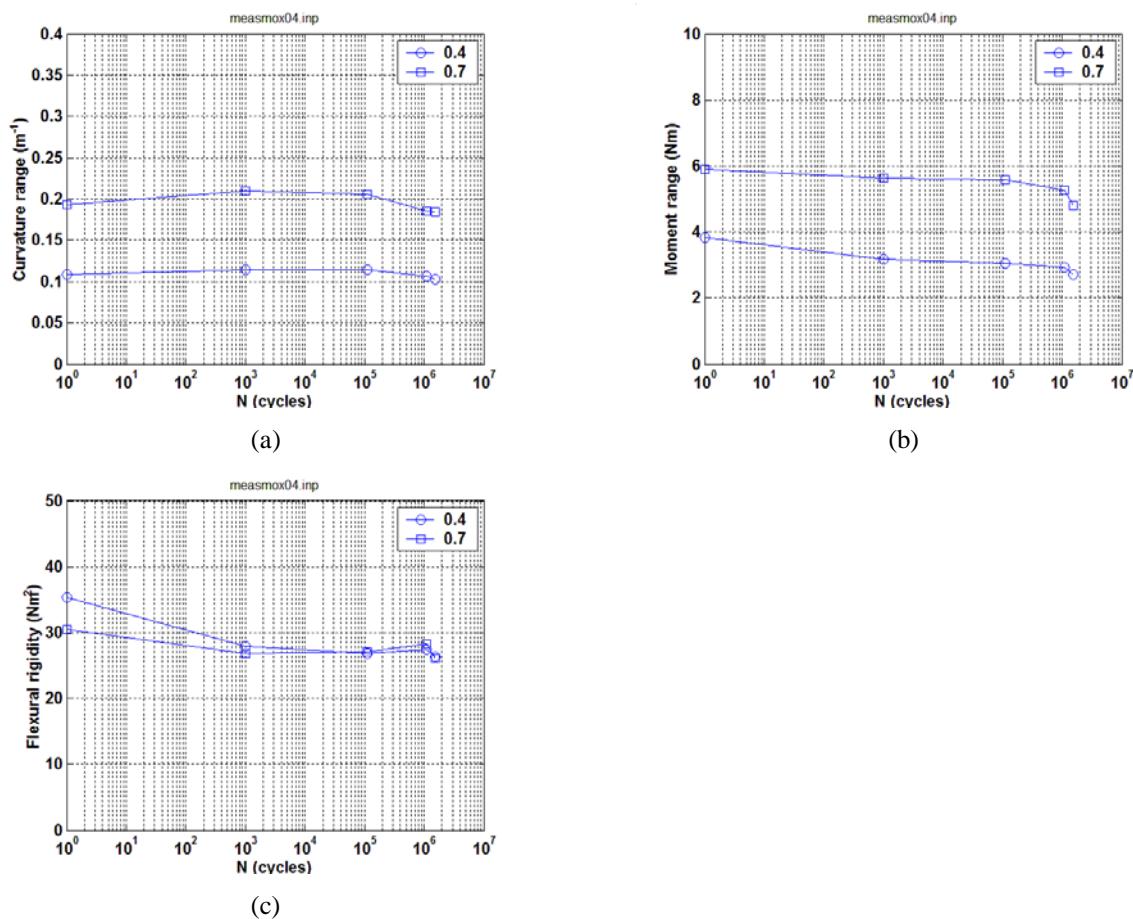
Periodic quasistatic measurements of rod deformation were conducted using two relative displacement levels—0.4 and 0.7mm—at the selected target number of cycles as described above, and results are given in Fig. 65. The moment range exhibited a decreasing trend, and flexural rigidity showed a similar decrease. The effect of measurement displacement on the rigidity response was seen at the beginning, but it became diminished at the later stage of the test. The initial level of rigidity was slightly higher than that of MOX2, perhaps due to the smaller displacement used in the measurement of this specimen. The overall decrease in rigidity was about 20%.

Fig. 65. Variations in (a) curvature range, (b) moment range, and (c) flexural rigidity as a function of the number of cycles for MOX4 (MOX-B-05). Measurements were made with 0.4 and 0.7 mm relative displacements; $N_f = 2.15 \times 10^6$ cycles at $\pm 5.08 \text{ N}\cdot\text{m}$, 5 Hz.

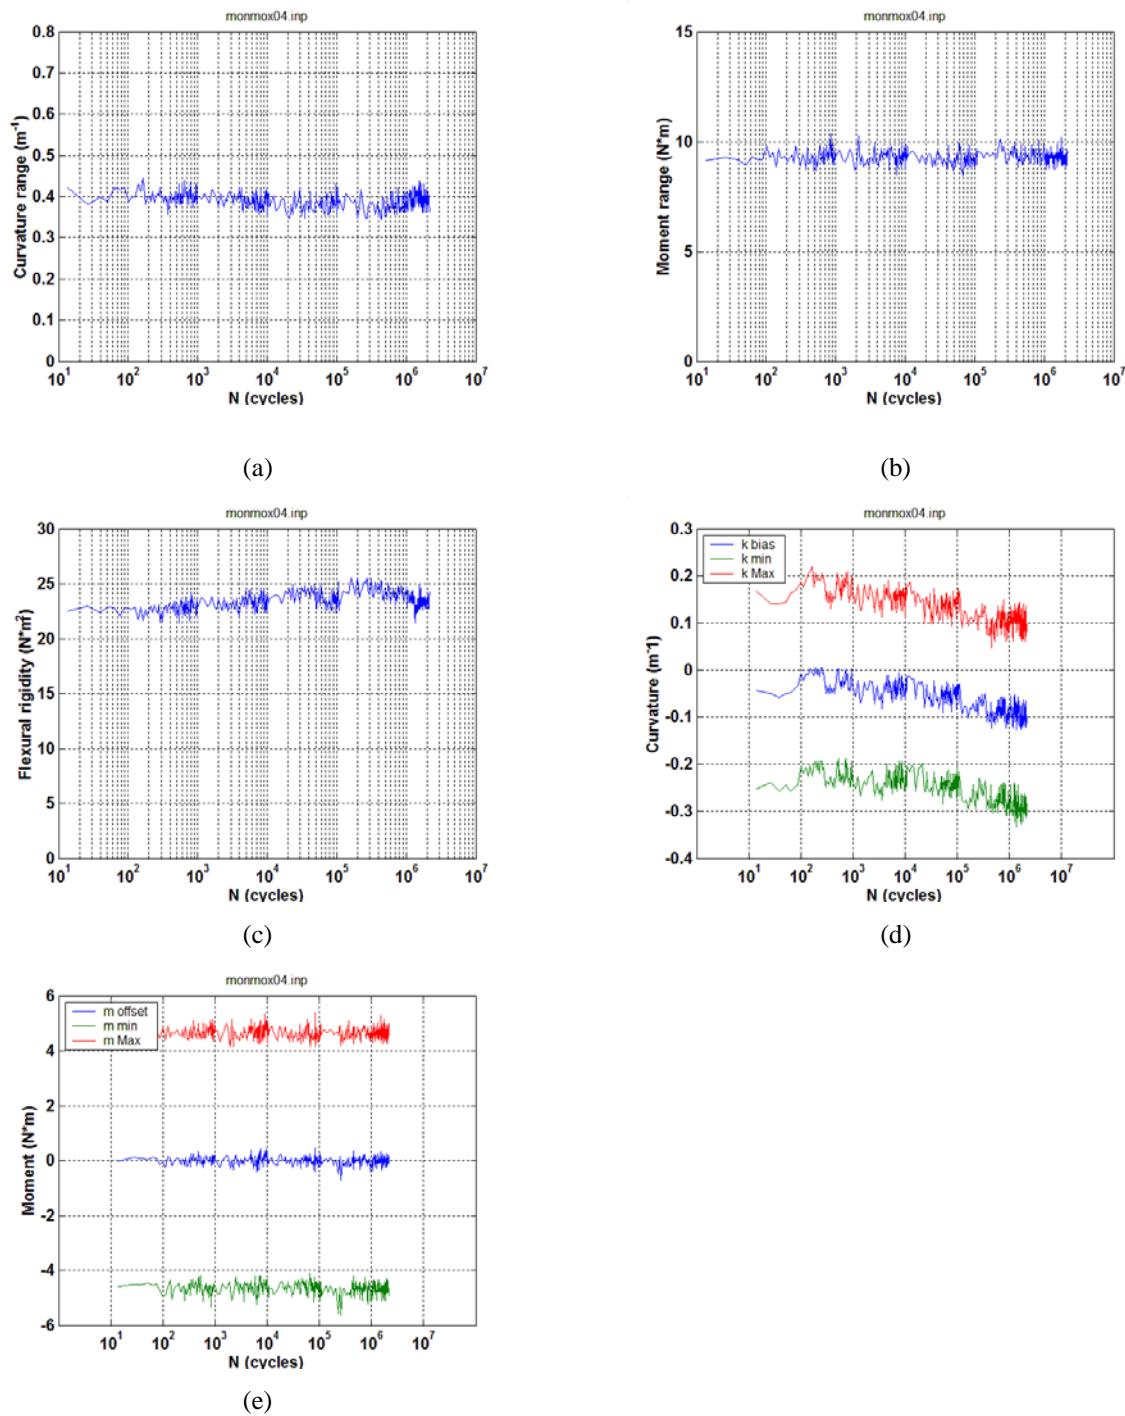
Flexural rigidity from online monitoring exhibited a rise-and-fall trend during the cycle test, as shown in Fig. 66. The rigidity started with 22.5, increased to 24.5, and dropped to $23 \text{ N}\cdot\text{m}^2$ prior to the failure. Detailed examination showed that the moment-curvature loop drifted downward along with the accumulated number of cycles, as can be seen from the parallel curvature fatigue curves. The fatigue failure seemed related to the single-side fracture development.

Fig. 66. Variations in (a) curvature range, (b) applied moment range, (c) flexural rigidity, (d) maximum and minimum values of curvature, and (e) maximum and minimum values of moment as a function of the number of cycles for MOX4 (MOX-B-05); $N_f = 2.15 \times 10^6$ cycles at $\pm 5.08 \text{ N}\cdot\text{m}$, 5 Hz.

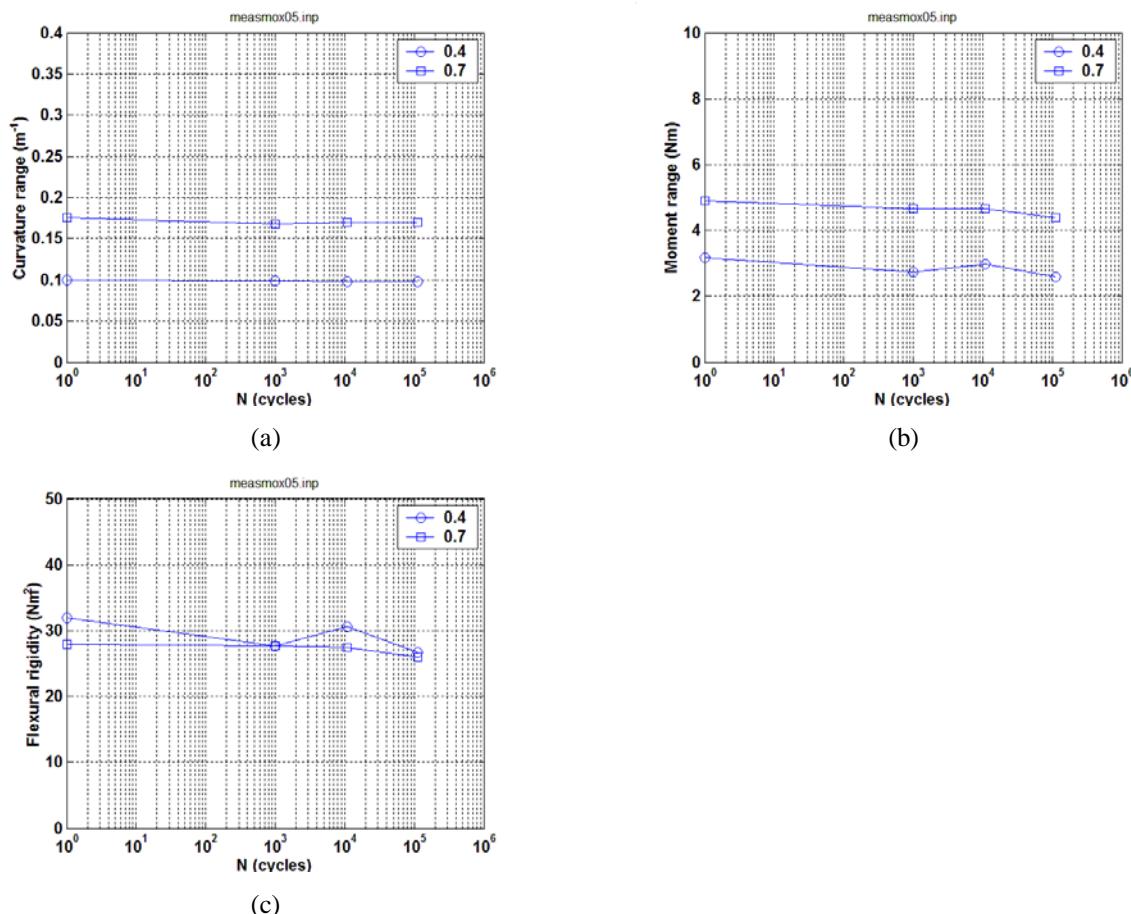
Periodic quasistatic measurements of rod deformation were conducted using relative displacement levels of 0.4 and 0.7 mm at the selected target number of cycles as described above, and results are given in Fig. 67. The prefatigue rigidity was about $30 \text{ N}\cdot\text{m}^2$, which was slightly lower than that of MOX4, even though the measurement displacements were the same. This was reflected in the difference in the mechanical response of various rods under deflection. As can be seen, the flexural rigidity showed a decrease with about 13% drop at the later stage of fatigue.

Fig. 67. Variations in (a) curvature range, (b) moment range, and (c) flexural rigidity as a function of the number of cycles for MOX5 (MOX-B-06). Measurements were made with 0.4 and 0.7 mm relative displacements; $N_f = 4.49 \times 10^5$ cycles at ± 6.10 N·m, 5 Hz.

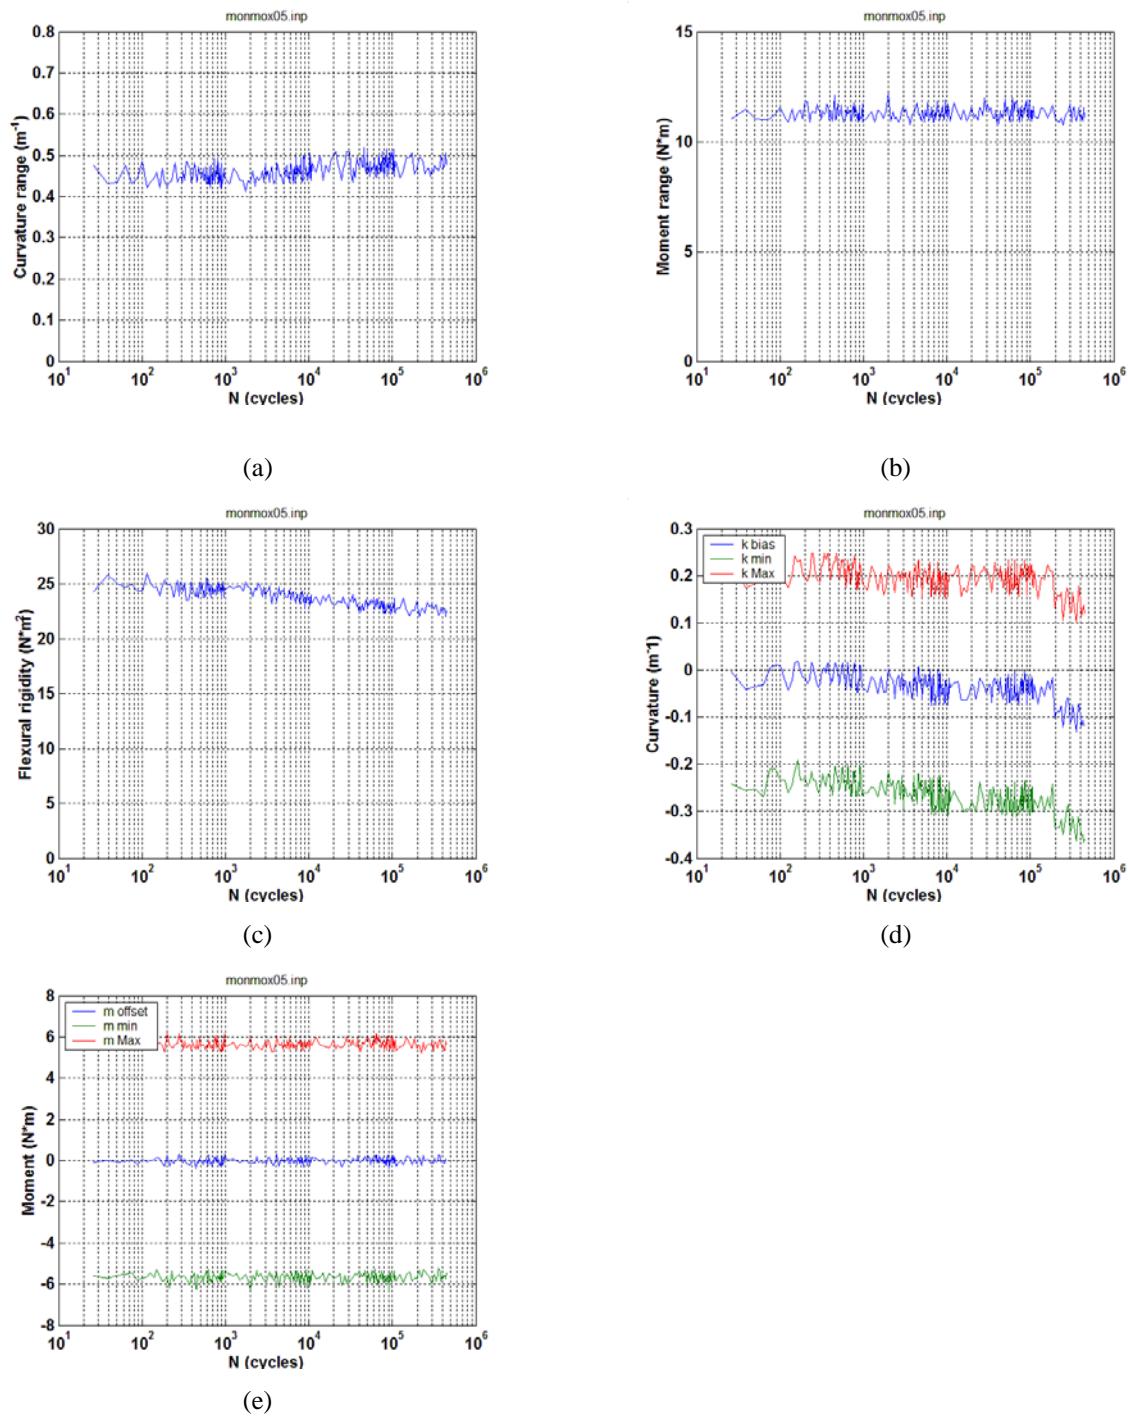
Online monitoring (Fig. 68) showed a well-defined decreasing trend on flexural rigidity with the same percentage of decrease as in the measurement. Downward drifting similar to that in MOX4 was seen, along with the accumulated number of cycles. The fatigue failure appeared to be related to the single-side fracture development.

Fig. 68. Variations in (a) curvature range, (b) applied moment range, (c) flexural rigidity, (d) maximum and minimum values of curvature, and (e) maximum and minimum values of moment as a function of the number of cycles for MOX5 (MOX-B-06); $N_f = 4.49 \times 10^5$ cycles at $\pm 6.10 \text{ N}\cdot\text{m}$, 5 Hz.

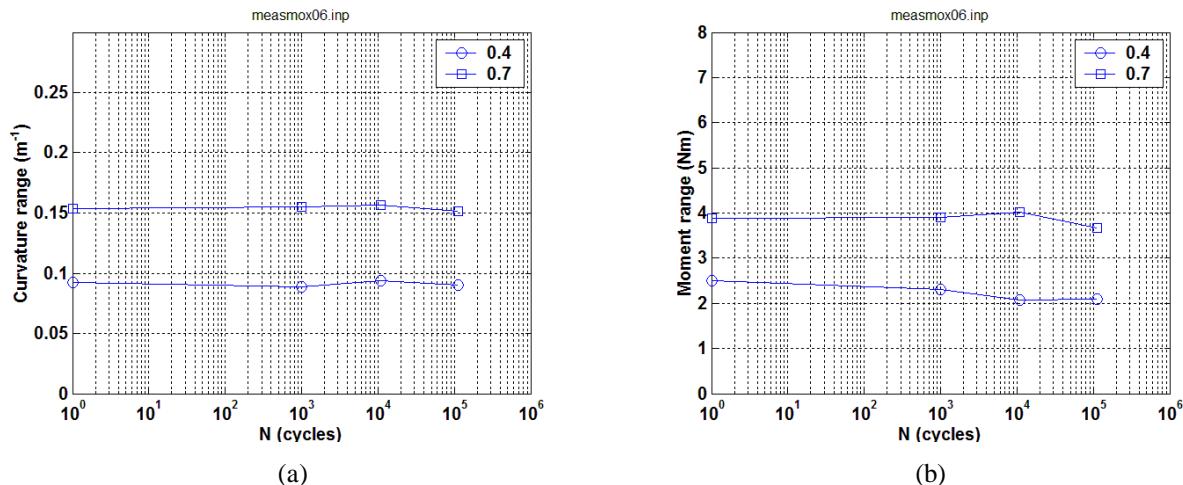
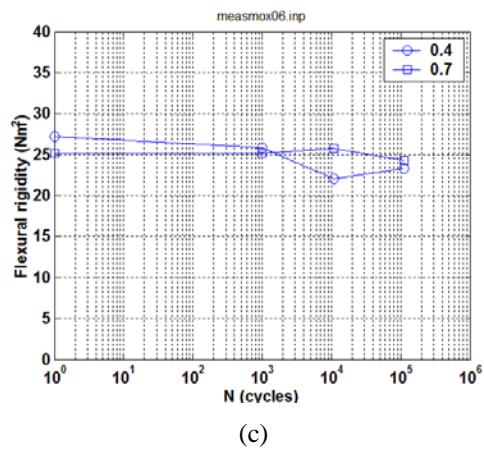
At 0.4 and 0.7 mm, the initial rigidity of MOX6 was between 25 and $27 \text{ N}\cdot\text{m}^2$. For the same relative displacements, the level of rigidity of MOX6 was obviously lower than that of MOX 4 and 5. This result indicates that the drop from 2 ft may have induced additional damage to the rod and thus may have caused the reduced fatigue life that was observed.

Periodic quasistatic measurements of rod deformation were conducted routinely using two relative displacement levels—0.4 and 0.7 mm—at the selected target number of cycles as described above, and results are given in Fig. 69. As can be seen, the flexural rigidity showed a certain amount of decrease, with the largest drop at about 15% occurring at 0.4 mm.

Fig. 69. Variations in (a) curvature range, (b) moment range, and (c) flexural rigidity as a function of the number of cycles for MOX6 (MOX-B-07). Measurements were made with 0.4 and 0.7 mm relative displacements; $N_f = 5.42 \times 10^5$ cycles at ± 5.08 N·m, 5 Hz.

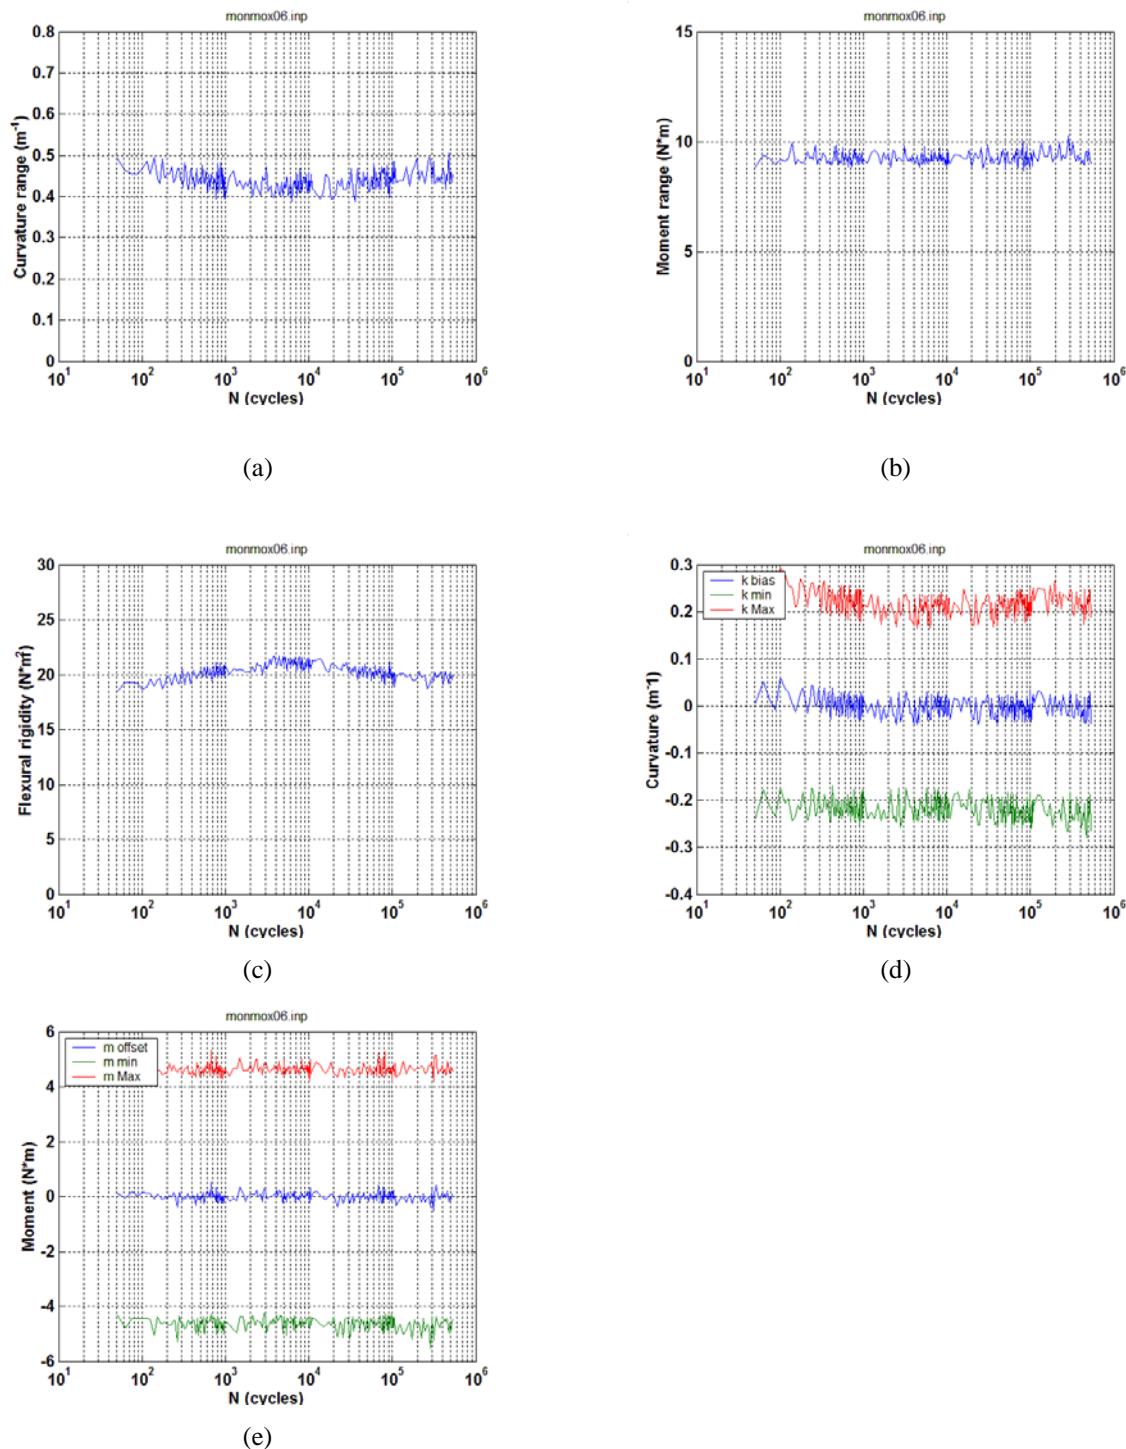
As with MOX4, online monitoring of MOX6 (Fig. 70) showed a rise-and-fall pattern for the variation in flexural rigidity. However, the overall rigidity of MOX6 ($20 \text{ N}\cdot\text{m}^2$) was lower than that of MOX4. Therefore, reduced rigidity was exhibited in both the periodic measurement process and in online monitoring. This is an important indication that dropping or transient shocks during NCT can have an accelerated aging effect on the fatigue performance of HBU SNF. The observation and related mechanisms warrant further investigation to confirm such phenomenon.

Fig. 70. Variations in (a) curvature range, (b) applied moment range, (c) flexural rigidity, (d) maximum and minimum values of curvature, and (e) maximum and minimum values of moment as a function of the number of cycles for MOX6 (MOX-B-07); $N_f = 5.42 \times 10^5$ cycles at $\pm 5.08 \text{ N}\cdot\text{m}$, 5 Hz.

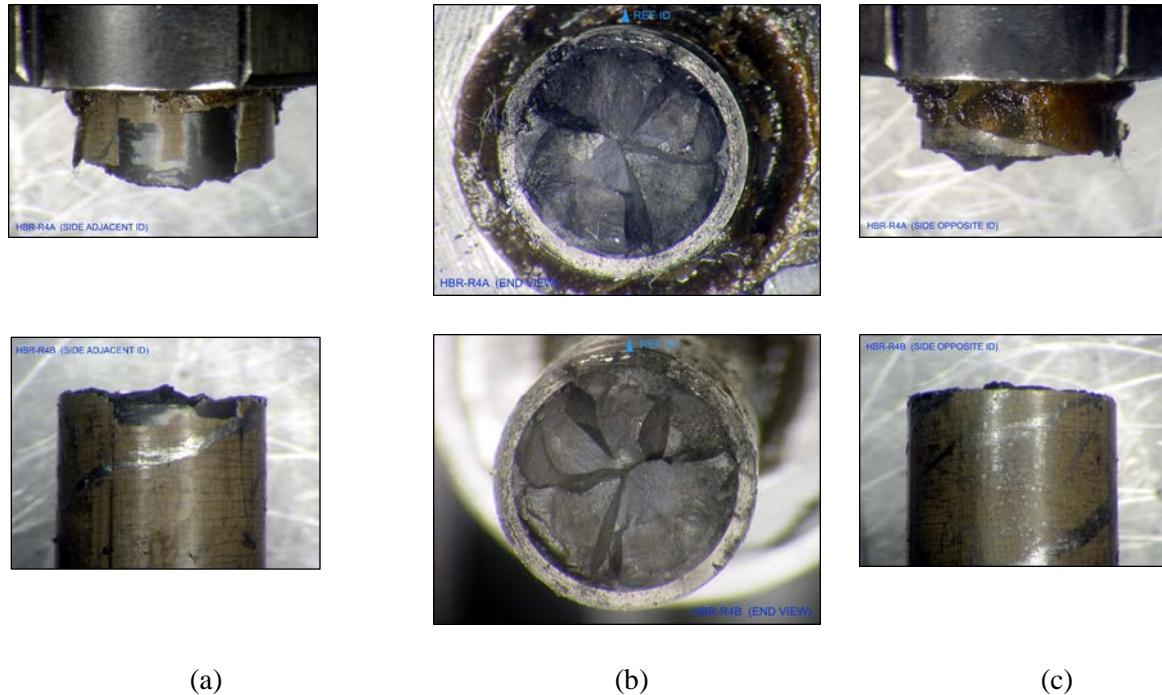
Fig. 71 (a) Lateral or front view, (b) transverse view, and (c) back view of fracture surface for HBR R4 tested at $\pm 8.89 \text{ N}\cdot\text{m}$, 5 Hz, $N_f = 2.7 \times 10^5$ cycles.

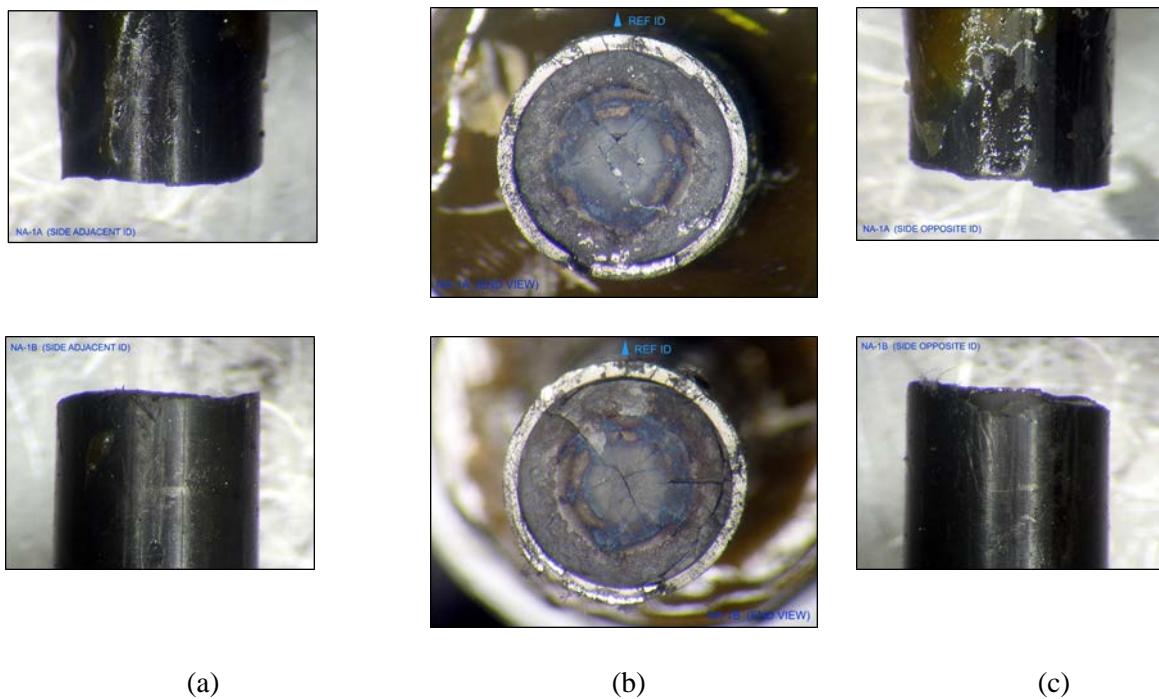
Fig. 72 (a) Lateral or front view, (b) transverse view, and (c) back view of fracture surface for NA1 tested at $\pm 12.7 \text{ N}\cdot\text{m}$, 5 Hz, $N_f = 1.57 \times 10^4$ cycles.

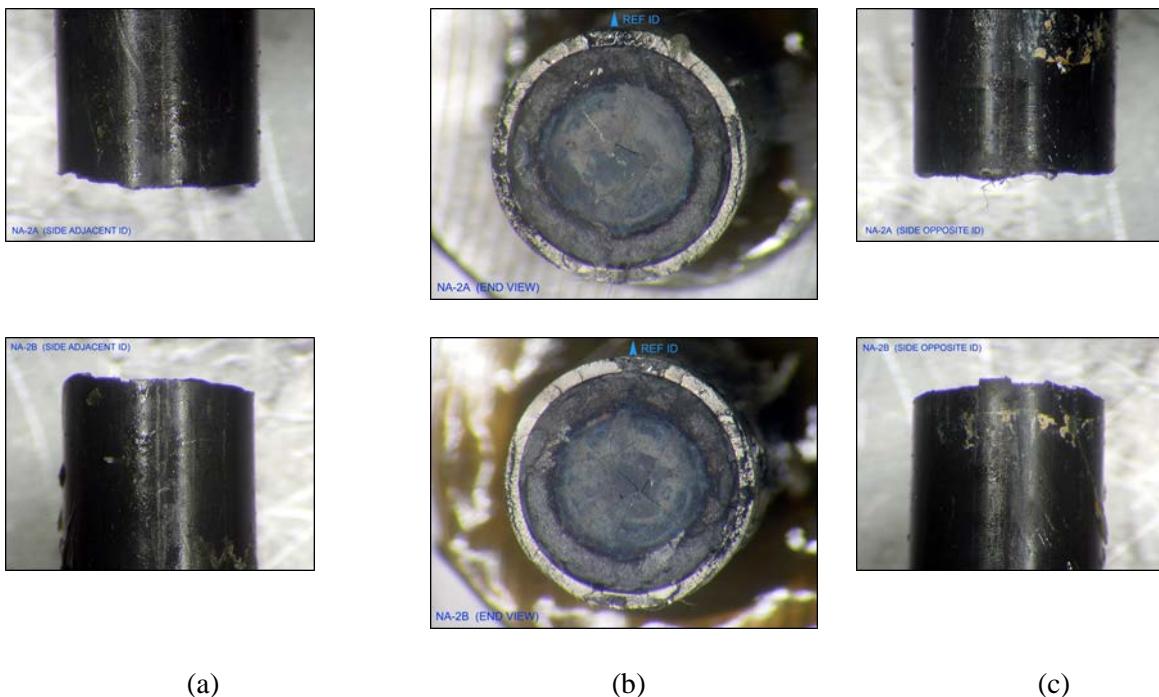
Fig. 73 (a) Lateral or front view, (b) transverse view, and (c) back view of fracture surface for NA2 tested at $\pm 10.16 \text{ N}\cdot\text{m}$, 5 Hz, $N_f = 2.20 \times 10^4$ cycles.

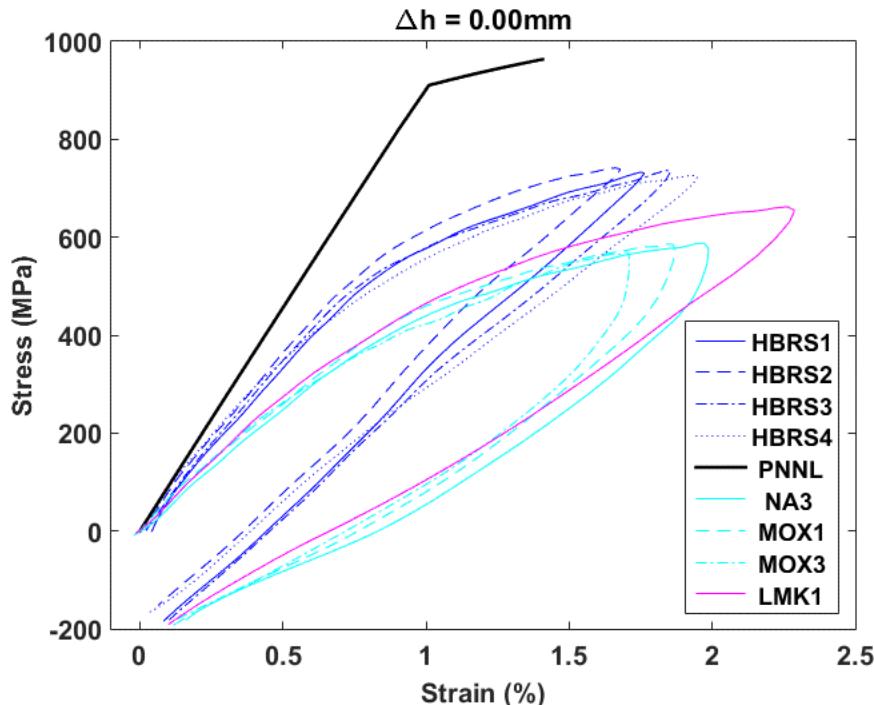
Fig. 77 summarizes the equivalent stress and strain results from static testing on all SNF rods (HBR, NA M5TM, and MOX M5TM). The static responses of NA M5TM and MOX M5TM specimens were quite consistent. The three stages of the curve (Fig. 77) can be identified with the first and second deflection points (approximately 90 and 300 MPa, respectively). The curves of NA and MOX fuels were obviously well below those of HBR fuels, due to the lower yield stress of M5 cladding compared to Zircaloy-4 cladding. The maximum stress of HBR fuels at the same relative displacement (24.00 mm) was between 733 and 748 MPa, while that of NA and MOX were between 510 and 530 MPa. The maximum strains among the three tested fuels were close in value, ranging from 1.67 to 1.98%. The stress level at the first deflection for NA/MOX M5TM fuels was located near 100 MPa, and the second was between 300 and 400 MPa. These stress levels are lower than those of the HBR fuel.⁹ It is interesting to note that the behavior of BWR LMK is similar to that of M5, except with slightly higher maximum stress and strain levels.

A comparison revealed a large discrepancy between the curves of CIRFT static results and the Pacific Northwest National Laboratory (PNNL) data for Zircaloy-4 cladding, where the HBR CIRFT equivalent stress level appears to be lower and HBR strain level appears to be higher than that of the PNNL data. Regarding the stress level, this could be due to an overestimation of the SNF moment of inertia used in the equivalent stress evaluation or the residual stress in a CIRFT-tested SNF samples. It is emphasized that the concept of reduced pellet moment of inertia and Eqs. (2) and (3) were used to demonstrate the relative stress levels between different SNFs. More modeling is needed to understand the deformation mechanisms and to predict the response of the SNF rod under the corresponding loading condition.

Fig. 77 (a) Stress-strain curves based on static testing results for HBR, NA, and MOX SNF. Relative displacement was 24.00 mm; the loading/unloading rate at each point was 0.1/0.2 mm/s.

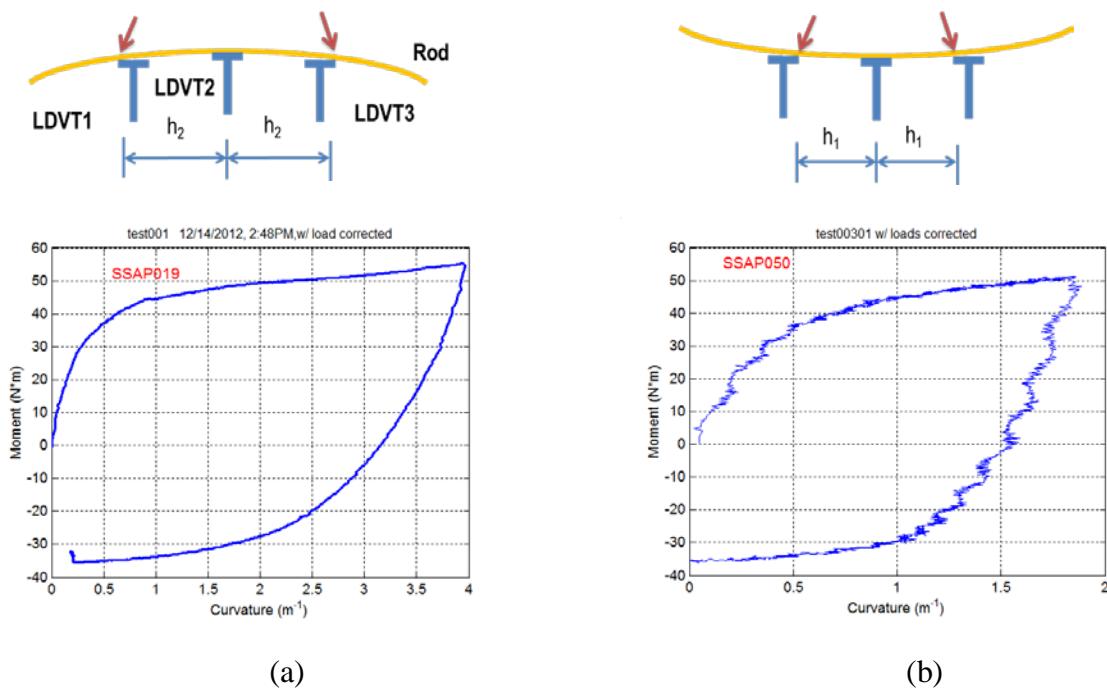
As shown in Fig. 79, at a similar level of applied moment, the maximum curvature obtained is significantly larger when a rod is bending concavely with respect to the LVDTs than when a rod is bending convexly. The discrepancy can be corrected by adjusting sensor spacing h , as illustrated in Fig. 80. The moment-curvature curves in both cases converge if a sensor spacing adjustment Δh of 2.5 mm is used (21% of sensor spacing h and a little less than the contact radius of 3.0 mm). Of course, the actual sensor spacing adjustment can be calibrated, while the study demonstrated that the curvature based on flat-probe contact can be corrected if necessary.

Fig. 79. Moment-curvature curves based on stainless steel aluminum pellet (SSAP) rod testing in which the rod is bent with respect to three LVDTs; (a) concave and (b) convex.

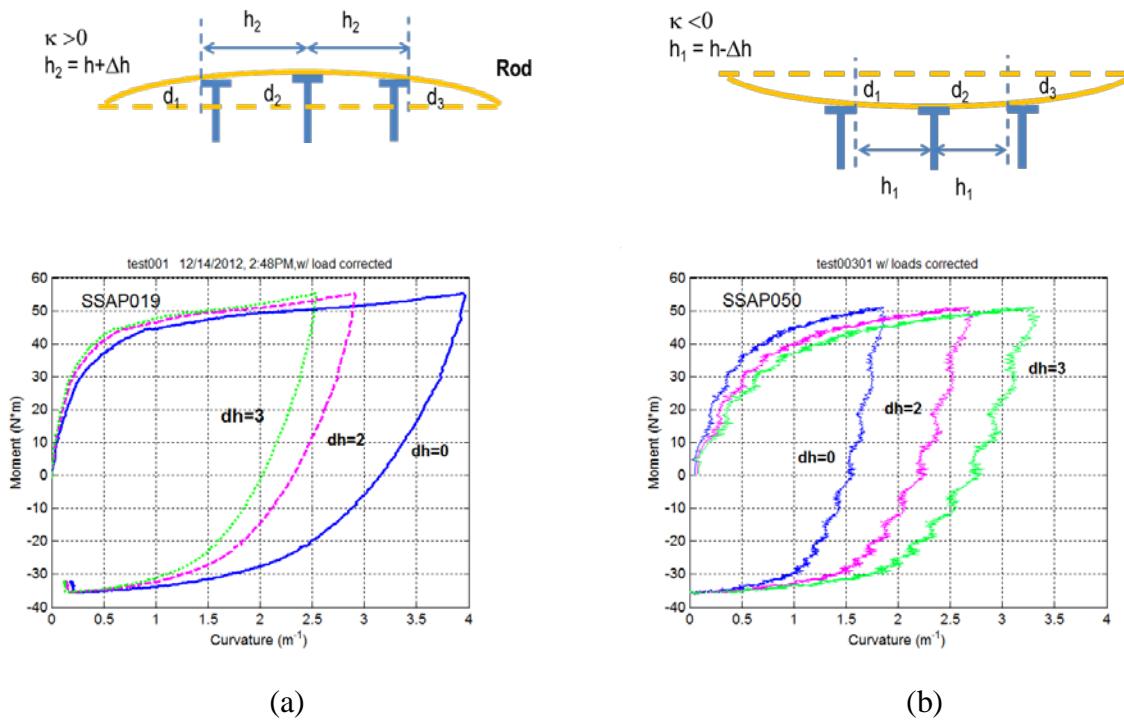
Fig. 80. Moment-curvature curves as a function of sensor spacing adjustment in which a rod is bent with respect to three LVDTs: (a) concavely and (b) convexly.

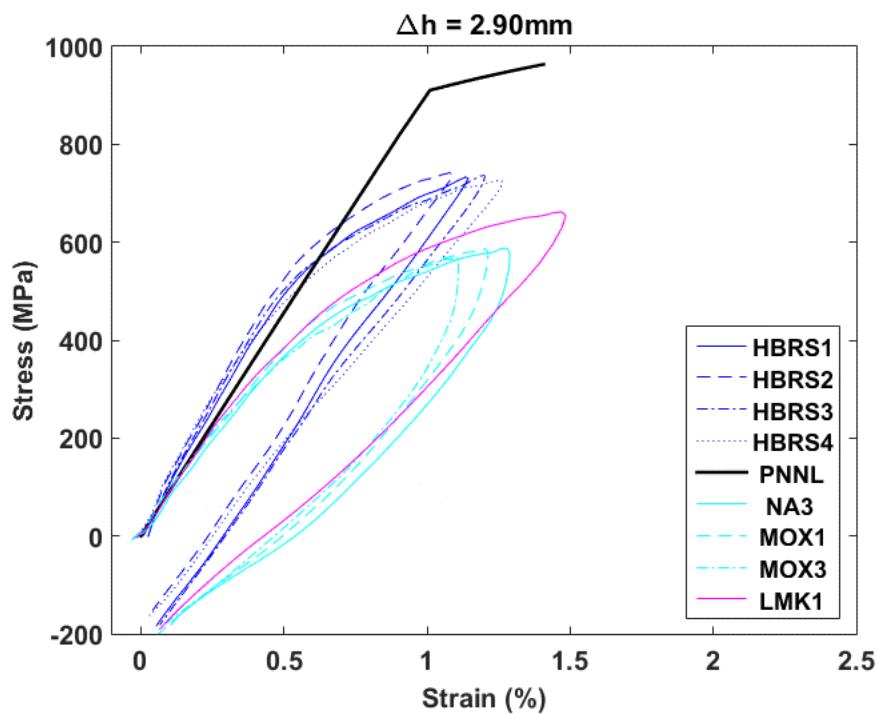
Additional stainless steel aluminum pellet (SSAP) surrogate specimens were used to optimize the sensor spacing adjustment factor, where Δh of 2.9 mm was selected. Based on the adjustment sensing factor Δh of 2.9 mm, updated stress-strain profiles were developed, as shown in Fig. 81, where the updated strain level of CIRFT HBR data is very similar to that of PNNL data. The associated CIRFT bending load vs. curvature data and PNNL bending resistance without pellets are shown in Fig. 82; due to pellet contribution, HBR and LMK has much higher bending resistance compared to PNNL data with the same clad dimension as that of HBR. Further evaluation of the probe sensing adjustment in dynamic CIRFT testing will be pursued in the next report cycle.

Fig. 81. Updated stress-strain profiles based on adjustment factor Δh of 2.9 mm.

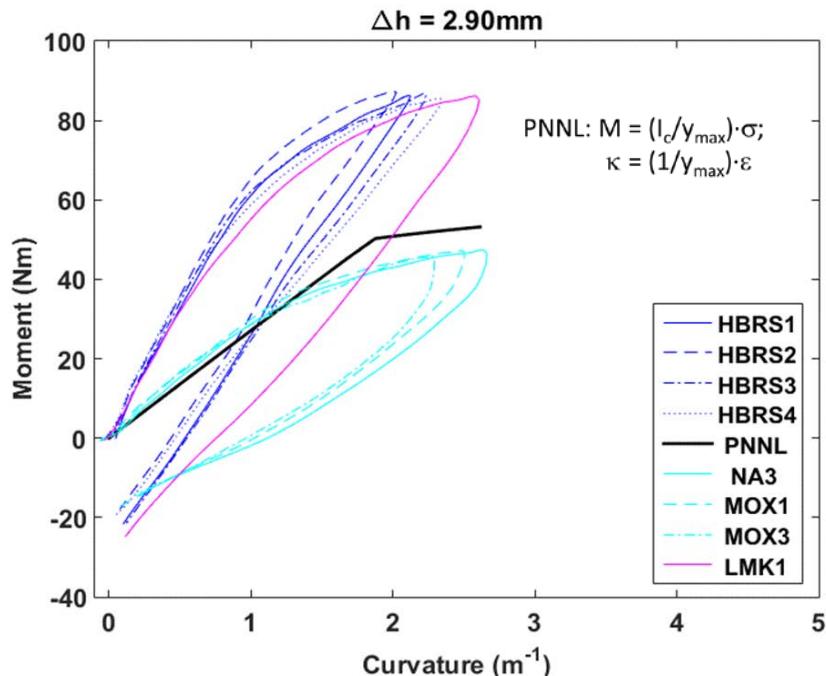
Fig. 82. Moment-curvature plots based on bending tests and comparison with PNNL data with sensing spacing correction; no pellets were involved in PNNL's moment evaluation. Due to dimension and material variability of the tested SNF, the variability in CIRFT bending resistance was also observed.

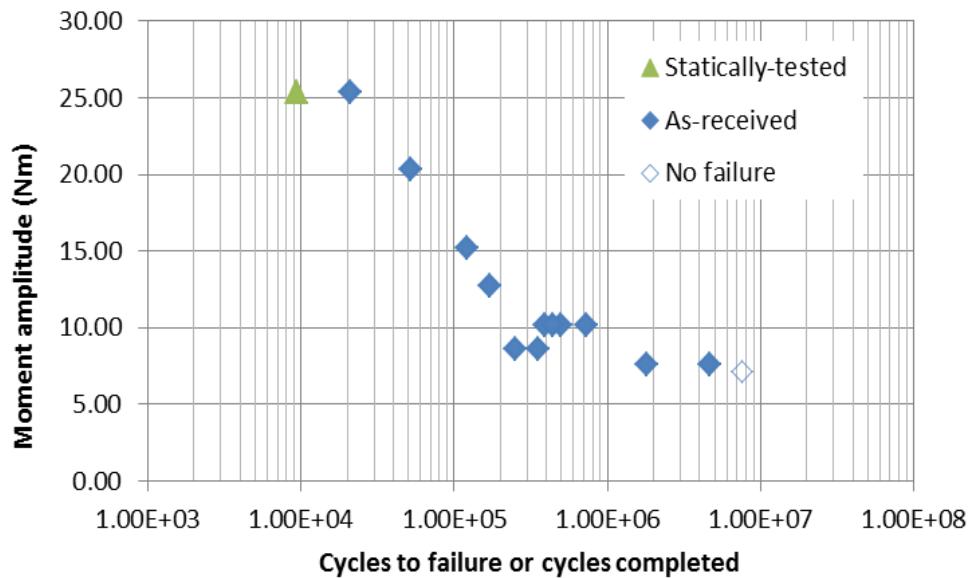
The CIRFT dynamic testing results are summarized in Fig. 83 and Fig. 84. Overall, the decreasing trend in test specimen lifetime with the increasing amplitude is well defined.

Fig. 83. Applied moment amplitude as a function of cycles to failure or cycles completed. The data point of pre-statically tested is based on a follow-up dynamic test of LMK01.

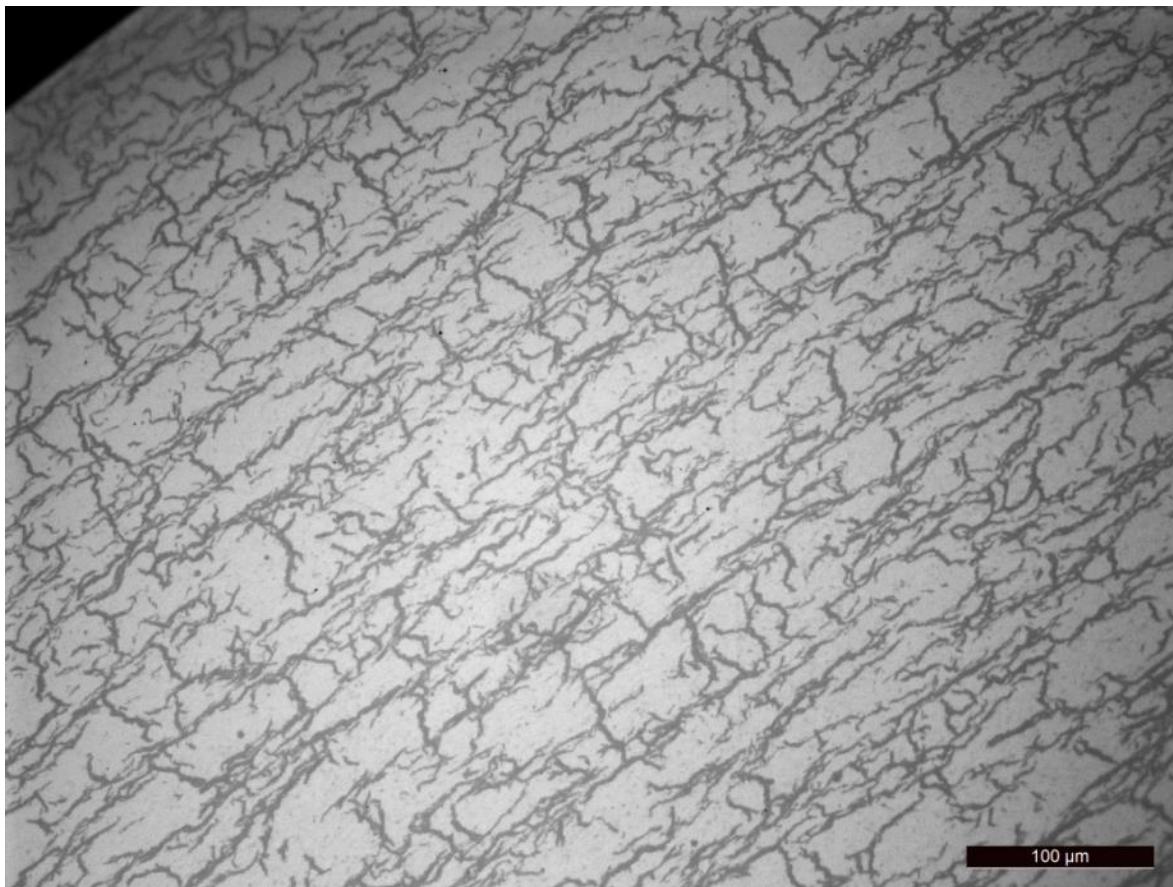
Fig. 125. High magnification micrograph showing radial hydrides of Sample HR-HBR#2 with hydrogen content $H \approx 286$ ppm. The specimen was sectioned at the mid-plane of a 6"-long sample.
