***FY 2015 Status Report:
CIRFT Testing of High-Burnup
Used Nuclear Fuel Rods from
Pressurized Water Reactor and
Boiling Water Reactor
Environments***

*September 4, 2015
M2-FCRD-UFD-2015-000101*

Jy-An John Wang, Hong Wang, Hao Jiang, and Y. Yan

Prepared by
OAK RIDGE NATIONAL LABORATORY
Oak Ridge, TN 37831-6283
managed by
UT-BATTELLE, LLC
for the
US DEPARTMENT OF ENERGY
under contract DE-AC05-00OR22725

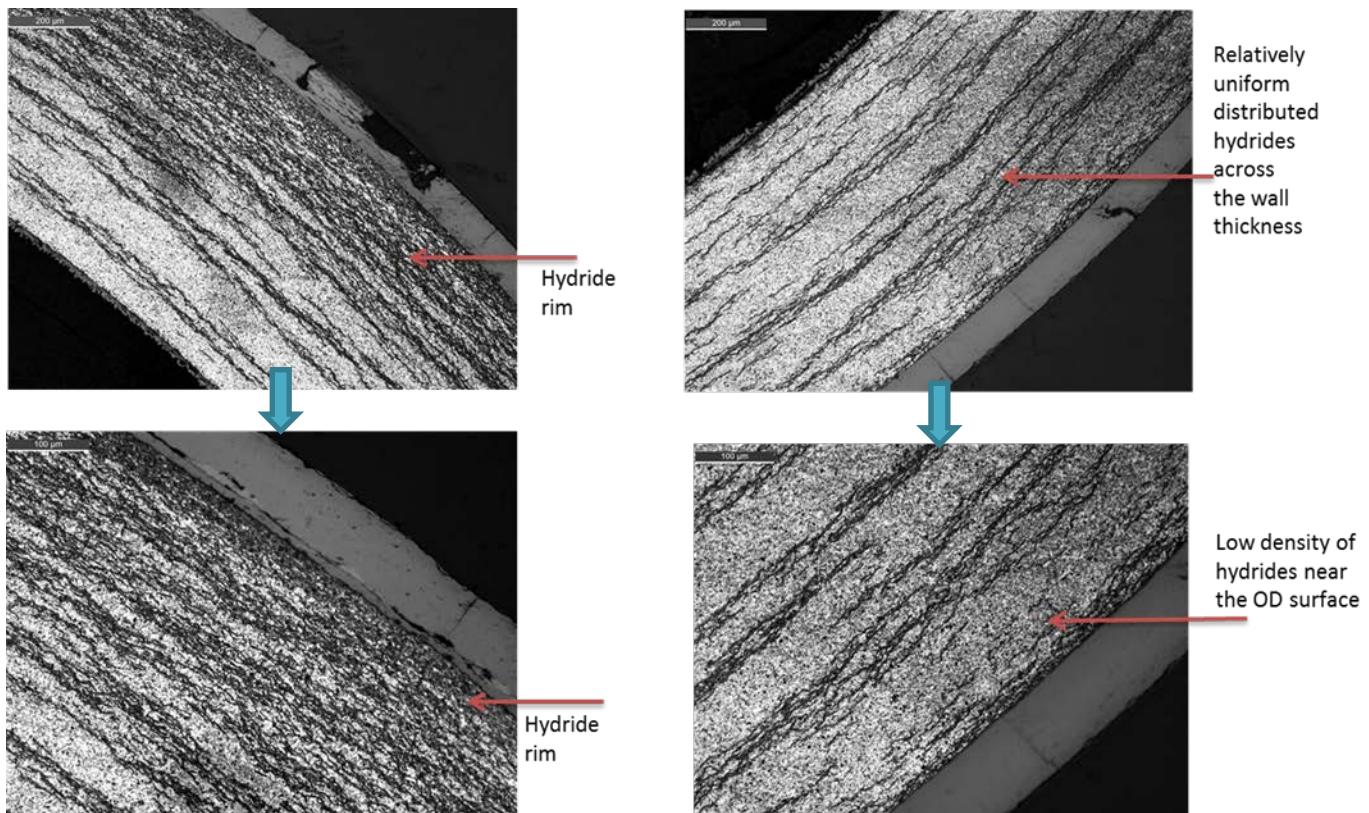
Fig. 135. SEM images of fracture D10 specimen shows non-uniform hydride ring along the outer diameter of the clad wall.

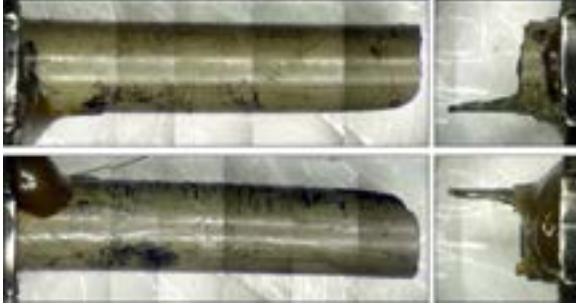
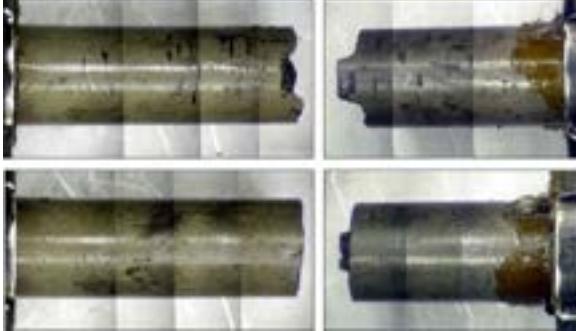
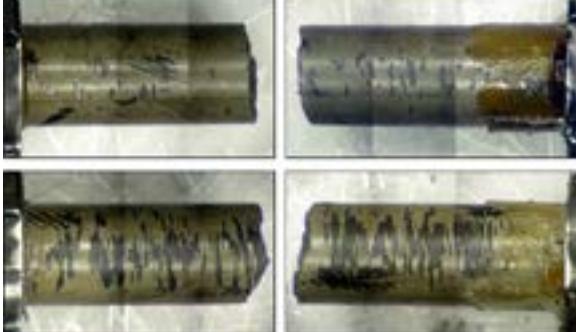
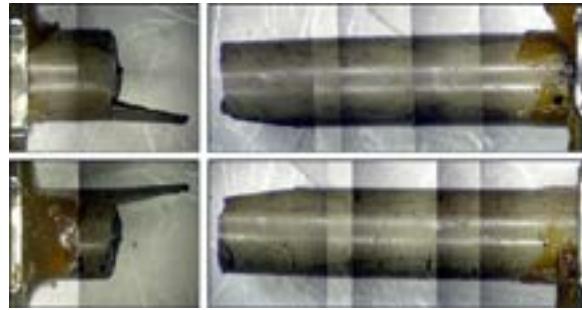
Table 3. Summary of static tests

Overall, the rods failed within the gage sections in all of the tested rods. The majority of the rod fractures involved the pellet-to-pellet interfaces (PPIs). S3 was exceptional in that the failure location seemed away from pellet-pellet interface, as no end face of the pellet can be identified from the fracture surface of the fuel. A summary of static test results is provided in Table 3.

Specimen ID	Specimen burnup	Testing condition and result	Fracture surfaces	Side view of fractured specimens
S1, 606C3C	66.8 GWd/MTU	Four static cycles to 24 mm max. relative displacement, 85.5 N·m max. moment, followed by dynamic loading ± 25.40 to 30.48 N·m, 5 Hz; 1.4×10^4 failure cycles, 0.9 g fuel fragments collected		
S2, 605D1E	66.5 GWd/MTU	Three static cycles to 24 mm max. relative displacement, 87.2 N·m max. moment, followed by dynamic cyclic loading ± 30.48 N·m, 5 Hz; 7.2×10^3 failure cycles, 0.6 g fuel particles collected		
S3, 609C5	66.5 GWd/MTU	Three static cycles to 24 mm max. relative displacement, 85.8 N·m max. moment, followed by dynamic loading: ± 30.48 N·m, 5 Hz; 9.6×10^3 failure cycles, 0.2 g fuel particles collected

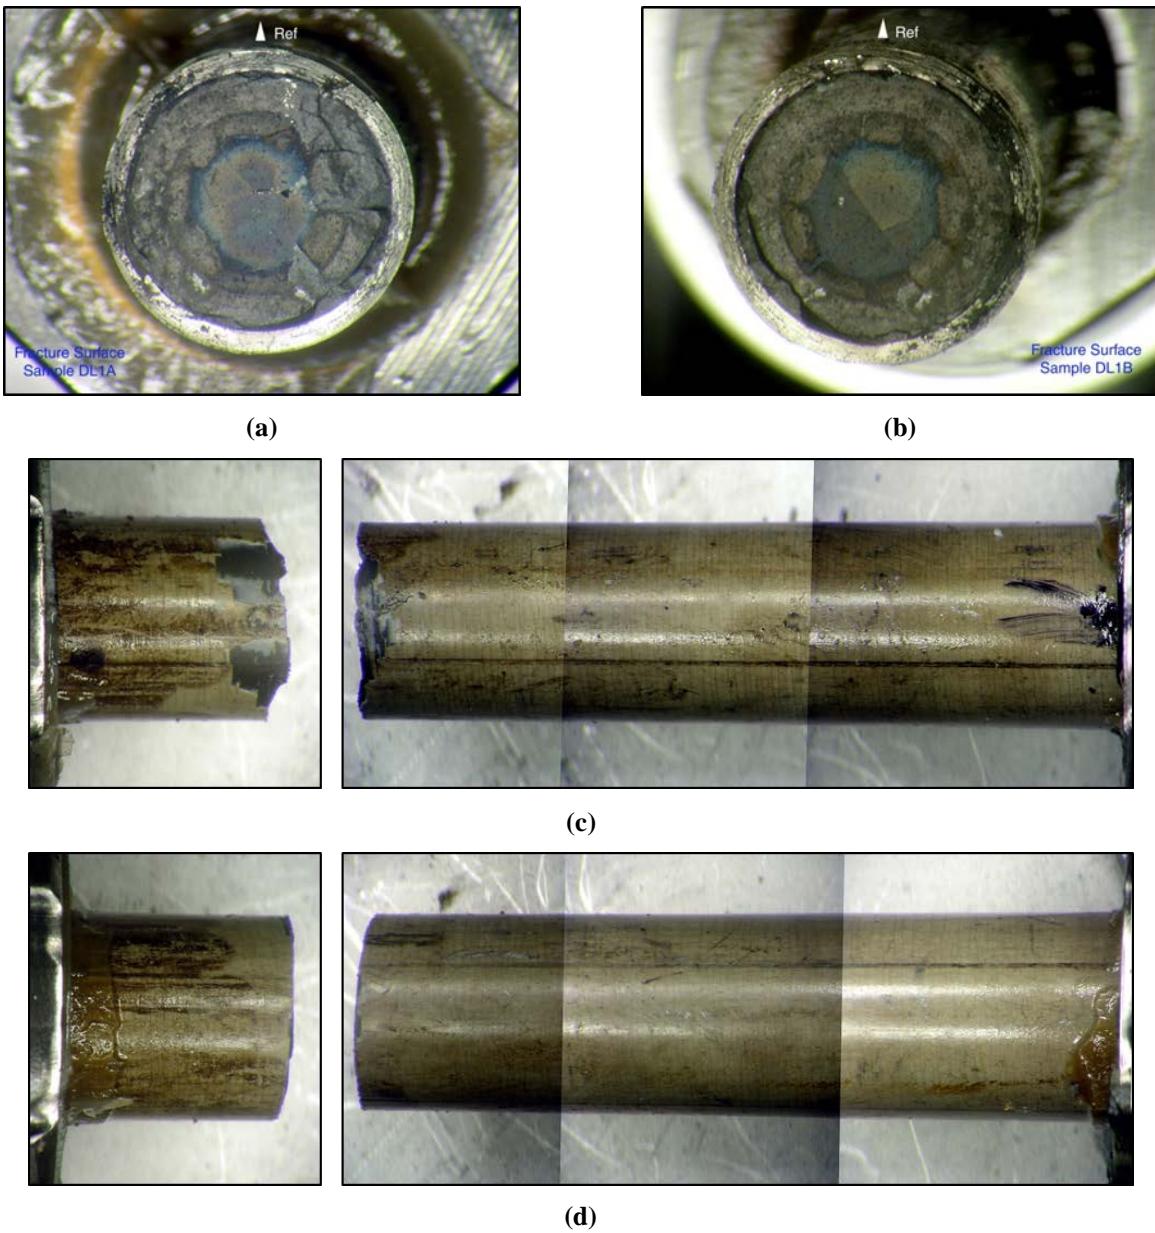
Figure 24. (a) and (b) Mating fracture surfaces, (c) frontal, and (d) back sides for D1 (607C4B), $N_f = 1.1 \times 10^5$ cycles under ± 15.24 N·m, 5 Hz. Fuel particles collected <1.0 g.

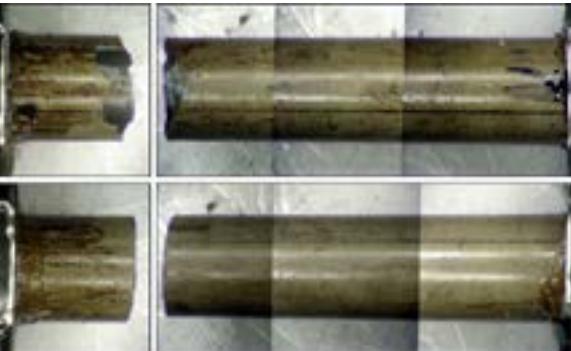
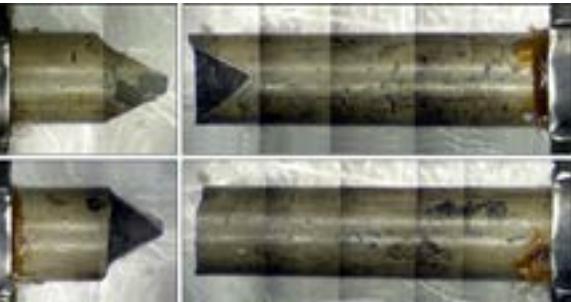
Table 8. Failure modes of rods from dynamic tests

Spec label	Applied Moment amplitude	$\Delta\kappa$	Number of cycles to failure	Cross section	Lateral view	
	N·m	m ⁻¹				
D1, 607C4B	15.24	0.6346	1.10×10^5			
D2, 608C4B	5.08	0.2626	6.40×10^6 w/o failure; follow-up 35.56 N·m, 5 Hz with 1.8×10^3 cycles to failure

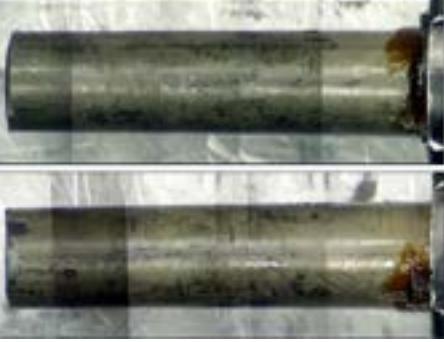
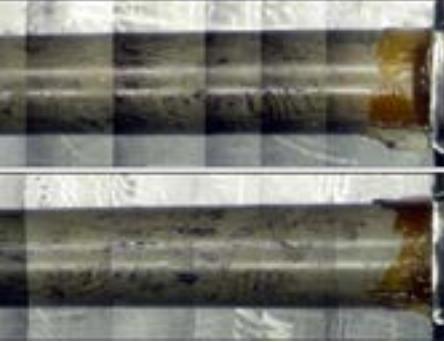
Table 8. Failure modes of rods from dynamic tests (continued)

Spec label	Moment amplitude	$\Delta\kappa$	Number of cycles to failure	Cross section	Lateral view	
	N·m	m ⁻¹				
D3, 605C10A	10.16	0.4469	1.00×10^6		 	
D5, 605D1B	9.144	0.4089	2.30×10^6

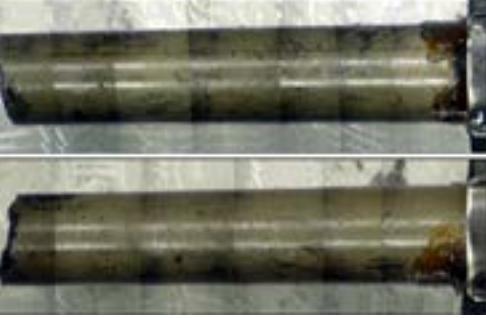
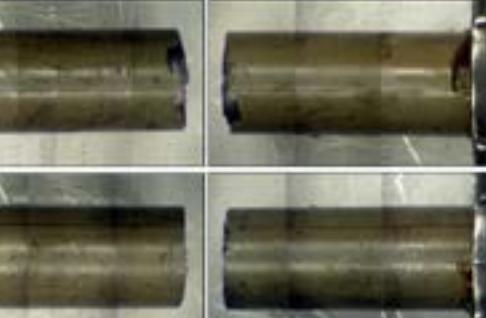
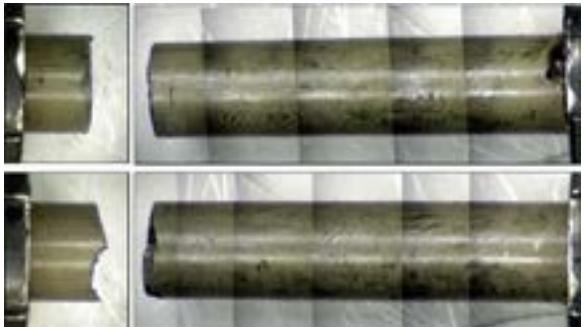
Table 8. Failure modes of rods from dynamic tests (continued)

Spec label	Moment amplitude	$\Delta\kappa$	Number of cycles to failure	Cross section	Lateral view	
	N·m	m ⁻¹				
D6, 609C4	12.7	0.6042	2.50×10^5		 	
D7, 609C3	20.32	0.9693	6.50×10^4

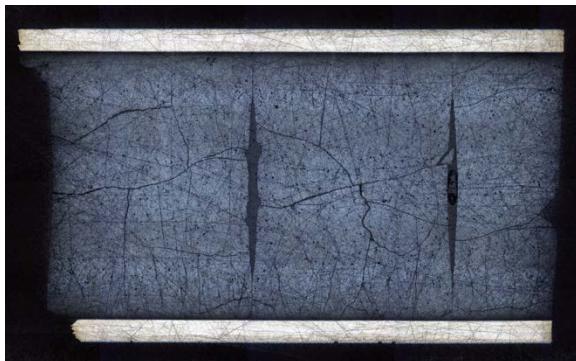
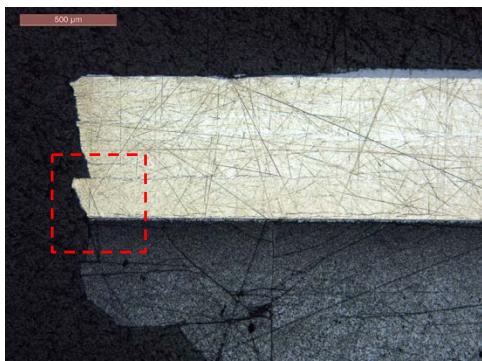
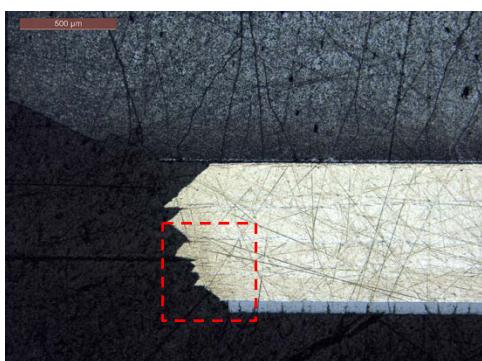
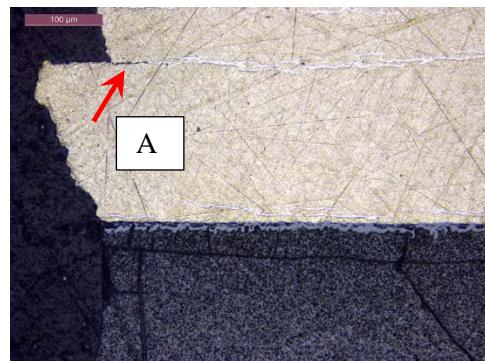
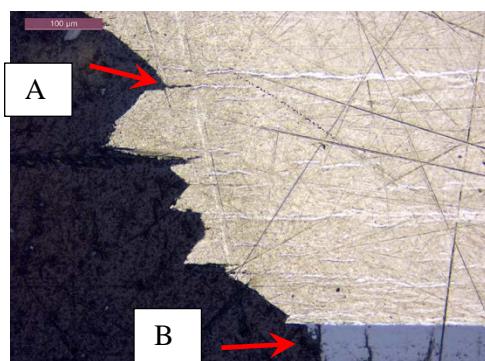
Optical images based on the axial section of S2 specimen are shown in Figure 30. Fuel failure occurred at the PPI as seen from the left-side images. Unlike those in the untested fuel segment, the primary axial fractures did not align but tilted toward the axial direction.

The pellet-to-cladding interface appeared to be in good contact. The fracture surface in the cladding exhibited a zigzag pattern both on the back and front sides of the specimen. The unique pattern resulted from the combination of brittle fracture of hydrides and ductile failure of the metal matrix under tension. Delamination can be seen over the hydride layers near the fracture surface. In addition, spalling and cracking of the surface oxide layer can be seen on the back and front sides.

Figure 30. (a) Axial cross section of S2/ 605D1E, (b) fracture surface near back side of rod and an enlarged area, and (c) fracture surface near front side of rod and an enlarged area. A—delamination, B—cracking of oxide layer.

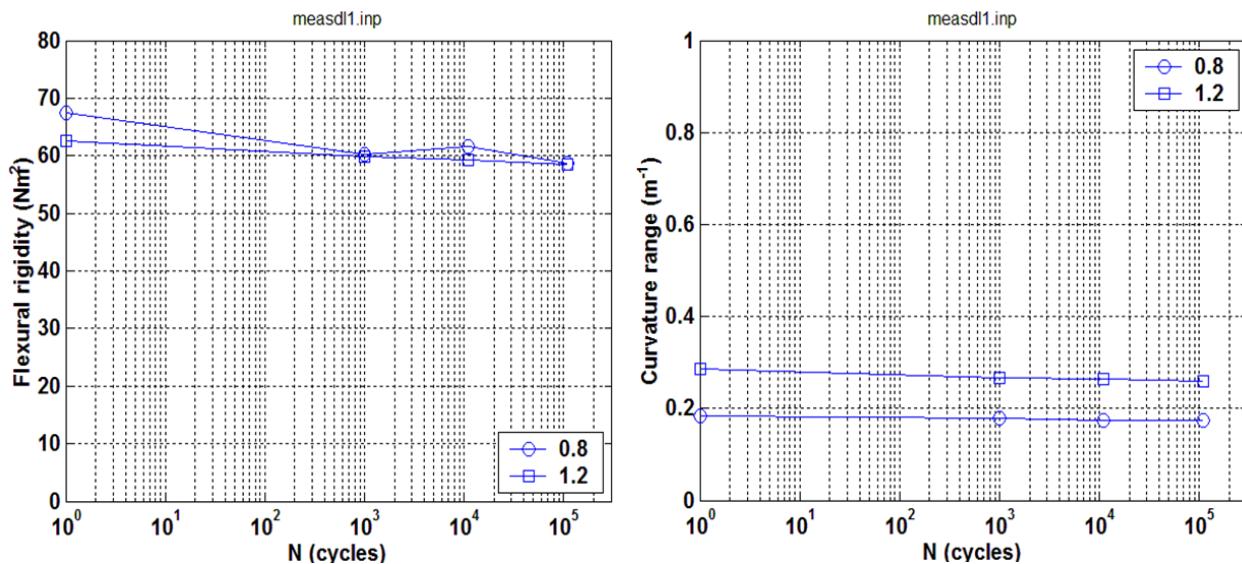
Figure 10. ORNL hot-cell CIRFT data, flexural rigidity, and curvature [3].

The condition of the ORNL HBR fuel rod hot-cell testing specimens resembles that of the clad-epoxy-pellet section model with epoxy-filled gaps at the pellet-pellet interfaces. The HBR fuel specimen was tested under a $6.25 \text{ N}\cdot\text{m}$ bending moment. Figure 10 shows ORNL hot-cell CIRFT data. The flexural rigidity based on the hot-cell test data was observed to be between 60 and $70 \text{ N}\cdot\text{m}^2$, and the curvature was around 0.09 m^{-1} . The initial (first cycle) test data usually have the highest flexural rigidity since the pellet-clad and pellet-pellet interface bonds should maintain the best status before bending fatigue damage. The flexural rigidity in the first test data was a little lower than the FEA estimate, which indicates this testing sample probably has interfacial debonding rather than perfect bonding at the initial test stage.

With good interface bonding and without fuel rod fracture, the fuel rod can carry most of the bending moment under normal transportation vibration. This is a result of the higher Young's modulus of the fuel pellet compared with the clad, along with a much higher yield stress, as shown in Table 1. ORNL fuel data validate that inserted pellets can carry more moment resistance than the clad because of their higher stiffness if the pellet-clad and pellet-pellet interface bonds remain intact. Because of the high flexural strength of the HBR pellets, the fuel rod responds to the bending moment within the linear elastic range. The high flexural rigidity estimated from FEA agrees well with that estimated from bending fatigue testing data. Furthermore, under cyclic loading, it is expected that the interface bond will be progressively degraded as is demonstrated in Figure 10, with decreasing flexural rigidity under increased loading cycles.

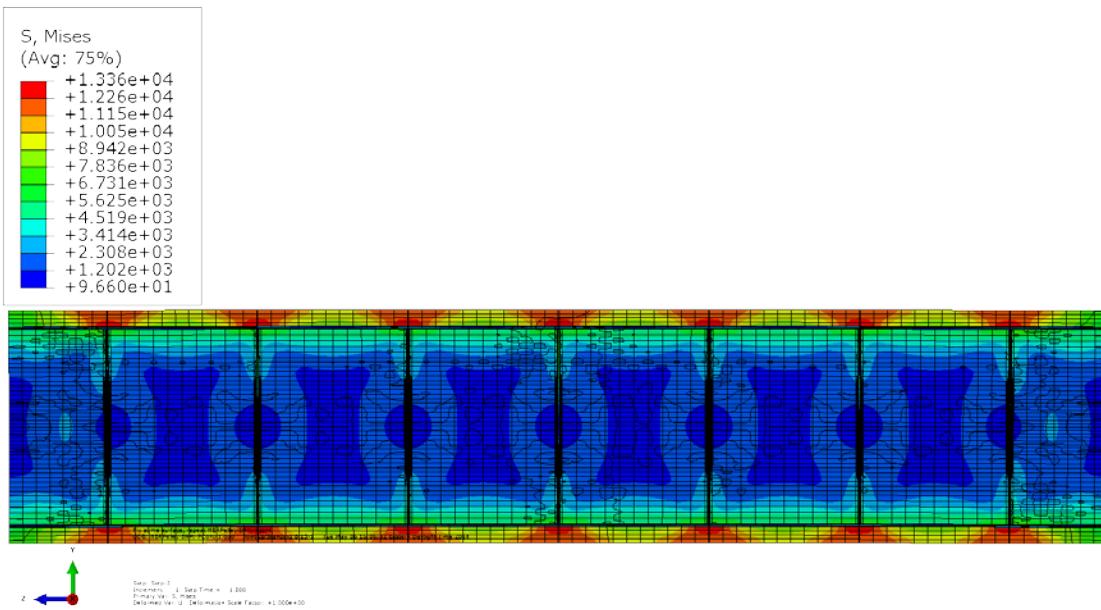
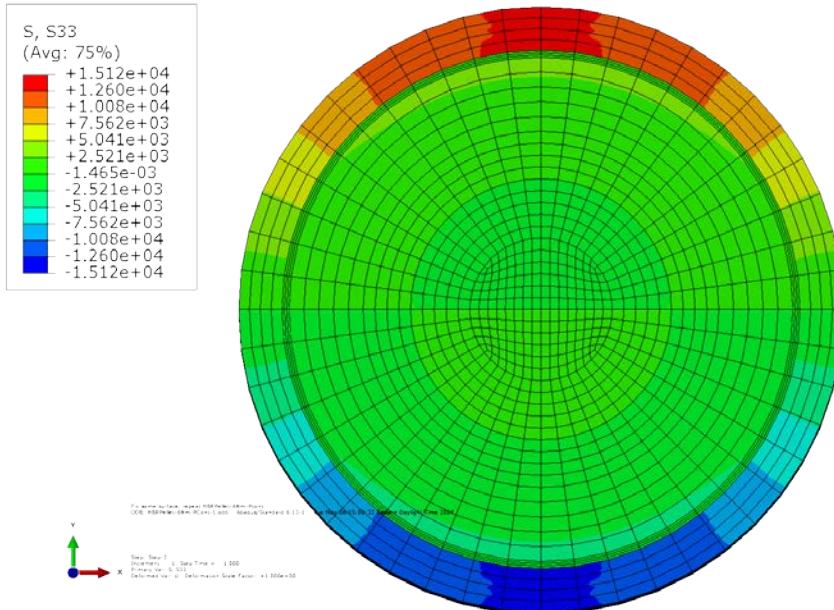
The normal stress and curvature responding to the bending moment are illustrated in Figure 13. Compared with the results shown in Figure 6, there are significant differences in the stress distribution between the pellet-pellet interface bonding case and the pellet-pellet interface debonding case; the pellet-clad interface remains perfectly bonded in both cases. For instance, at the pellet-pellet interface in the debonding case, the maximum stress occurs at the clad and is located at the top and bottom portions of the pellet-pellet interface regions. As a result of the small bending moment, the maximum stress at the clad is 10 times lower than the yield strength of Zr-4, as shown in Table 1, so the Zr-4 clad does not yield. In most of the clad, the stress is much lower than the maximum because the perfect pellet-clad bonding provides good support to the clad. Since there are gaps between pellet-pellet interfaces, the clad deforms continuously until the gaps are reduced by direct contact of the pellet-pellet surfaces. However, no stress concentration is observed at the pellet-pellet contact corners. The resulting σ_{zz} clearly indicates that the clad takes over more of the bending moment resistance than the pellets at the debonded pellet-pellet interfaces.

At the debonded pellet-pellet interfaces, the pellets can transfer load only via hard contact, so the load-carrying capacity shifts significantly from the pellets to the clad. When the Zr-4 clad starts to carry most of the bending moment at the pellet-pellet interface region, the result is maximum stress concentration at the Zr-4 clad. However, in most of the gauge section, the pellets still provide sufficient internal support to the clad because of good cohesive bonding at the pellet-clad interfaces, and they will carry most of the bending load. Therefore, there is much lower stress in most regions of the Zr-4 clad.

dog-bone shape appears in a horizontal direction inside an HBR pellet as a result of von Mises stress distribution. However, in Figure 13, the dog-bone shape inside an HBR pellet is vertically oriented. The third discrepancy lies in the induced curvature. In the debonding case, the curvature is 0.16 m^{-1} , double that of the perfect bond case shown in Figure 6.

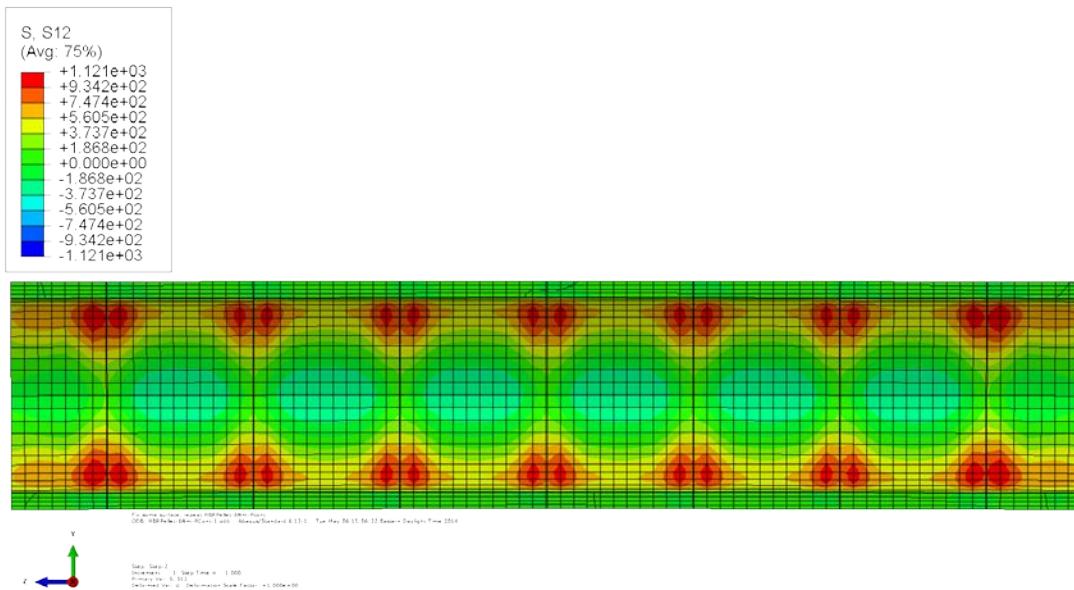
In Figure 14, the difference from the results in Figure 7 for the perfect bond case is apparent. With the pellet-pellet interfaces debonded, the shear stresses surge near the pellet-pellet interface debonding region inside the cladding. The reason might be an increase in shear stress due to a composite material mismatch at the debonded pellet-pellet interface boundary under bending flexural deformation. With good cohesive bonding at pellet-clad interfaces, the clad transfers some shear load at the debonding region. If there are small gaps at the pellet-pellet interfaces, the shear stress concentration occurs at both the top tension and bottom compression regions of the clad. Maximum stress levels are higher than in perfect bond cases; however, the shear stresses are still one order of magnitude lower than the normal stress in the same simulation case.

Figure 14. Shear stress distribution at the clad of the clad-epoxy-pellet section model of HBR pellets with debonded pellet-pellet interfaces with gaps and bonded pellet-clad interfaces using epoxy.
