Ocular Visit

Date:	February 5, 2026
Title:	Technical Inspection For Network Infrastructure
Location:	Robinsons Metro East
Address:	Marcos Highway, Brgy. Dela Paz, Pasig City
Coordinates	14°37′09″N 121°06′00″E
Name of Engineer:	Jake Mamaril

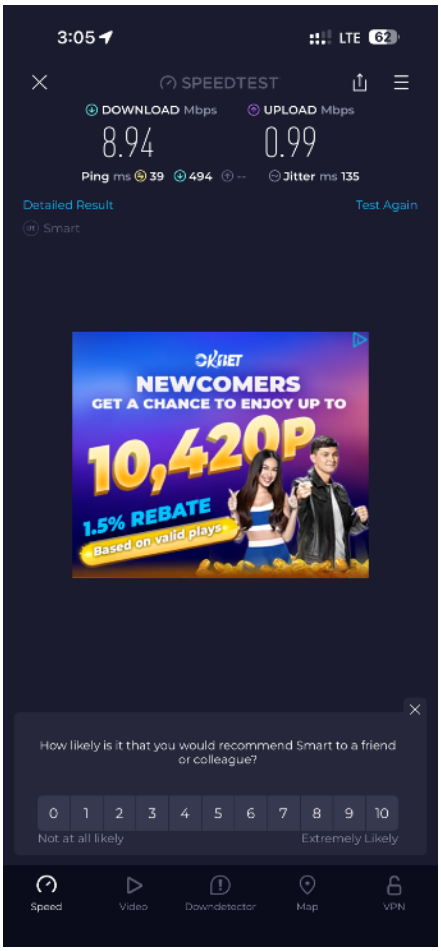
Network	Technology 4G / 5G	Download	Upload	Latency	Notes
Smart	LTE	8.94	0.99	135	Low Bandwidth
Globe	LTE	12.0	2.82	22	Low Bandwidth
Gomo	N/A	N/a	N/a	N/a	-
Dito	LTE	44.3	39.8	26	Acceptable speed

3:05
LTE 62
SPEEDTEST
DOWNLOAD Mbps
UPLOAD Mbps
8.94
0.99
Ping ms 39 494 --
Jitter ms 135
Detailed Result
Test Again
Smart
NEWCOMERS
GET A CHANCE TO ENJOY UP TO
10,420P
1.5% REBATE
Based on valid plays
How likely is it that you would recommend Smart to a friend or colleague?
0 1 2 3 4 5 6 7 8 9 10
Not at all likely
Extremely Likely
Speed
Video
Downdetector
Map
VPN

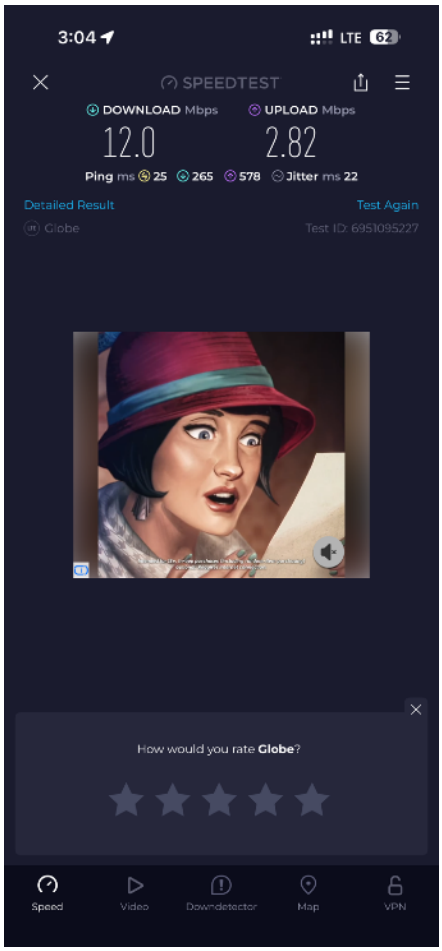
3:04
LTE 62
SPEEDTEST
DOWNLOAD Mbps
UPLOAD Mbps
12.0
2.82
Ping ms 25 265 578
Jitter ms 22
Detailed Result
Test Again
Globe
Test ID: 6951095227
How would you rate Globe?
Speed
Video
Downdetector
Map
VPN

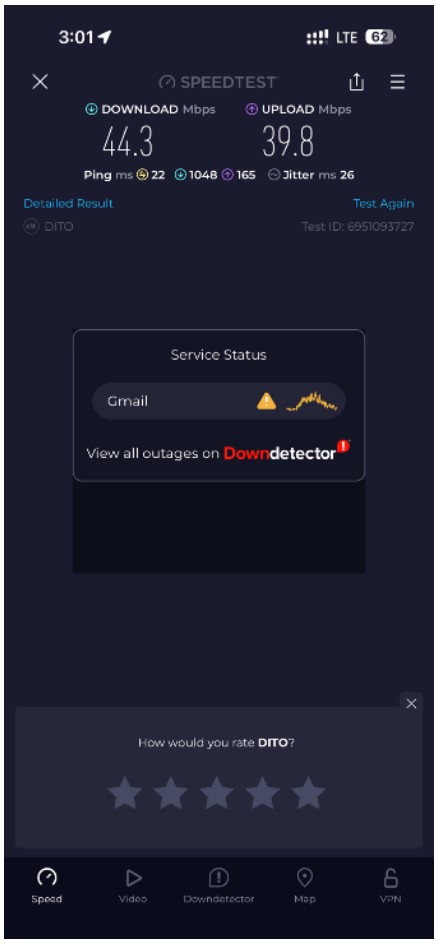
3:01
LTE 62
SPEEDTEST
DOWNLOAD Mbps
UPLOAD Mbps
44.3
39.8
Ping ms 22 1048 165
Jitter ms 26
Detailed Result
Test Again
DITO
Test ID: 6951093727
Service Status
Gmail
View all outages on Downdetector
How would you rate DITO?
Speed
Video
Downdetector
Map
VPN
