Report # 95408

Property Address: **1731 Mountain Blvd. Oakland, CA. 94611**
Inspection Date: **3/16/2026** Inspector: Mike Brooks

Roof Inspection

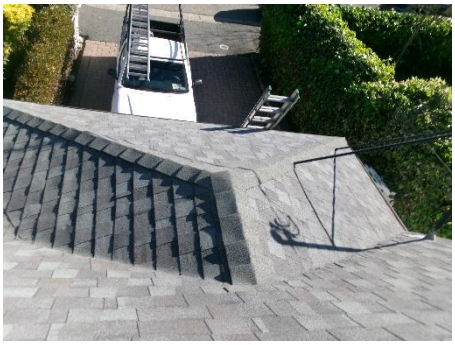
PHOTO 1

1. Overviews of the current conditions of the roof and its related components. Photos 1 – 5. Roof under solar is not visible and therefore not part of this inspection. Patio cover is not part of this inspection. Photo 6
