Inspection Report

Property Address:
1731 Mountain Blvd
Oakland CA 94611

DB Standard Home Inspection

Report ID
20260314-1731-Mountain-Blvd

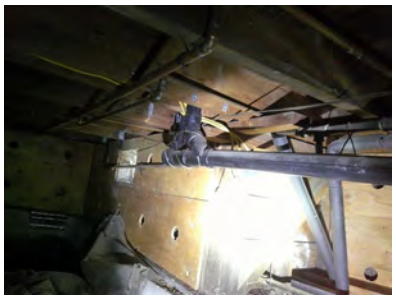
The crawl space entrance is located on the exterior. Included are general photos from inside the crawl space. FYI
