WOOD DESTROYING PESTS AND ORGANISMS INSPECTION REPORT

BUILDING NO.	STREET, CITY, STATE, ZIP	Date of Inspection	No. of Pages
1731	Mountain Blvd, Oakland CA 94611	3/21/2026	15

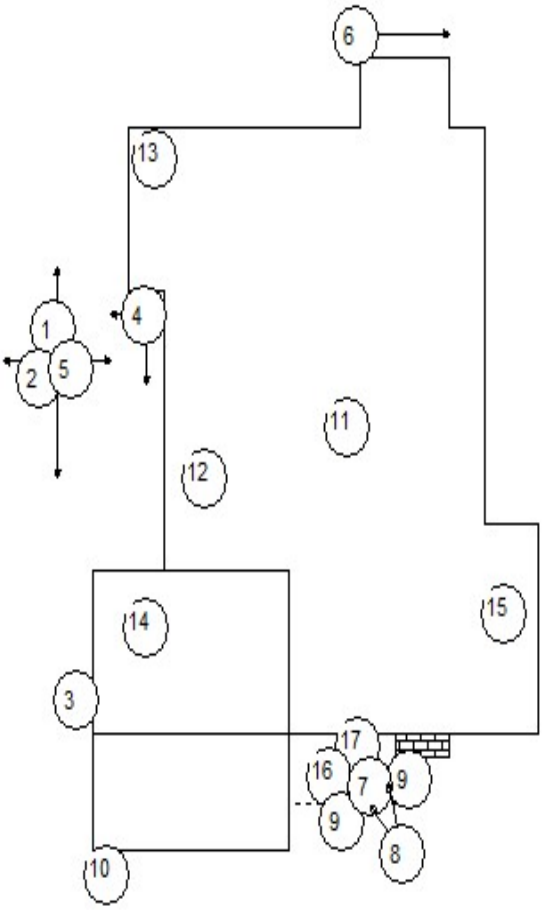
NOTE: DIAGRAM IS DISPLAYED ON PAGE 2

ITEM 3 FINDING: The soffit cover has been damaged by fungus at the area(s) indicated on the diagram.

ITEM 7 FINDING: The front patio cover support post has been damaged by fungus at the area(s) indicated on the diagram.

ITEM 8 FINDING: The front patio decorative fascia has been damaged by fungus at the area(s) indicated on the diagram.

ITEM 9 FINDING: The front patio cover support beams have been damaged by fungus at the area(s) indicated on the diagram.

ITEM 13 FINDING: The back bedroom hardwood floor and underlayment have been damaged by fungus at the area(s) indicated on the diagram.

RECOMMENDATION: Remove and replace all damaged wood members. If the damage is found to extend into an inaccessible area a supplemental report will be issued with any additional findings, recommendations and bids. Paint to match as close as possible.
