Two rockets, four flights, summer 2026

Supersonic flight test and failure reconstruction

Dual-deploy high power rocket — NAR Level 2 certification

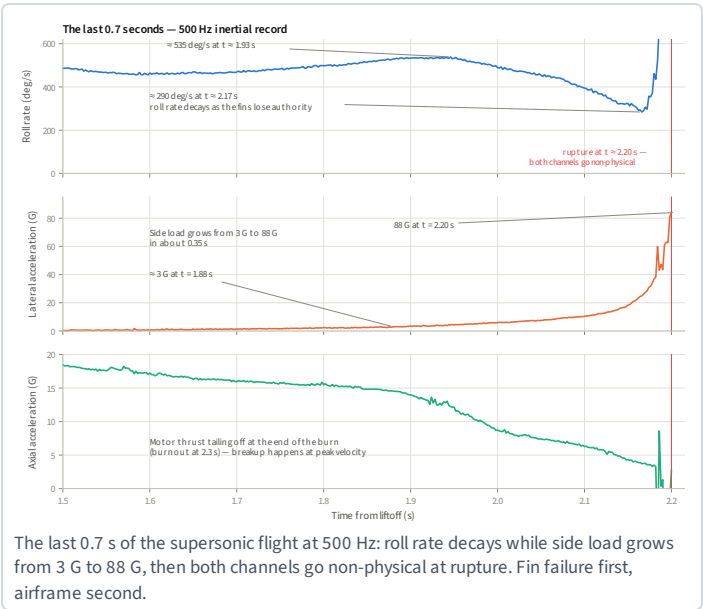
I flew the second rocket on a subsonic shakedown to 2,833 feet first, then on the supersonic attempt, where it reached 1,367 ft/s (about Mach 1.2) at 2.14 s and broke apart at 2.20 s. The avionics bay came down intact with the complete 500 Hz flight record.

The data showed side loading rising from 3 G to 88 G in about a third of a second while the roll rate decayed from about 535 to 290 deg/s, and all four fins were missing from the wreckage: the fins failed first and the airframe opened afterward. I also caught that the altimeter's 7,131 ft summary altitude was an artifact of the exposed static port and threw it out. Redesign specified: thicker, stiffer fins with a stronger root attachment and a composite airframe.

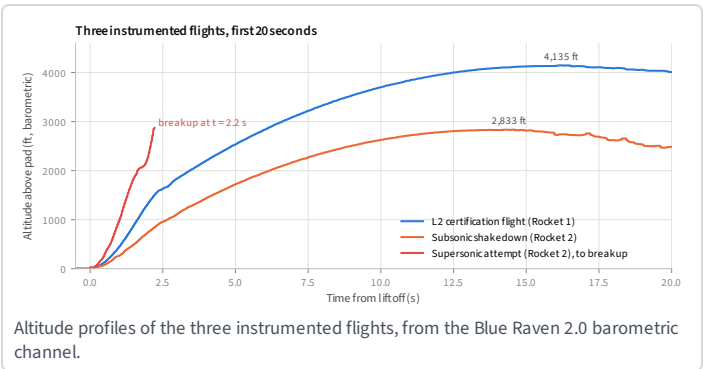
My first Level 2 attempt failed right in front of me: the drogue came out, the main never did. I found the cause in the recovery train — I had accounted for the length of the shock cord but not for the shroud lines — restaged the main parachute directly behind the nosecone, and flew again.

The certification flight earned my Level 2: a J250 motor to 4,135 feet, within 6.8 degrees of vertical at burnout, main deployment at 1,498 feet and a 19 ft/s descent, on a 3D-printed electronics bay I designed that survived a 59.6 G touchdown.
