Two rockets, four flights, summer 2026

Supersonic flight test and failure reconstruction

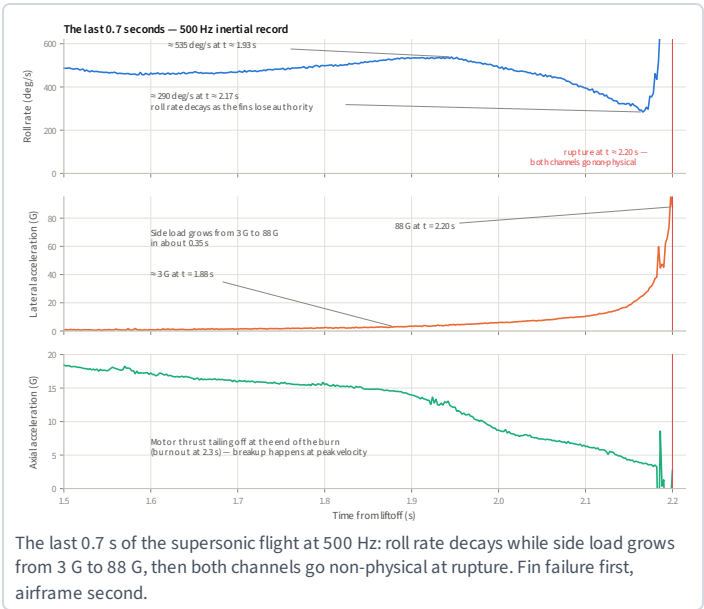
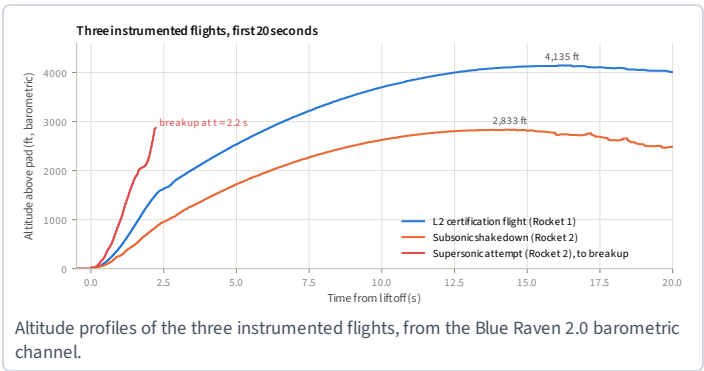
My first Level 2 attempt failed right in front of me: the drogue came out, the main never did. I found the cause in the recovery train — I had accounted for the length of the shock cord but not for the shroud lines — restaged the main parachute directly behind the nosecone, and flew again.

The certification flight earned my Level 2: a J250 motor to 4,135 feet, within 6.8 degrees of vertical at burnout, main deployment at 1,498 feet and a 19 ft/s descent, on a 3D-printed electronics bay I designed that survived a 59.6 G touchdown.
