Edwin Calles Molina

Aerospace Engineering student at Cal Poly Pomona. I design rockets, build them, fly them, and work from the data that comes back.

Supersonic flight test and failure reconstruction

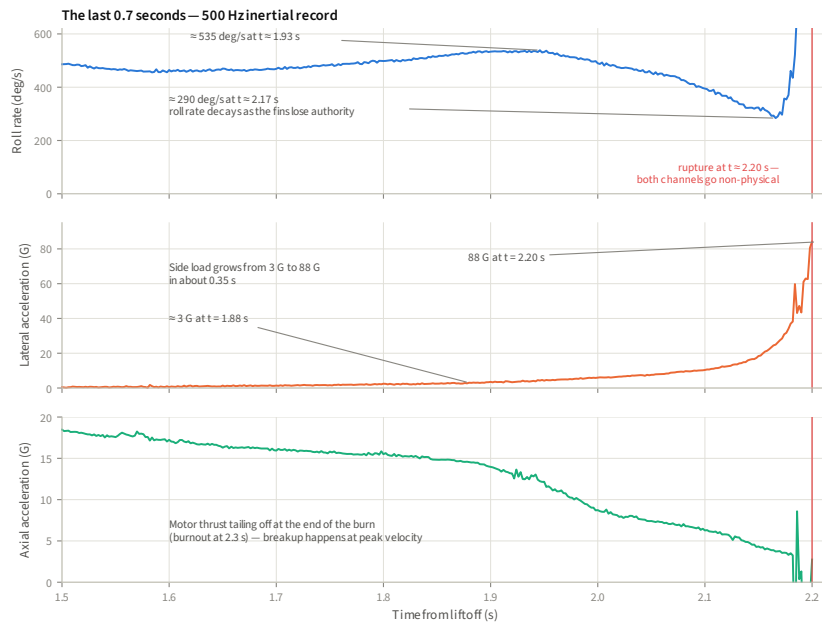
I spent weeks going through that data and the wreckage. The data showed that side loading went from 3 G to 88 G in about a third of a second, the roll rate decayed from about 535 to 290 deg/s, and all four fins were missing from what I recovered.

My first read was that the airframe wasn't strong enough — but the roll rate started dropping before the airframe came apart, which meant the fins failed first and the airframe opened afterward. I had to throw out my first explanation and go with what the data showed.

The last 0.7 seconds before rupture, from the 500 Hz record. Roll rate peaks at about 535 deg/s and then decays while the side load grows from 3 G to 88 G. At $t \approx 2.20 \text{ s}$ both channels go non-physical, which is the airframe letting go rather than any sensor limit.

I specified the redesign from what the data showed: thicker, stiffer fins with a stronger root attachment, and a composite airframe replacing the original tube. The changes I ended up making were materials and manufacturing decisions rather than changes to the shape of the rocket. The rebuild is in progress and has not flown yet.

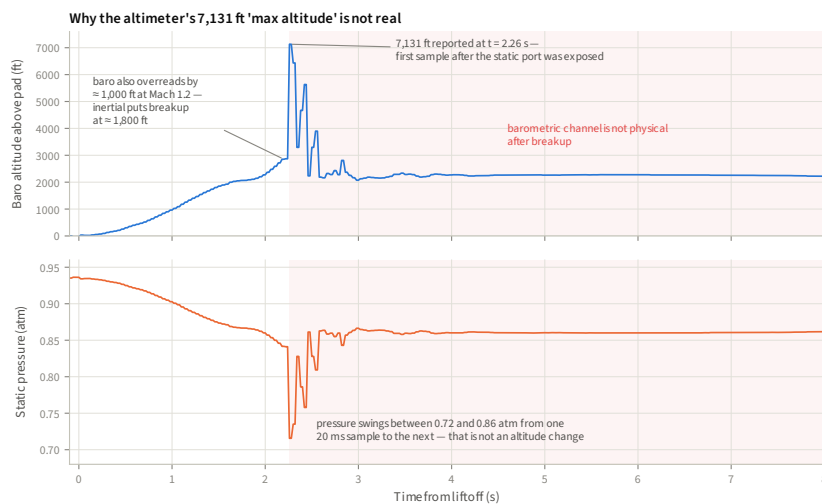
The altimeter's summary file reported a peak altitude of 7,131 feet, far above what actually happened. When the airframe opened, the static port was exposed, and the pressure reading started swinging between 0.72 and 0.86 atm from one 20 ms sample to the next, which is not an altitude change. By cross-checking it against the backup inertial data I was able to establish the real trajectory, and I threw the corrupted value out. The barometric channel was not trustworthy before the breakup either: at Mach 1.2 the pressure at a flush static port is not free-stream static, and that channel reads roughly a thousand feet high. Integrating the inertial record instead puts the breakup at about 1,800 feet.

Why the altimeter's 7,131 ft summary value is an artifact: the static pressure channel becomes non-physical the moment the airframe opens.
