PRINT REPORT

LFM-0122-200-056

ReportNumber:	01	ProjectNumber:	LFM-0122-200-056
PartNumber:	LFM-0122-200-056	InquiryNumber:	LFM-0122-200-056.001
Requirements:	DO-01	DrawingNumber:	LFM-0122-200-056.idw
PartTitle:	Tube honeycomb	Visual testing date:	04.04.2022

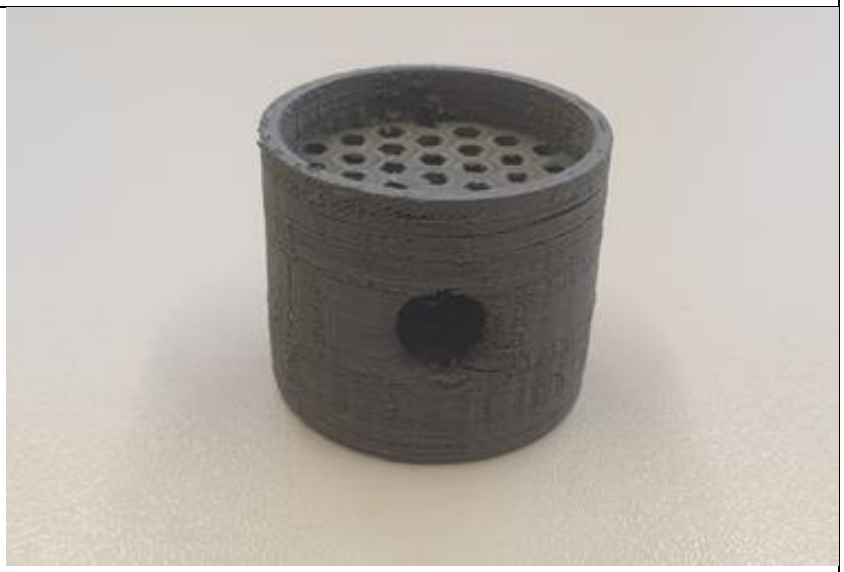
Rough surface **Over extrusion at honeycombs and walls**

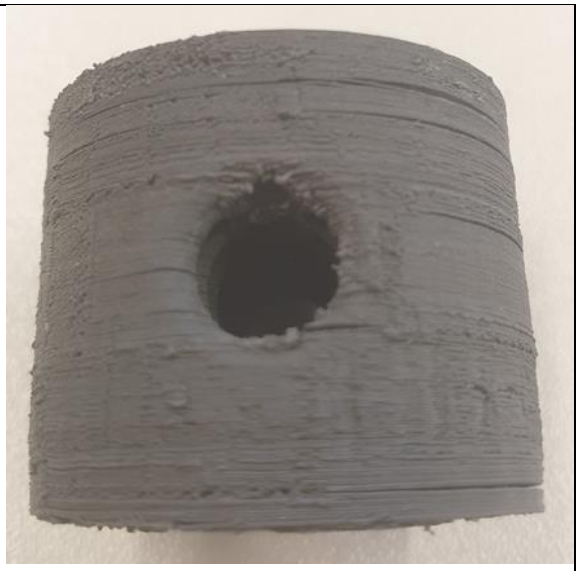
Rough surface **Blobs** **Under extrusion** **Gaps** **Layer delamination**

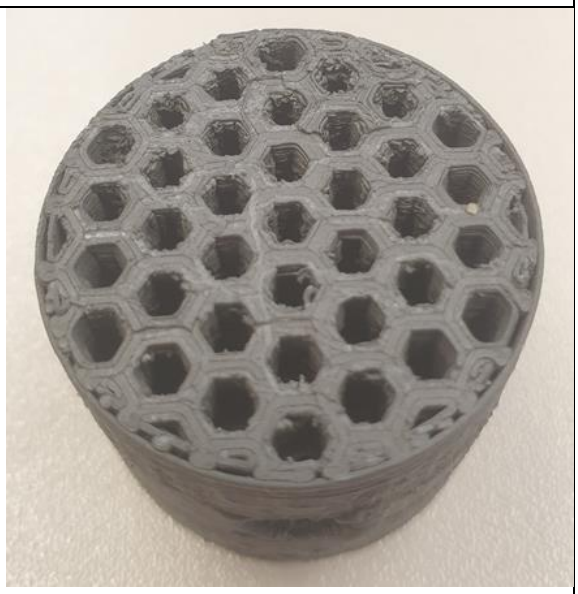
Rough surface **Over extrusion at honeycombs** **Layer delamination due to raft removal**
