SOUTHWEST BORDER SECURITY

Additional Actions
Needed to Better
Assess Fencing's
Contributions to
Operations and
Provide Guidance for
Identifying Capability
Gaps

View GAO-17-331. For more information, contact Rebecca Gambler at (202) 512-8777 or gambler@gao.gov.

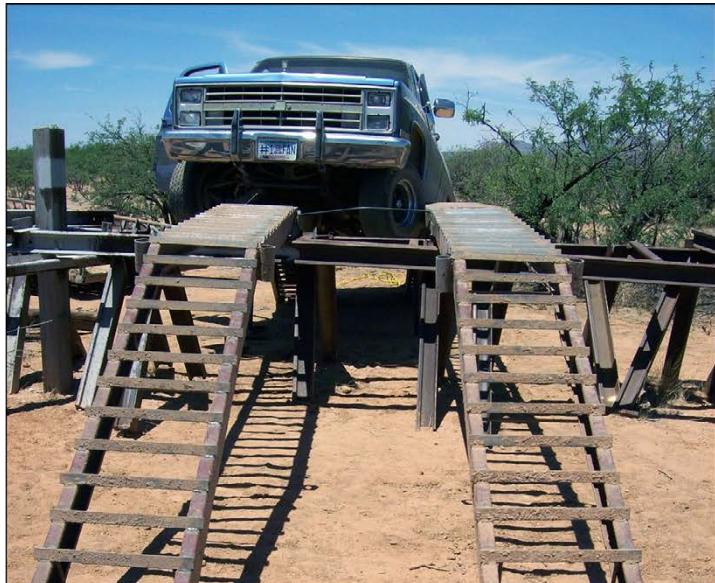
Agents we spoke with in the El Paso sector explained that creating breaches in legacy pedestrian fencing requires less effort compared to modern designs, and can be done using bolt or pipe cutters. In addition, these agents also described observing illegal entrants cutting and dragging sections of vehicle fencing off the border and illegally entering the United States in vehicles. Agents we spoke with in the Tucson sector also told us that while pedestrian fencing is generally easier to breach, they have also observed breaches in more modern fence designs, including bollard fence, which agents stated were cut using portable power tools.

Figure 7: Select Methods used by Illegal Entrants to Defeat Border Fencing on the Southwest Border

Truck attempting to defeat vehicle fencing with ramps
