Home Survey – Level 3

REFERENCE
0103

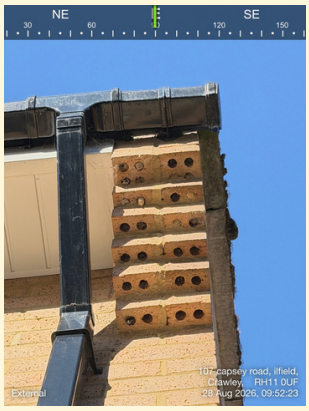
Fig. 13

Based on your readings, Elevated moisture meter readings were recorded in sections of the external wall, particularly around the kitchen elevation area. The readings may be associated with localised rainwater penetration, defective pointing/rainwater goods, or other sources of moisture ingress.

Further investigation is recommended, including monitoring moisture levels under dry weather conditions and inspecting the external wall and rainwater goods.

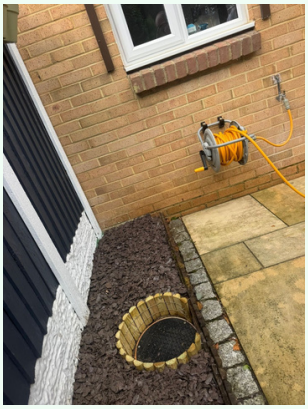
Fig. 83

No external foul water drainage inspection chambers or manholes were identified or exposed during the inspection. These are understood to serve the kitchen drainage and the first-floor family bathroom.
The Client/Vendor verbally identified a foul water manhole located to the rear right-hand side of the property, beneath approximately 100 mm of slate chippings, with a plastic membrane/layer below, near to the external kitchen wall.
Following the inspection, the Client/Vendor identified the location of the manhole and provided photographs via the estate agent on 02/09/2026. These photographs have been reviewed/are provided for reference and are included with this report. Refer to the attached photographs.
If confirmation of the drainage arrangement or condition is required, further investigation by a suitably qualified drainage contractor, including exposing and inspecting the manhole and carrying out a CCTV drainage survey where appropriate, is recommended.
