Ballard-Fremont Greenways

Stone Way Feedback

March 2023

We are writing on behalf of Ballard-Fremont Greenways with our concerns and suggestions regarding the area around Stone Way N between N 34th and N 36th St.

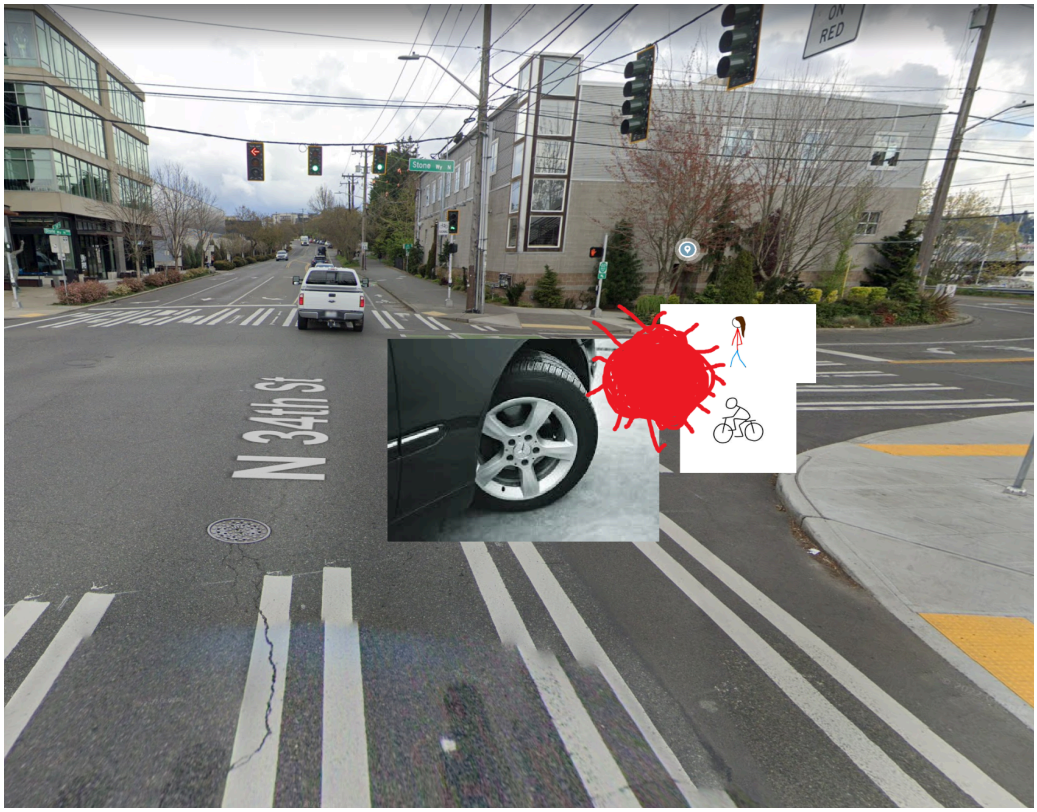
The current situation for pedestrians / cyclists / mobility device users near the project areas (SPU + Sellen) is unacceptable. This map highlights the problems (with photos) along with our recommendations.

- As can be seen in this map, the sidewalk access near the construction sites is extremely poor.
    i) There are cars blocking the sidewalk regularly in front of Evo along the north side of N 35th.

ii) No parking signs block the south side of N 35th.

iii) The sidewalk on the east side of Interlake Ave is closed limiting access to the preschools.

iv) The sidewalk on the east side of Stone Way N is closed between 35th and 36th due to Sellen Construction.

(1) Cars parked in the bike lane.

(2) Pedestrians walking in the bike lane.

v) The detour signs are wrong or confusing:

- Recommendations
  - i) Ensure all sidewalks remain accessible
    - (1) No cars on sidewalks
    - (2) No “No Parking” signs on sidewalks
  - ii) Maintain an **adjacent** pedestrian reroute along the east side of Stone Way between 35th and 36th
    - (1) Car parking can be removed.
    - (2) Maintain the bicycle lane.
    - (3) There are existing **adjacent** pedestrian reroutes only a block further north along Stone

iii) Maintain sidewalk access to the preschools along Interlake Ave

(1) Reopen the sidewalk on the north side of N 35th (east of Interlake Ave)

(2) Reopen the sidewalk on the east side of Interlake Ave

iv) Fix wayfinding and include signage that directs pedestrians and cyclists from the closure, as well as further away.
