To: Marie-Claude Léonard, Chief executive of the Société de Transport de Montréal From: Emma Reddy, student at McGill University

Subject: (URGENT) Intersection Redesign Critical

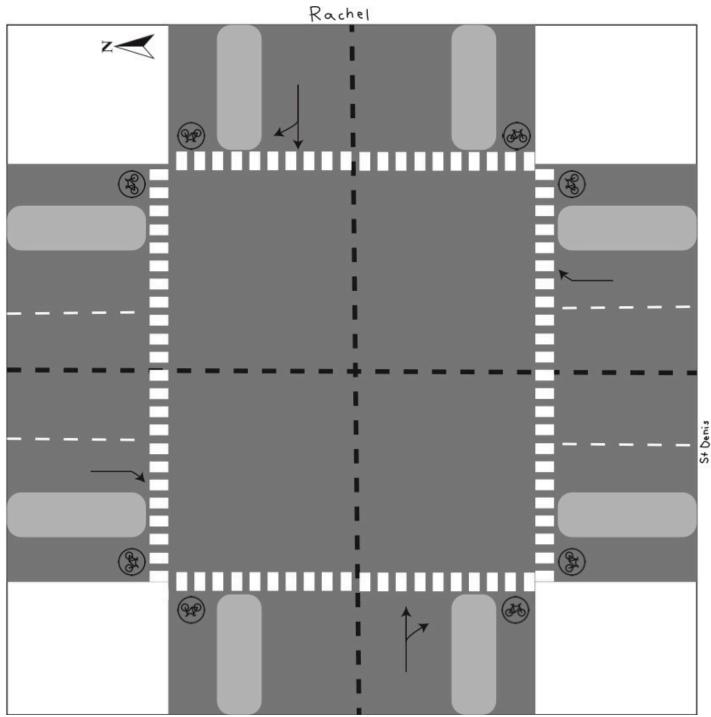
Figure 3: Redesigned intersection plan of Rue Rachel and Rue Saint-Denis

The second major project is to overhaul the layout on Rachel and transform the existing two-way bike lane into two one-way bike lanes (*Figure 3*). This would require sacrificing the parking spots currently available on Rachel in order to free up space. However, during my one-hour observation, I only counted six vehicles parked on Rachel within 100 meters of the intersection. On the other hand, there were 19 bikes crossing through the intersection within only 10 minutes. Adding to the existing bike lane infrastructure would greatly improve the safety of this intersection.
