Impact Of Climate Changes On Overhead Transmission Lines

Croatian Transmission System Operator Plc.
Croatia

2024 IEEE PES Innovative Smart Grid Technologies Europe (ISGT EUROPE) | 979-8-3503-9042-1/24/$31.00 ©2024 IEEE | DOI: 10.1109/ISGTEUROPE62998.2024.10863337

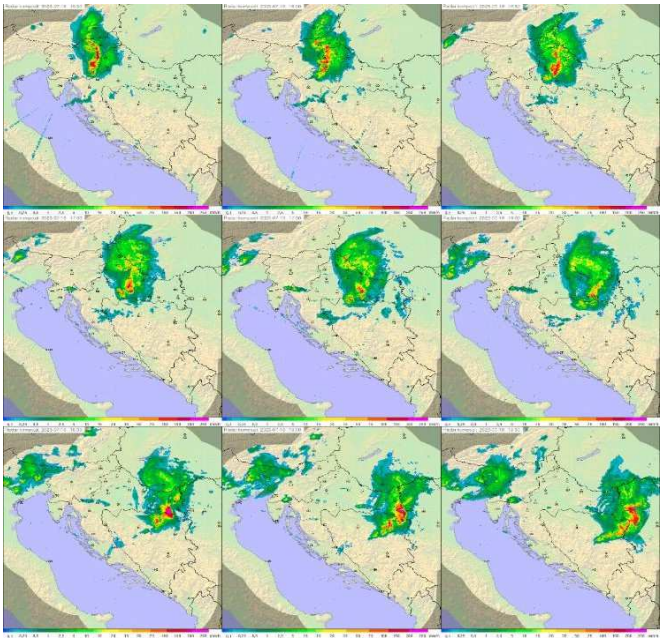
During the afternoon, a convective storm formed west of Slovenia and intensified around the border area of Italy, Slovenia and Austria. The storm moved towards the affected areas from the west (Slovenia) towards Zagreb and further east. Radar images (source: State Hydrometeorological Institute - DHMZ) show the direction of the storm from 15:30 (immediately before the first driving event) until 18:30, in steps of 30 minutes (Figure 1).

Fig. 1 - The storm over Croatia from 15:30-18:30 h on radar

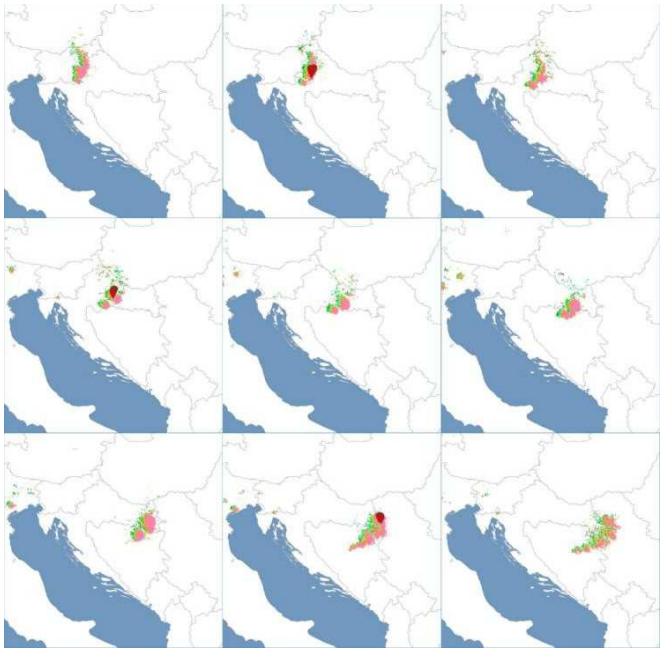
In parallel with ongoing storm, numerous lightning strikes occurred on mentioned areas of TAs ZG and OS, causing direct outages of nine overhead lines (Figure 3). HOPS uses system for locating atmospheric discharges (SLAP), that provides data on lightning strikes that occurred over the observed area. The SLAP system is connected to the SCADA system and enables the correlation of lightning strikes with the indication of events in the network.

Fig. 3 – Lightning strikes recorded during storm with lightning location system SLAP

An average wind speed during storm on July 19th, 2023, was 88 km/h and the storm encompassed 350 km wide area, whereby system SLAP recorded 363.872 lightning strikes (from 14:00 until 20:00), what equals 1010 strikes / min, with 9 OHL outages.

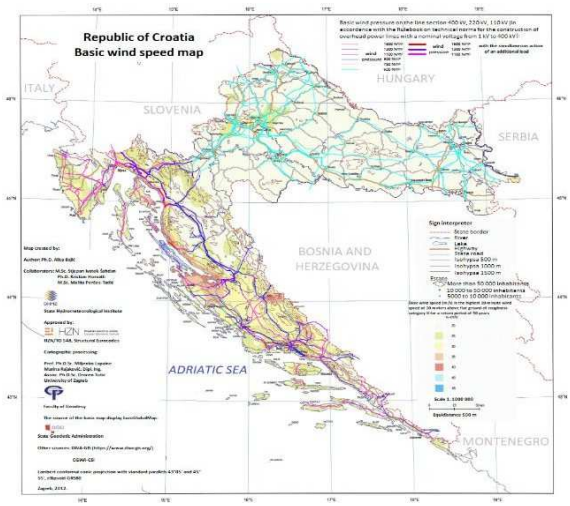
Fig. 9 – Map of the basic wind speed in the Republic of Croatia, with the routes of the existing OHLs and the wind pressure used during their design

As can be seen on the map, in the continental area the basic wind speed is 20-25 m/s, with maximal wind gust of 40 m/s and the probability that it will be exceeded in 50 years is 2%. On the coastal area, the basic wind speed exceeds 25 m/s, with maximal wind gust greater than 40 m/s. Even nowadays during design stage of OHLs (Eurocode), the loads on the structure are calculated differently than in the past, from previous chapter we saw that today is more and more possible to experience extreme weather conditions. It forces us to think weather the basic wind maps, which are an important input for the calculation at design stage, should be updated more often. Also, such maps should be correlated with most critical overhead lines from system operation state of view (according to N, N-1 and similar criteria), what could be trigger for TSO to require from OHL designers, consideration of stricter requirements.

- ensure enough modular towers and related equipment,
- educate technical staff from their companies on how to design and mount such equipment,
- prepare the "action plan for unpredictable weather phenomena" with neighbouring TSOs/DSOs and other organisations in country,
- update weather data and prepare risk maps on yearly basis (i.e. wind, ice, snow, wildfire, floods, lightings, salt, dust and other possible extreme conditions),
- correlate such maps with most critical overhead lines from system operation state of view,
- establish working group that will recognize and recommend stricter requirements according to valid standards and communicate them to the transmission line designers (i.e. NNA in Croatia).
