FINAL REPORT

DEMO-PC0001 – Demo boiler shutdown inspection

DEMO – Sample Process Plant (not a real client)

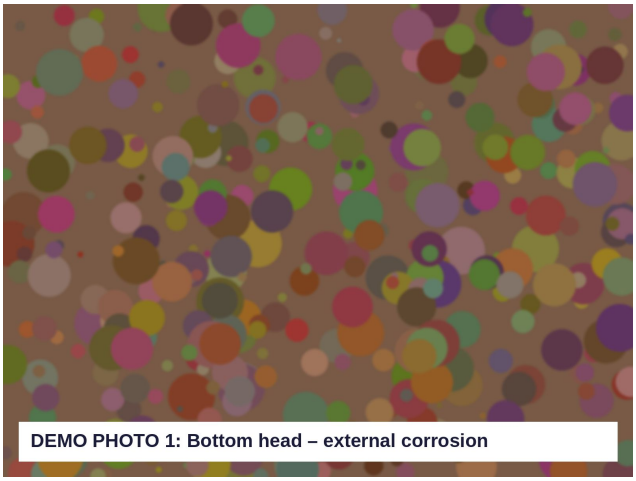
We carried out an external visual inspection and an ultrasonic thickness survey of the air receiver. External corrosion at the bottom head has progressed since the previous inspection. The drain valve has been replaced. The origin of the pitting at the north support leg could not be established from the as-found condition.

Point	Location	Nominal (mm)	t-min (mm)	Previous (mm)	Measured (mm)	ST rate (mm/y)	LT rate (mm/y)	Rem. life (y)
CML-01	Top head	12	8.2	11.6 (2025)	11.5	0.100	0.060	33.0
CML-04	Bottom head	12	8.2	10.6 (2025)	10.1	0.500	0.219	3.8
CML-05	Drain nozzle	7.1	4	6 (2025)	5.8	0.200	0.139	9.0

Asset	Ref.	Finding	Pri.	Raised	Status	Latest note	Due
V-201	F-001	External corrosion at bottom head	P1	10 Oct 2025	Open – deteriorated	10 Oct 2026: Pitting deeper; coating breakdown now approx. 45 % of the head.	—
V-201	F-002	Drain valve passing	P2	10 Oct 2025	Closed	10 Oct 2026: Valve replaced by client in March 2026.	—
V-201	F-003	Nameplate partly illegible	P3	10 Oct 2025	Open – unchanged	10 Oct 2026: No change.	—
V-201	F-004	Pitting at north support leg	P1	10 Oct 2026	Open		10 Apr 2027
V-201	F-005	Earthing strap loose	P3	10 Oct 2026	Open		—

Figure 1 – Bottom head – external corrosion (F-001)

P1: Action within 6 months. P2: Action at the next shutdown and not later than the set due date. P3: Continuous or routine attention.

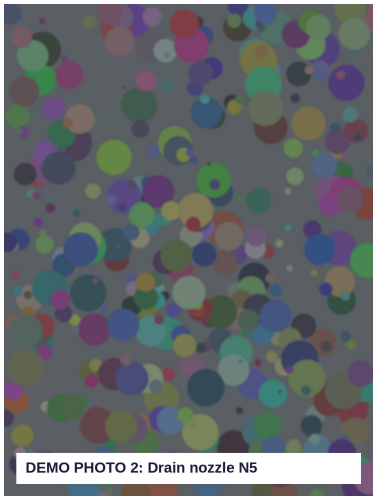
Figure 2 – Drain nozzle N5 with new valve (F-002)
