NFPA 211 LEVEL 2 CHIMNEY & FIREPLACE INSPECTION REPORT

Property Address: 1213 Cuyama Road, Ojai, California 93023

Inspection Date: June 12, 2026

Inspection Type: Level 2 Real Estate Transaction Inspection

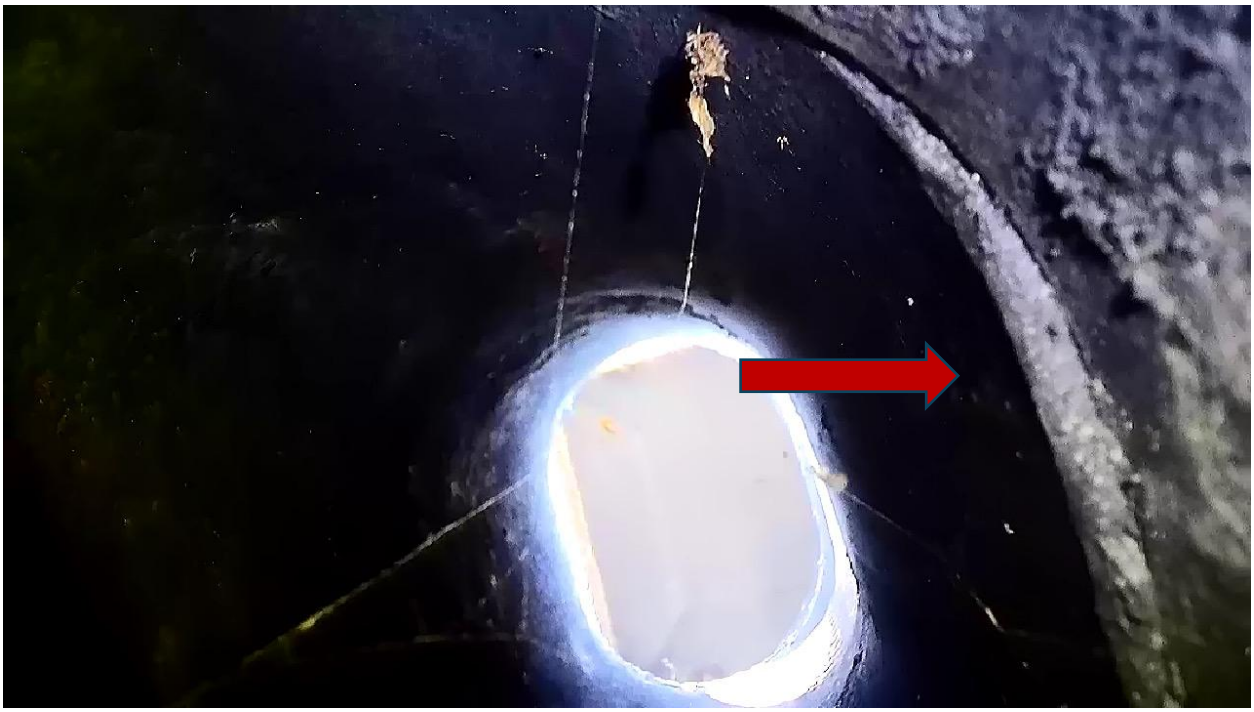
5. Smoke Chamber and Throat

The smoke chamber and throat area were found in generally satisfactory condition with no major defects noted.
