**INTERIM SURVEY REPORT:
RECOMMENDATIONS FOR ERGONOMICS INTERVENTIONS
FOR SHIP CONSTRUCTION PROCESSES**

**BATH IRON WORKS CORPORATION SHIPYARD,
Bath, Maine**

REPORT DATE:
July 2000

REPORT NO. EPHB 229-13b

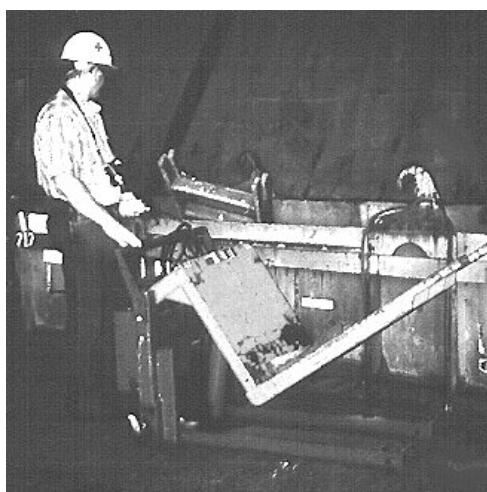
Figure 19. Tilting Bin Lifter

Possible interventions for the bin loaders in the panel line assembly area include adjustable bin lifters that raise and tilt the load towards the worker. Many inexpensive models of this type are commercially available (Figure 19). A hook-like tool for grasping individual workpieces may also help to bring the load closer to the material handler and also reduce the need for pinch-grip hand postures. Work practices of pre-sorting heavier items and emptying them by forklift onto a rotatable table top before handling may also be feasible.

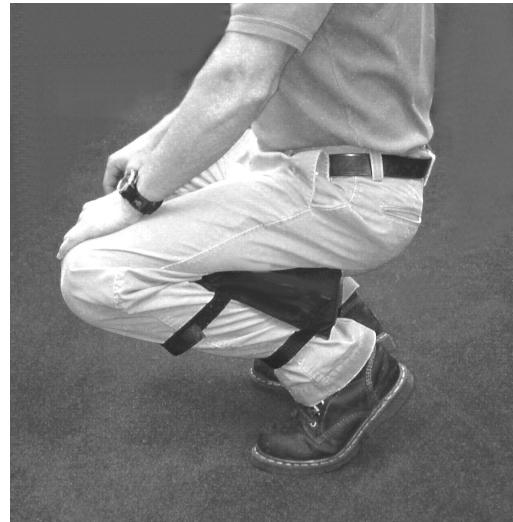
Figure 24. Foam Wedge to Prevent Knee Hyperflexion

Possible interventions for the panel line welders include the use of low profile, wheeled carts or stools as movable seats for the welders to reduce back flexion and the need to assume kneeling postures (Figures 23a and 23b). Such carts may be able to be custom designed to include upper body supports and knee supports that allow a variety of postures, such as semi-sitting or kneeling and leaning forward. Knee pads and thigh-supports (Figure 24) to prevent hyperflexion of the knees during squatting are also commercially available.

Suggested approximate work stool characteristics are shown in Table 5. Setup and training time is negligible. Total cost for a crew size supply of stools and knee supports is estimated to be \$3,800.
