PROPERTY CLAIMS NEXT STEPS

Claim Number: 01008682015
Date of Loss: 3/16/2025

Estimate Recap For Coverage A - Dwelling

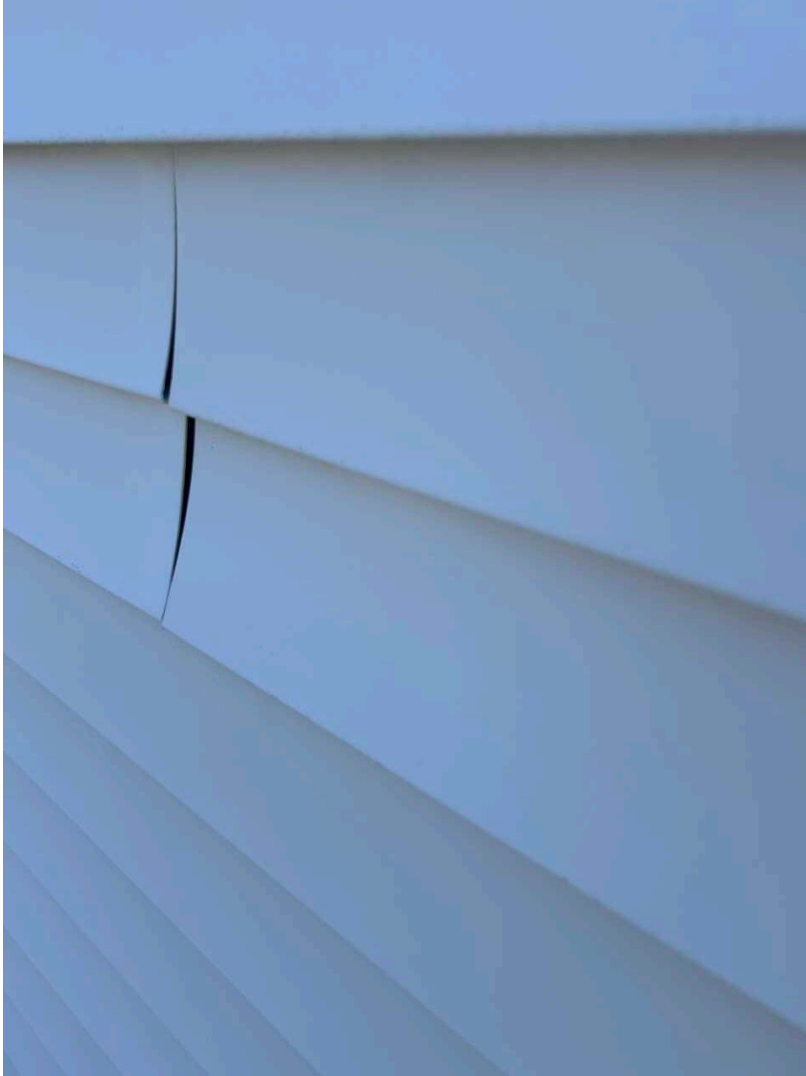
8 8-siding, install issues, squirrel? Date Taken: 3/27/2025

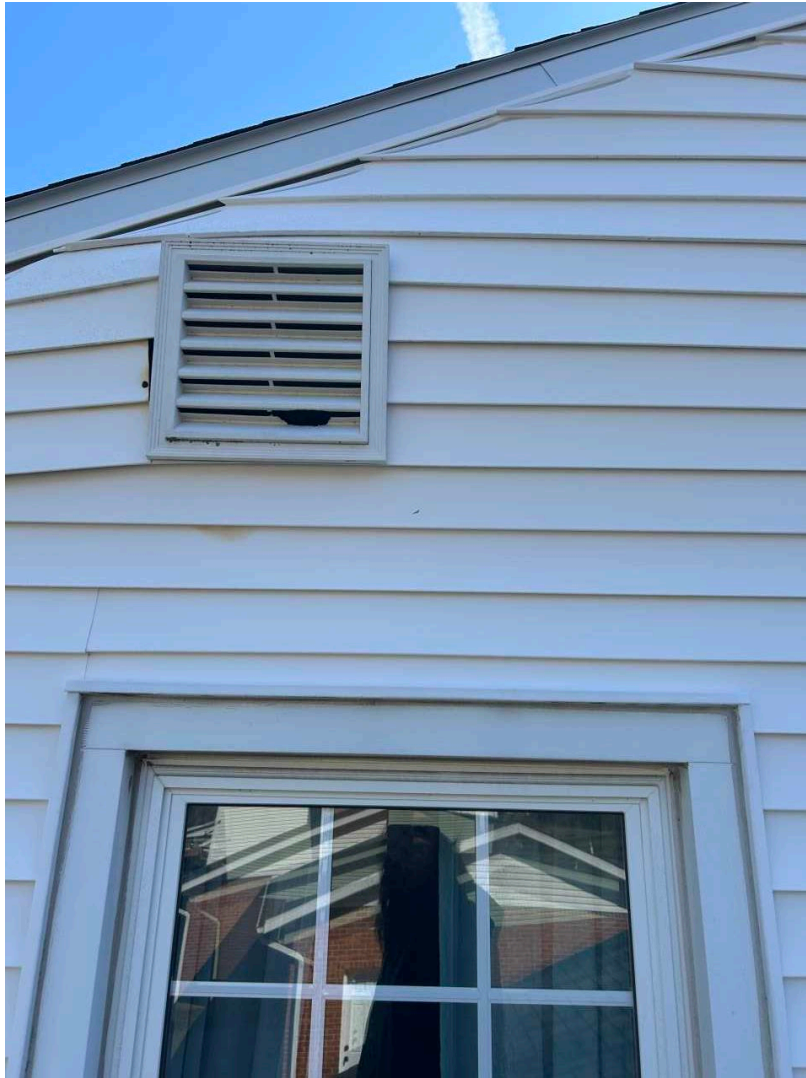
10 10-siding, install issues, squirrel? Date Taken: 3/27/2025

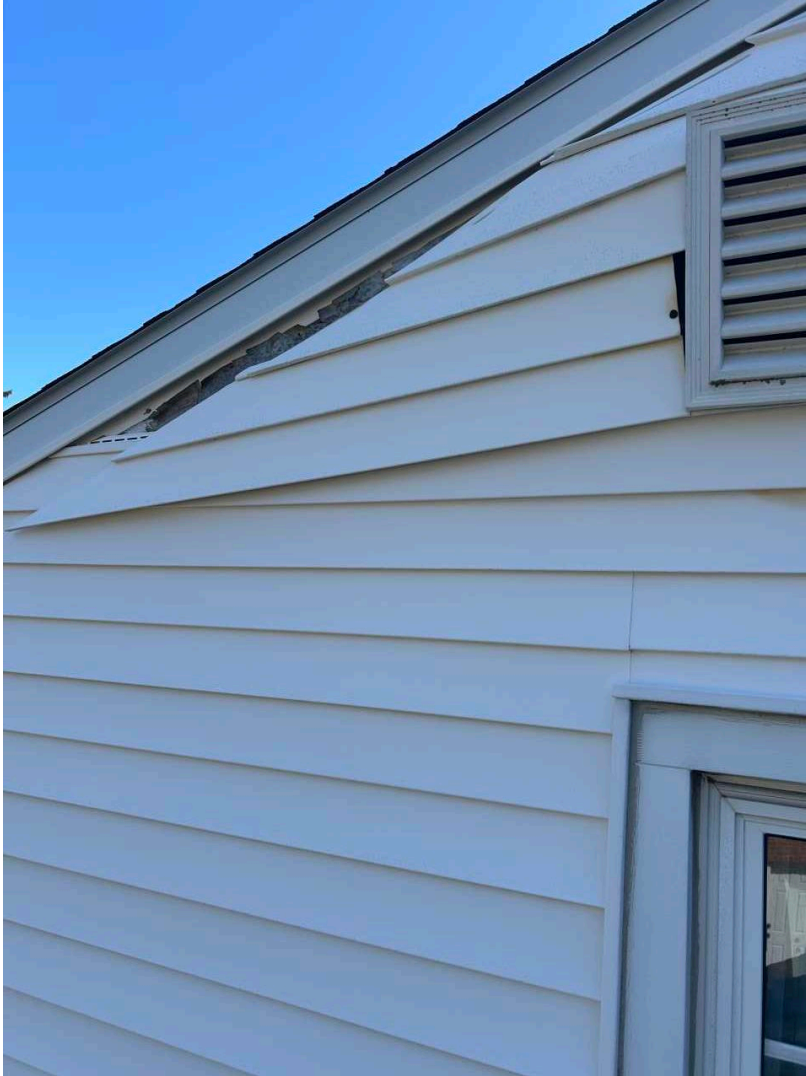
11 11-siding, install issues, squirrel? Date Taken: 3/27/2025

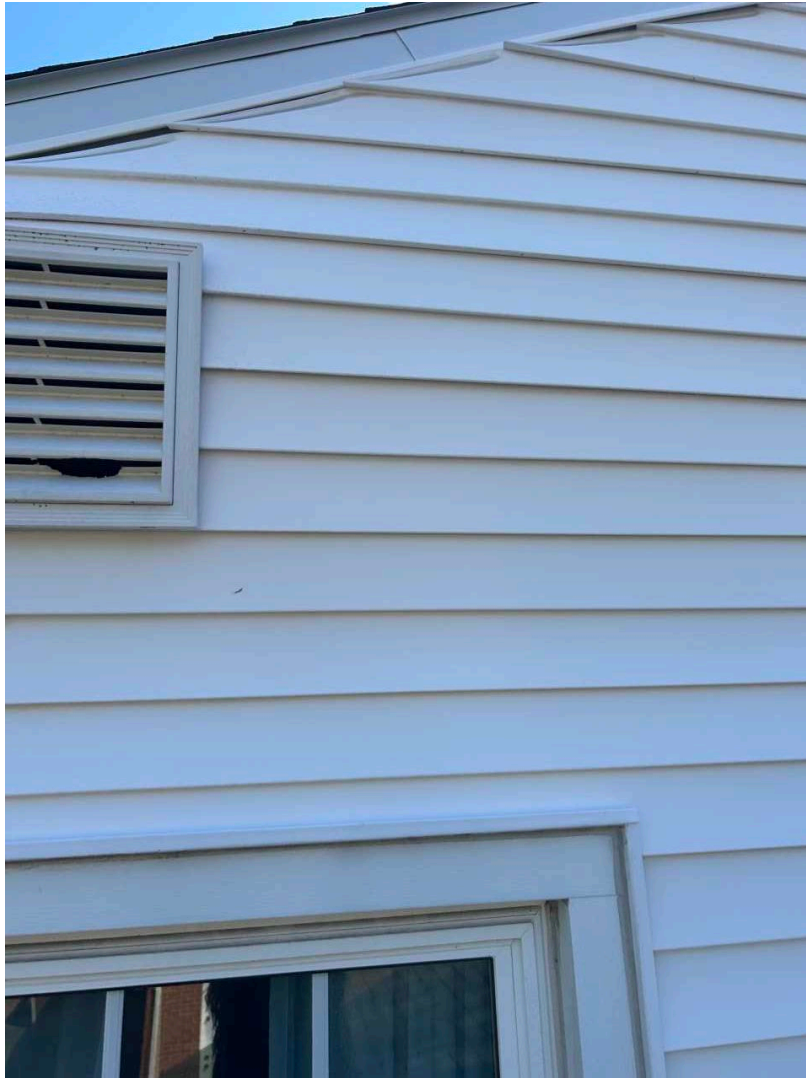
13 13-siding, install issues, squirrel? Date Taken: 3/27/2025

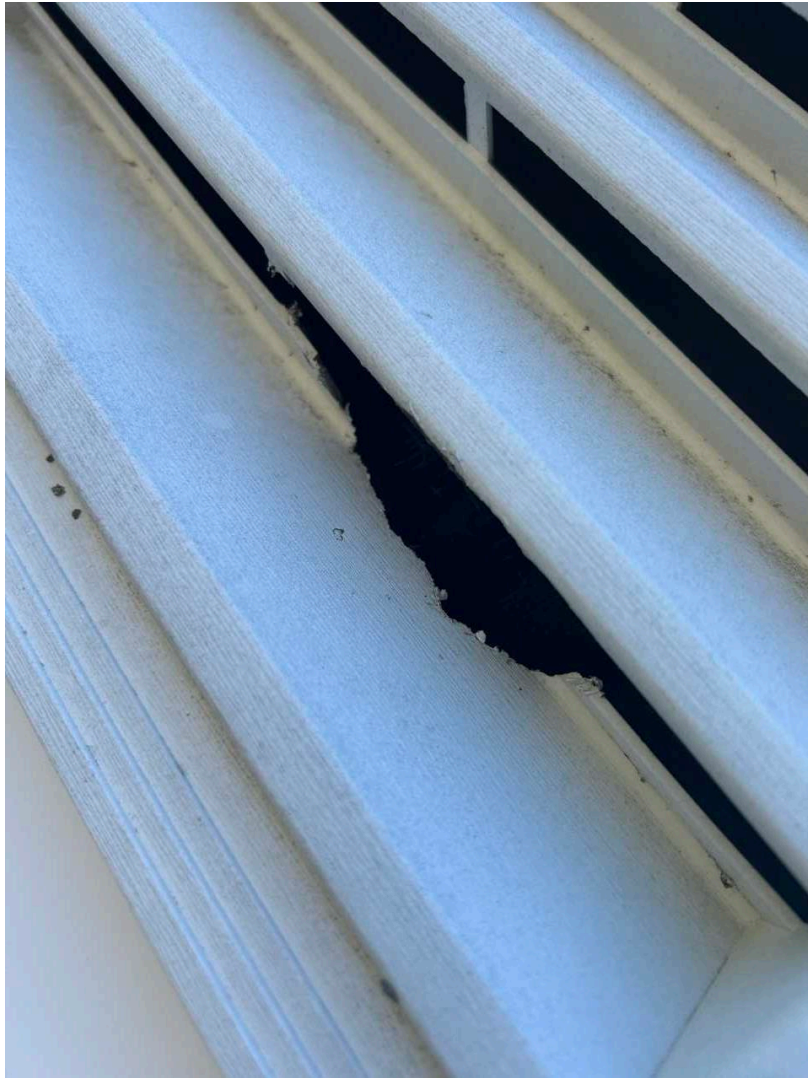
14 14-siding, install issues, squirrel? Date Taken: 3/27/2025
