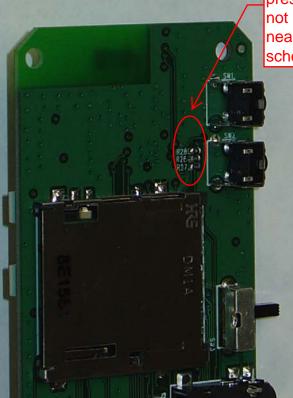
New battery in receiver

We need to discuss this... that small plastic indent will not be present in production units
