SHOP FINDINGS REPORT

Customer :	ETHIOPIAN AIRLINES
Customer repair order :	63870812
Aircraft registration :	ETAPS
AFI Request Number :	50809895
Incoming part number :	822-0990-004
Designation :	TRANSCEIVER HF / HFS 900D
Serial number :	1864VP

REMOVAL TEXT: R/H RADIO TUNING PANEL INOPERATIVE WHEN SELECTING HF RIGHT.
Removal date : 19FEB25
From : ETAPS

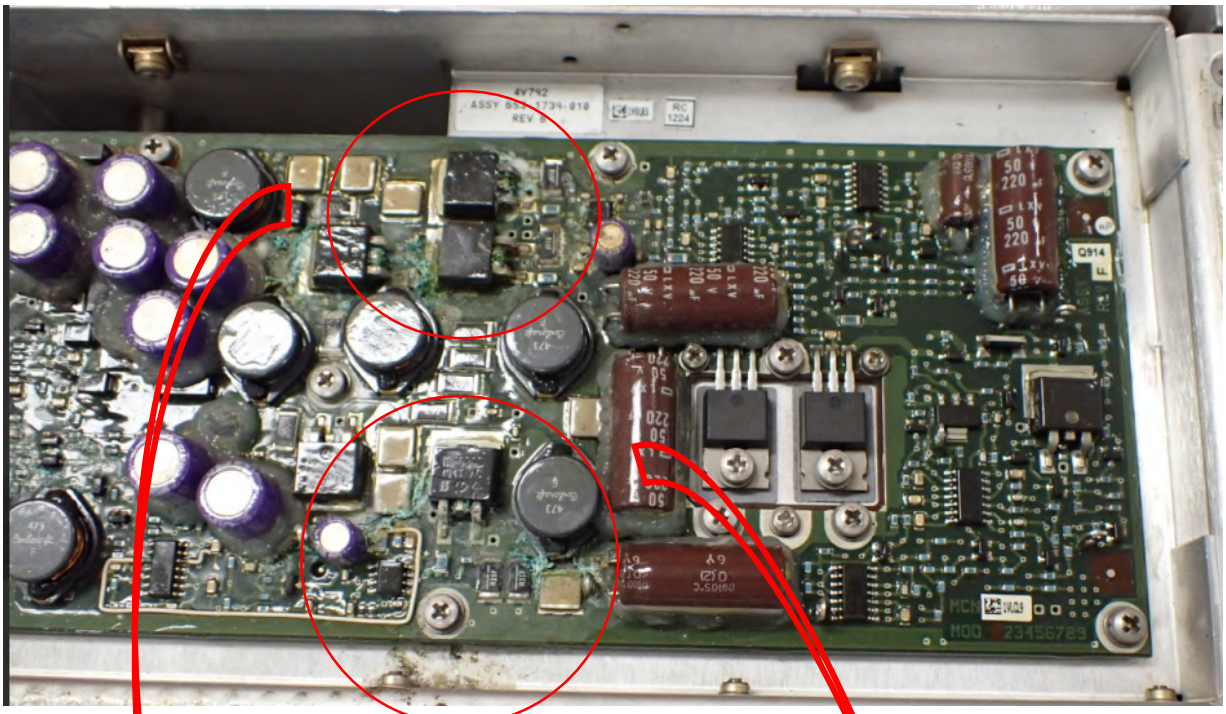
We found that the Unit was very dirty, with Pollution traces by liquid on the cover (CID).
The Voltage regulator card was corroded due to liquid's pollution (CID).Presence of corrosion and Verdigris.

Due to the damages, Voltage regulator circuit card A6A3A1 had to be replaced. PN: 828-0560-001

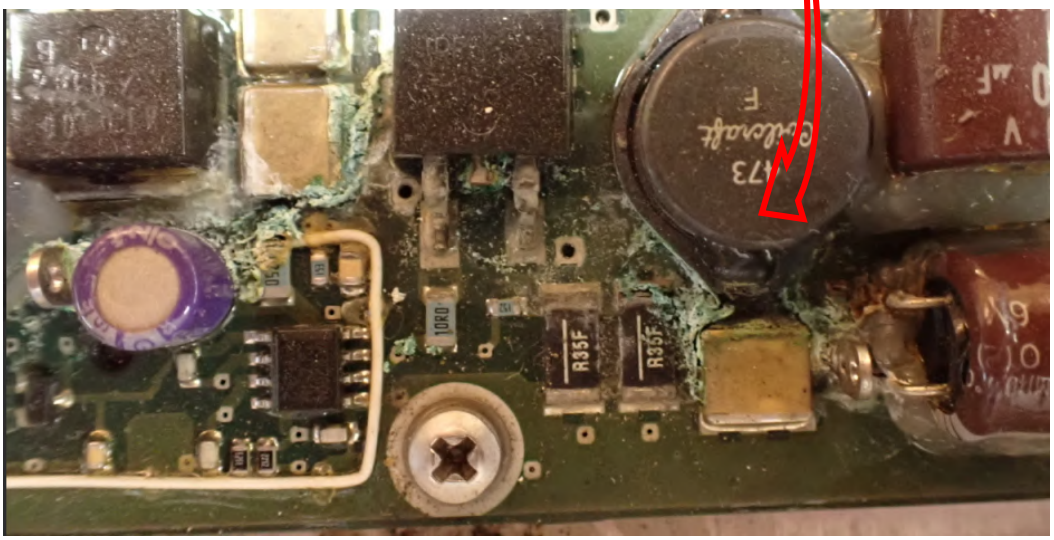
Presence Verdigris & Corrosion

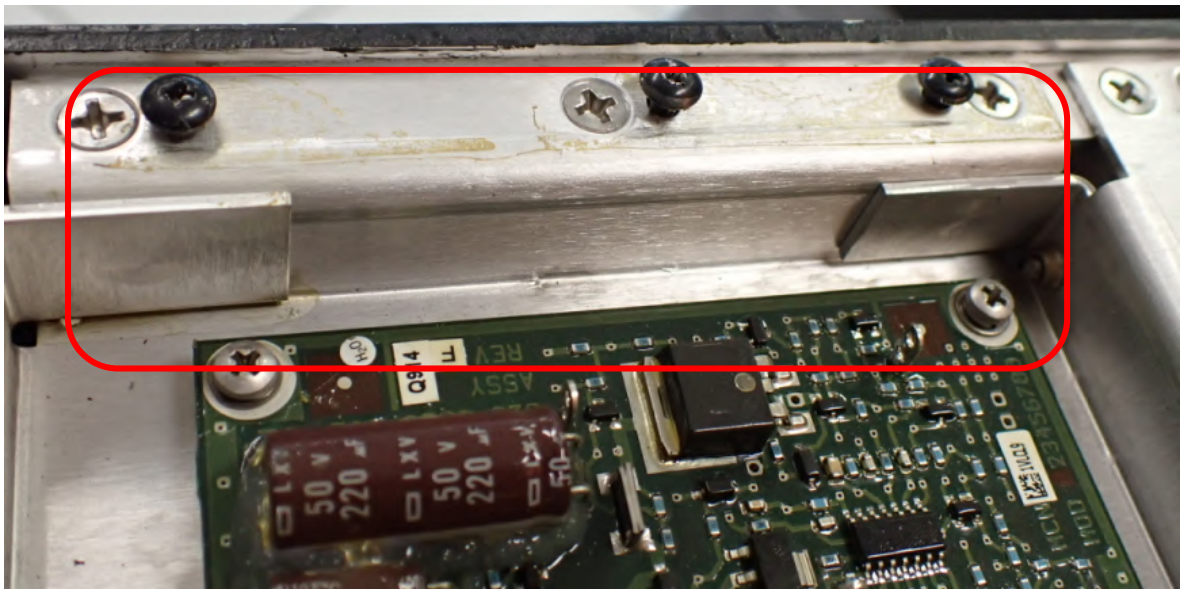
Traces of pollution causing damages
