This is a Quarto book on **Repair of Acova Sèche-Serviette** (750W PCE-150-050-IFW).

1 Carte électronique

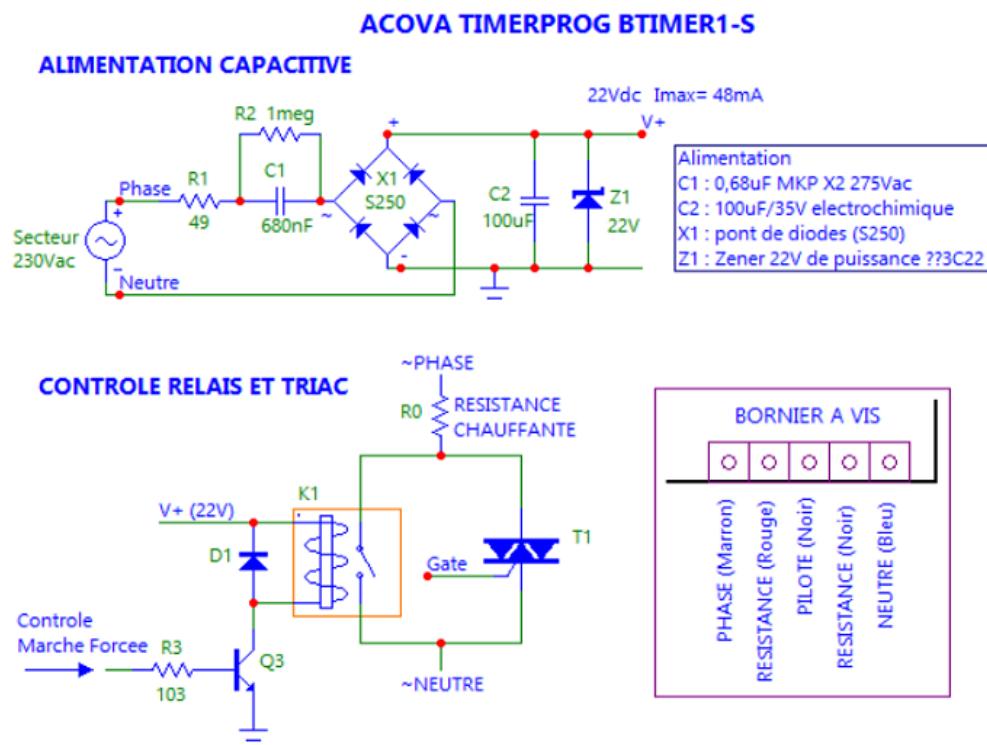
Figure 1.1: Carte IFW

Le Condensateur 470n K 310v~X2 339 MKP L1339 pas de 15 mm 9 x 17.5 X 15 mm est d'une capacitance de 470 nanofahrad or la mesure donne 200 nF => donc il est mort et coûte 1,90 € à remplacer.
