Site: Flores da Cunha, RS

Process: Pintura a pó - linha contínua.

Dalemolle Estruturas Metálicas.
Flores da Cunha, RS
Termografia 1
Estufa contínua,
Set Point : 190°C - Epristinta
Set Point : 170°C - WEG
Velocidade da linha: 0,8 m/min
24/04/2026

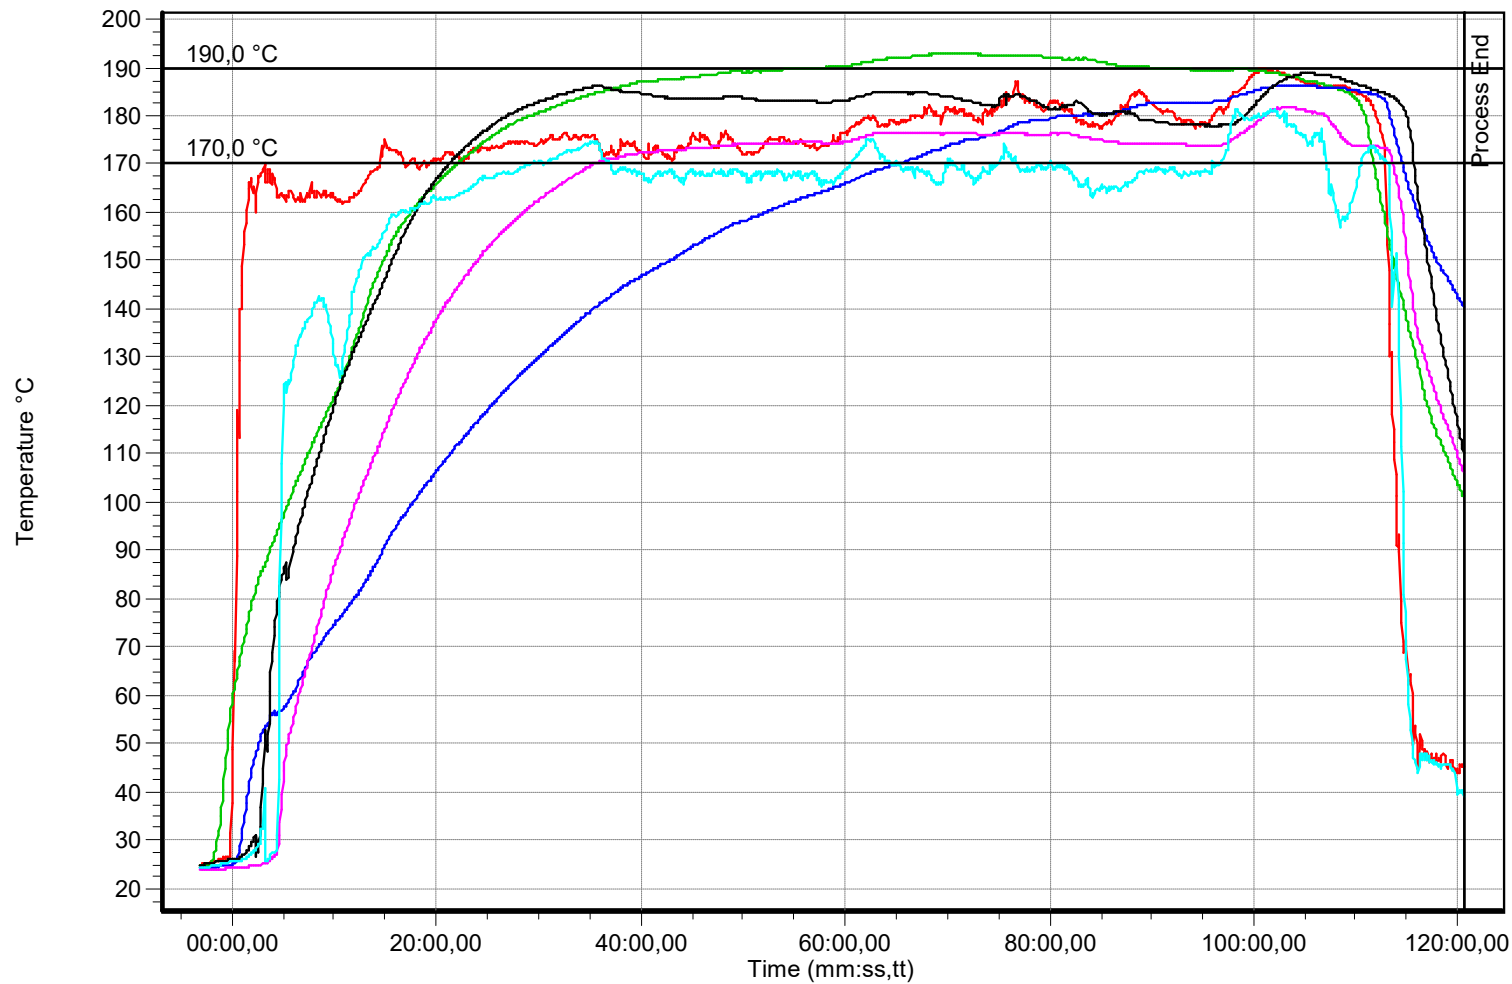
#1 (°C) Ar Superior	111:40,00	35:15,00	00:00,00	1092	189,8	100:35,00	24,9	-03:10,00	00:00,00	***	97:20,00	03:10,00
#2 (°C) Chapa 8 mm : ponto superior dir.	95:15,00	81:50,00	32:40,00	1076	192,9	69:20,00	24,6	-03:10,00	32:40,00	57:55,00	89:50,00	22:00,00

#3 (°C) Chapa 1" ponto central	63:50,00	31:45,00	00:00,00	790	186,3	103:20,00	24,4	-03:10,00	00:00,00	***	49:40,00	65:00,00
#4 (°C) Chapa 4,26 mm ponto superior esq.	98:30,00	77:40,00	00:00,00	1052	188,8	104:45,00	24,9	-03:10,00	00:00,00	***	94:35,00	21:10,00

#5 (°C) Chapa 6,30 mm ponto inferior dir	86:05,00	05:55,00	00:00,00	888	181,9	103:20,00	23,9	-03:10,00	00:00,00	***	78:20,00	35:20,00
#6 (°C) Ar Inferior	95:35,00	03:05,00	00:00,00	932	181,4	98:15,00	24,2	-03:10,00	00:00,00	***	28:30,00	28:45,00
