MA: Sandwich - 180 Cotuit Road Performance report

Q4 2025

Name: Sandwich – 180 Cotuit Road Location: Sandwich, MA
Size AC: 3111 kW
Size DC:4357kWp
Period: Dec 1, 2025 – Dec 31, 2025 Report Date: 01/08/25

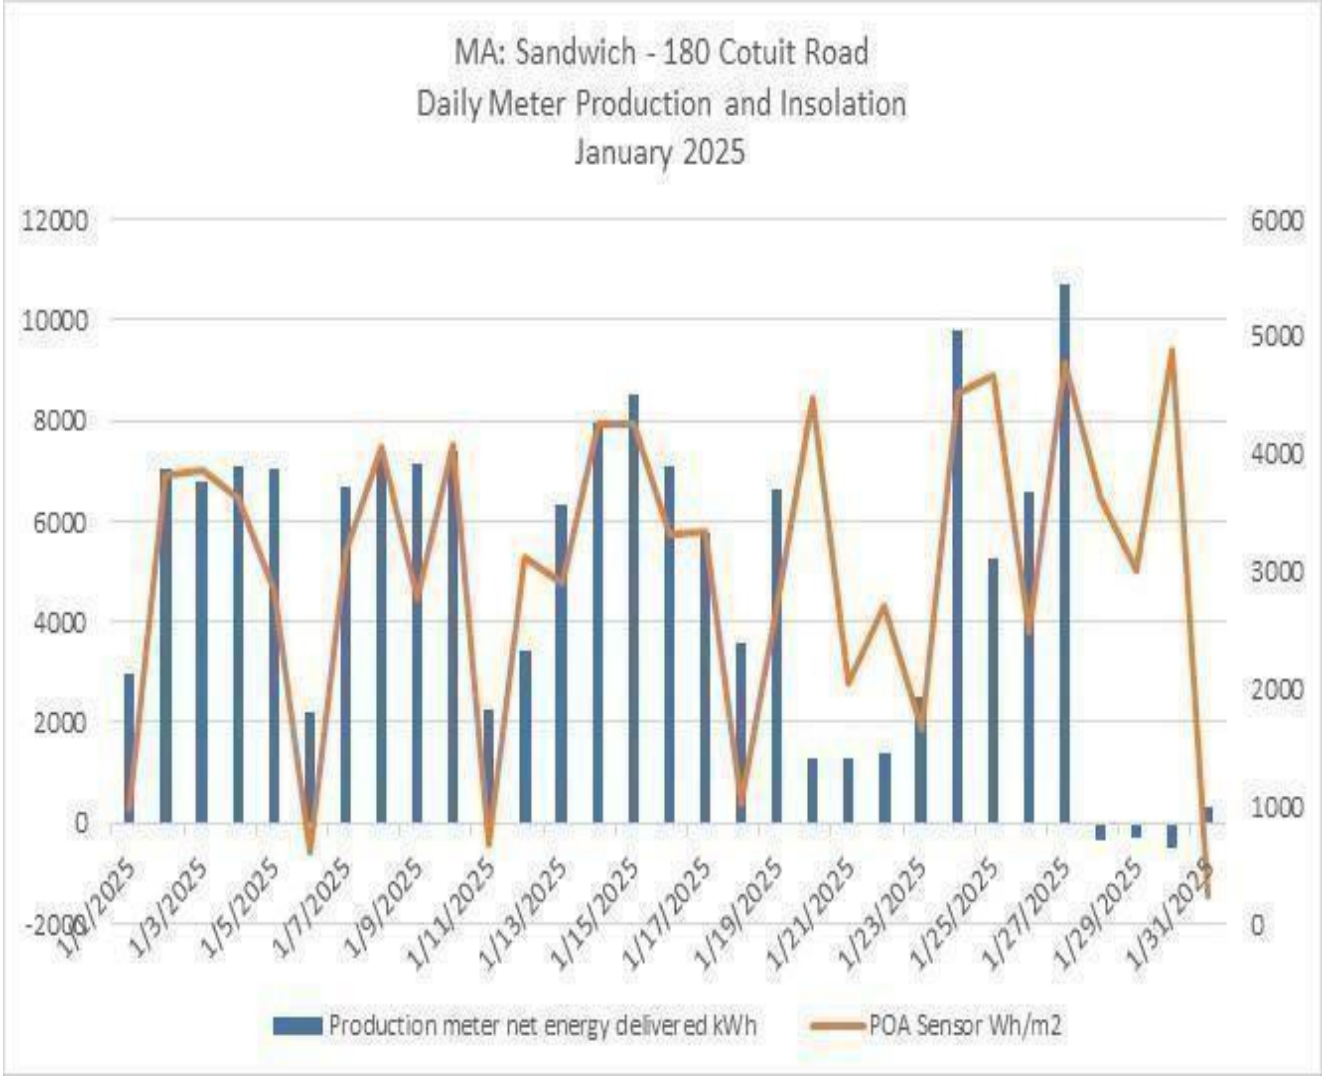
MA: Sandwich - 180 Cotuit Road January Production

1. Thesite was offline from 01/28 due to an inverter fault. Later, Power Electronics brought the site back online on 01/31 by pulling the logs. SR096048

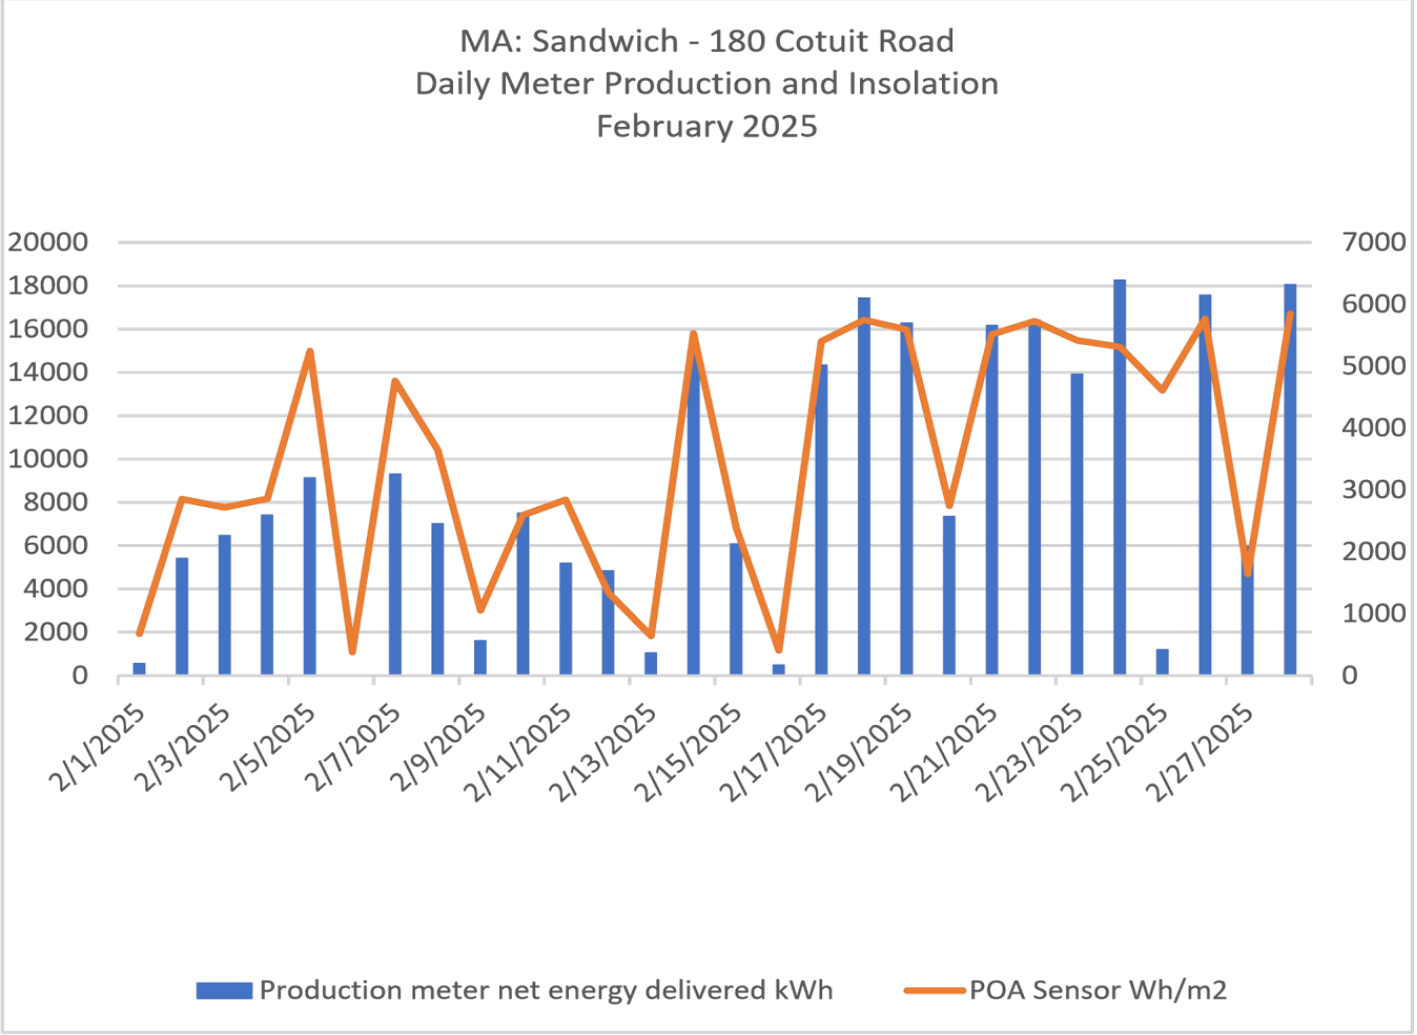
MA: Sandwich - 180 Cotuit Road February Production

1. On 02/18/25, the technician found CB 15 strings 19 & 20 carrying 4 amps. Further investigation is needed to check for a ground fault or module issue. SR096077, SR097256.
2. The site was offline from 6:30 to 14:15 on 02/25/25 due to an inverter fault. The PE technician enabled all modules, put them in start mode, and brought the site back online. SR097746.

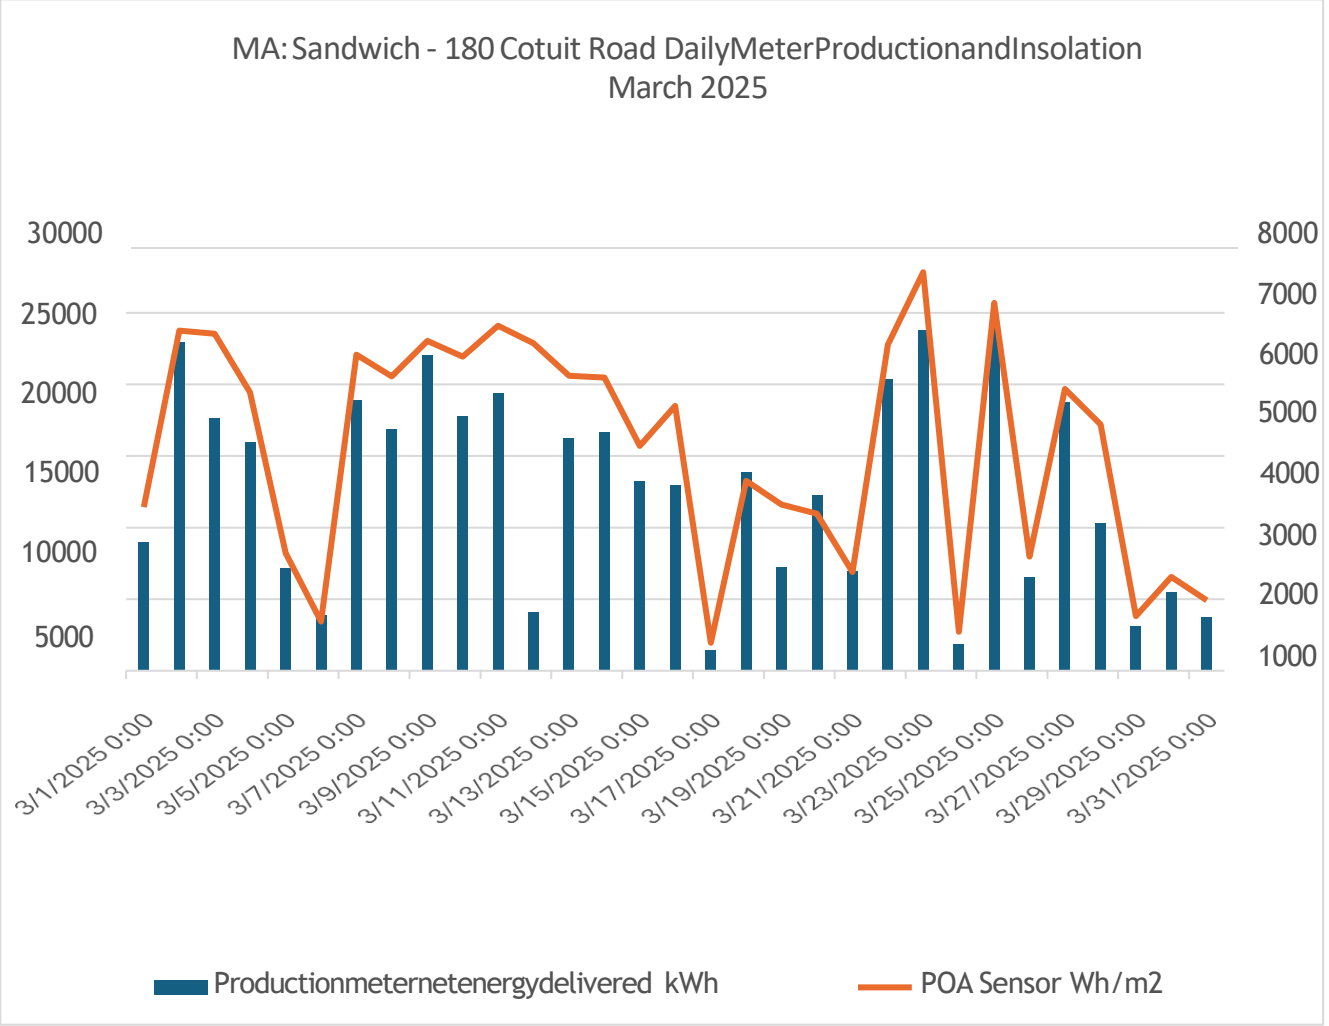
MA: Sandwich - 180 Cotuit Road March Production

1. The site was taken offline from 08:30 to 14:45 on 03/12 due to an HVAC technician being on-site to check the site camera. SR098449
2. Power Electronics on site to perform retrospective ventilation. The Inverter will be taken offline from 11:30 to 13:15 on 03/28. SR099079
3. On 02/18/25, the technician found CB 15 strings 19 & 20 carrying 4 amps. Further investigation is needed tocheck for a ground fault ormodule issue. SR096077, SR097256, SR099474

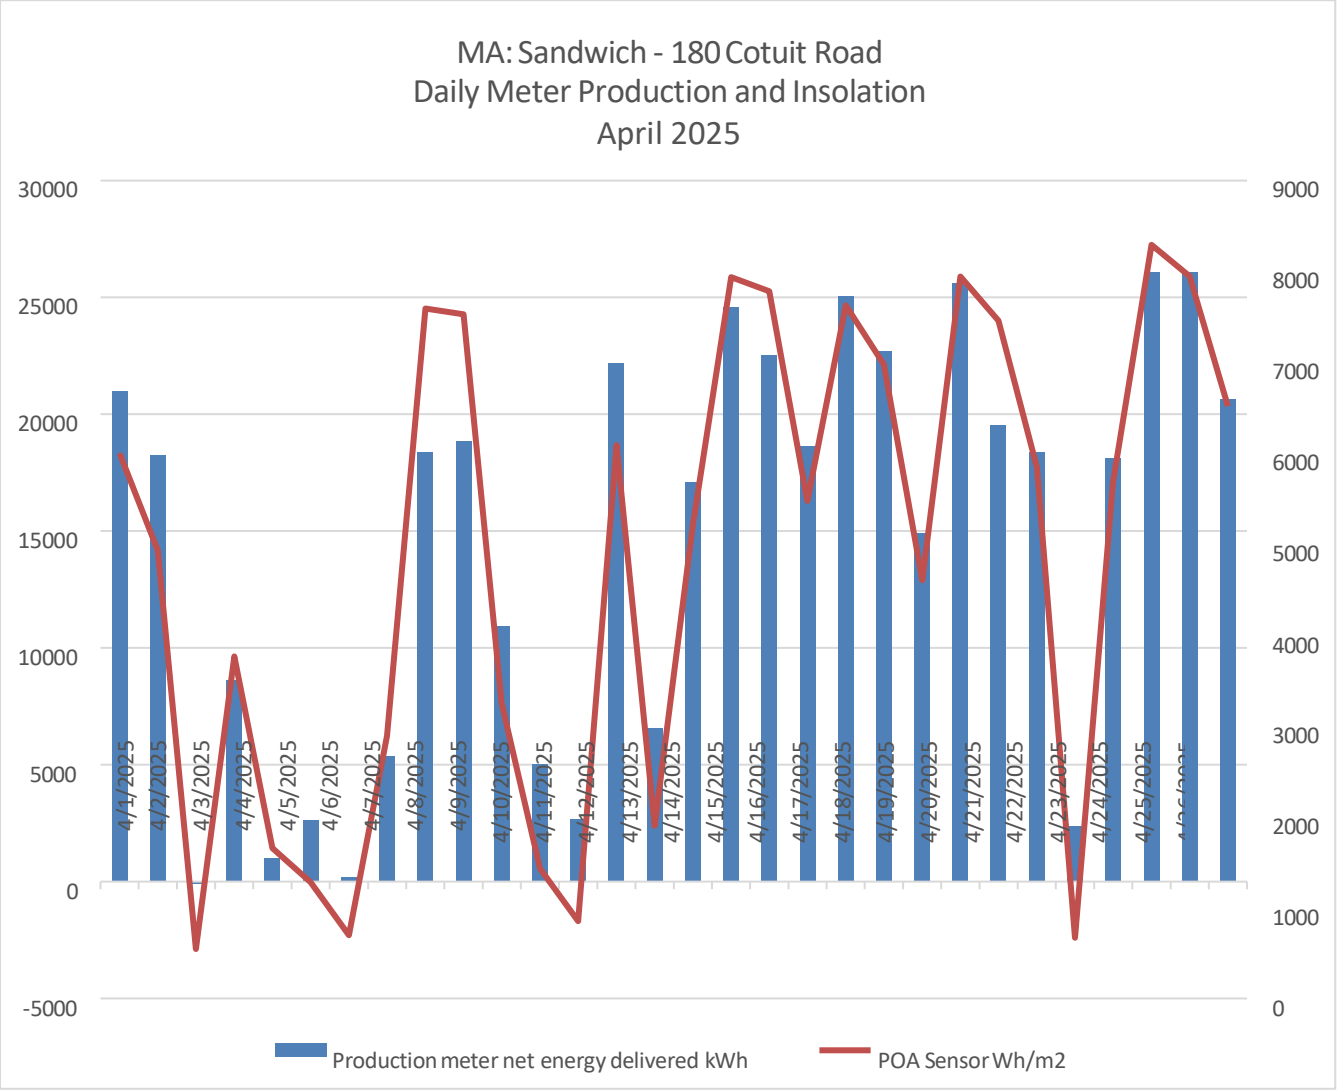
MA: Sandwich - 180 Cotuit Road April Production

1. Thesite was de-energized from 12:45 PM to 2:45 PM on04/02 while PEwas onsite to inspect inverter settings. **SR099316**
2. On 04/03 and 04/05, the inverter failed to start production but was brought back online after a technician performed a remote reset**. SR099371**

3. On 04/04, a technician checked in to investigate DC strings 19 and 20 in CB15 and discovered reverse polarity in jumper connections to a Northern Row. The jumpers were rewired with correct polarity, and final testing confirmed both strings were producing normally. **SR097256, SR099474 & SR099475.**

4. On 04/11/25, discrepancies were noted between meter and inverter readings, with the meter peaking at 3 MW while the inverter maxed at 2.2 MW. AE responded on 04/15/25, suggesting potential bin size logging or data latency issues and implemented logger setting changes. The issue now appears resolved, though the root cause remains unknown. PowerTrack still needs BESS data configured for accurate PV monitoring. **SR099700**

5. On 04/18, the inverter began production at 10:00 AM after experiencing a Softcharge DC5 fault. **SR099978**

6. Inverter tripped offline at 17:00 on 04/24 due to BW BF. PS. 151 fault and back online at 10Am on 04/25 after PE technician initiated the wake-up and soft charge process. **SR10036**

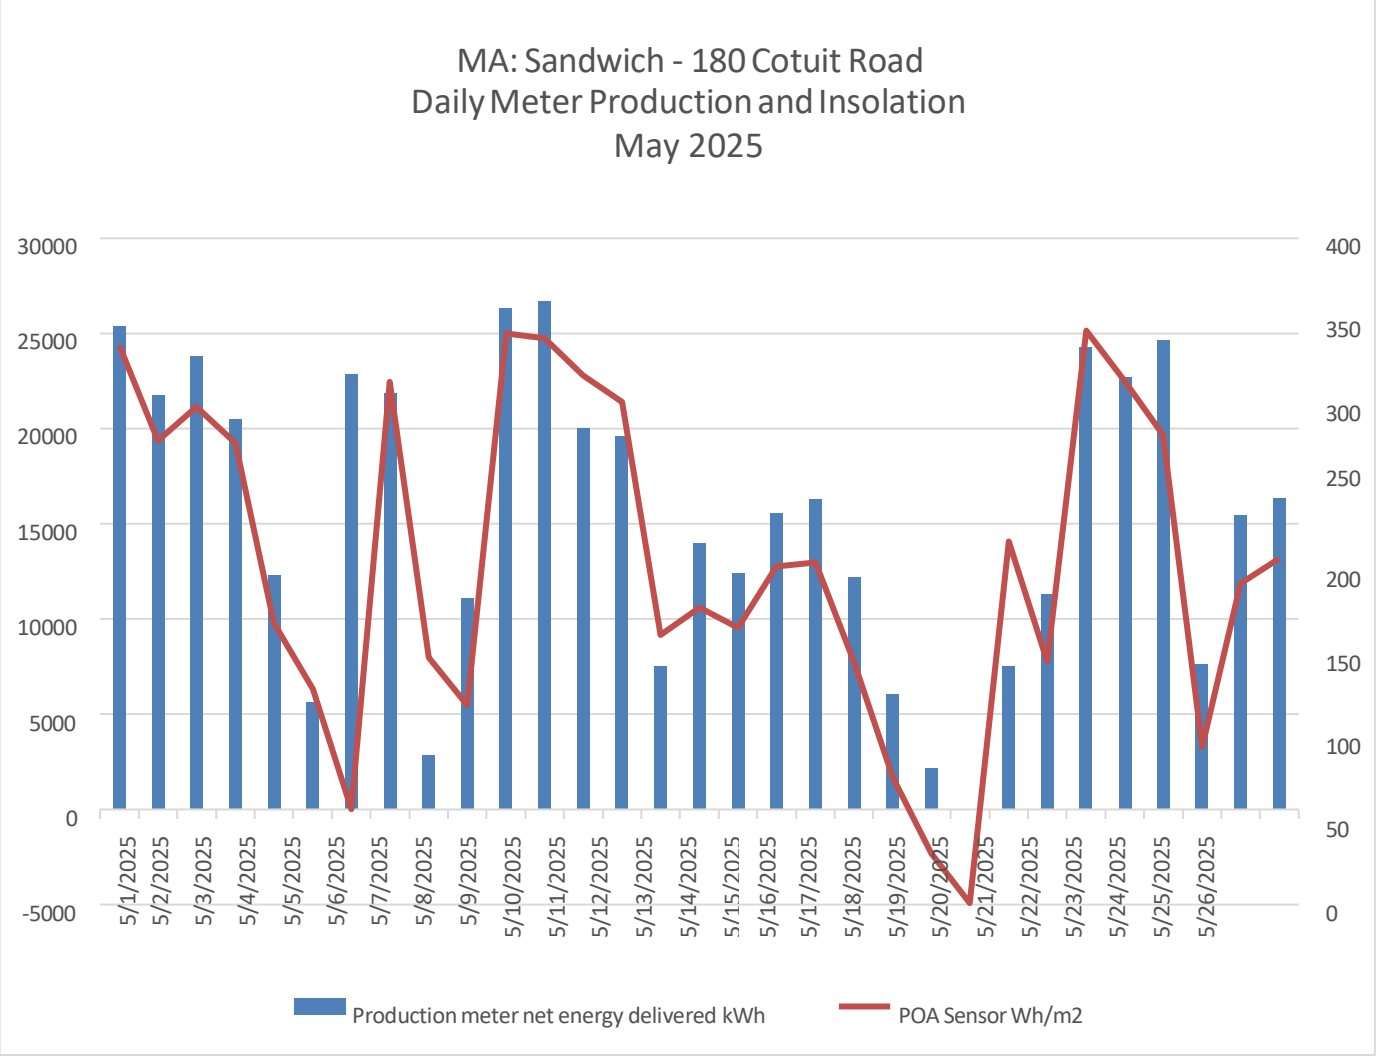
MA: Sandwich - 180 Cotuit Road May Production

1. The site was offline from 09:15 to 13:15 on 05/09. On 05/09, a technician reached out to Power Electronics and worked remotely with Pedro. Pedro was able to make changes to the parameters and get the inverter online. **SR101226**

2. Inverter 1 was offline from 18:15 on 05/13 to 09:45 on 05/14. Inverter was back online after technician with Remote support cleared fault and restarted inverter. **SR101418**

3. The site was offline from 10:30 to 11:45 on 05/15 as Power electronics technicians were on site to replace the main control board in an inverter 1 module. **SR101464**

4. Site was offline from 06:15 on 05/23 to 11:00 on 05/24. On 05/24, a technician was onsite and re-energized the site. The site was back online at 11:00 on 05/24. **SR101873**

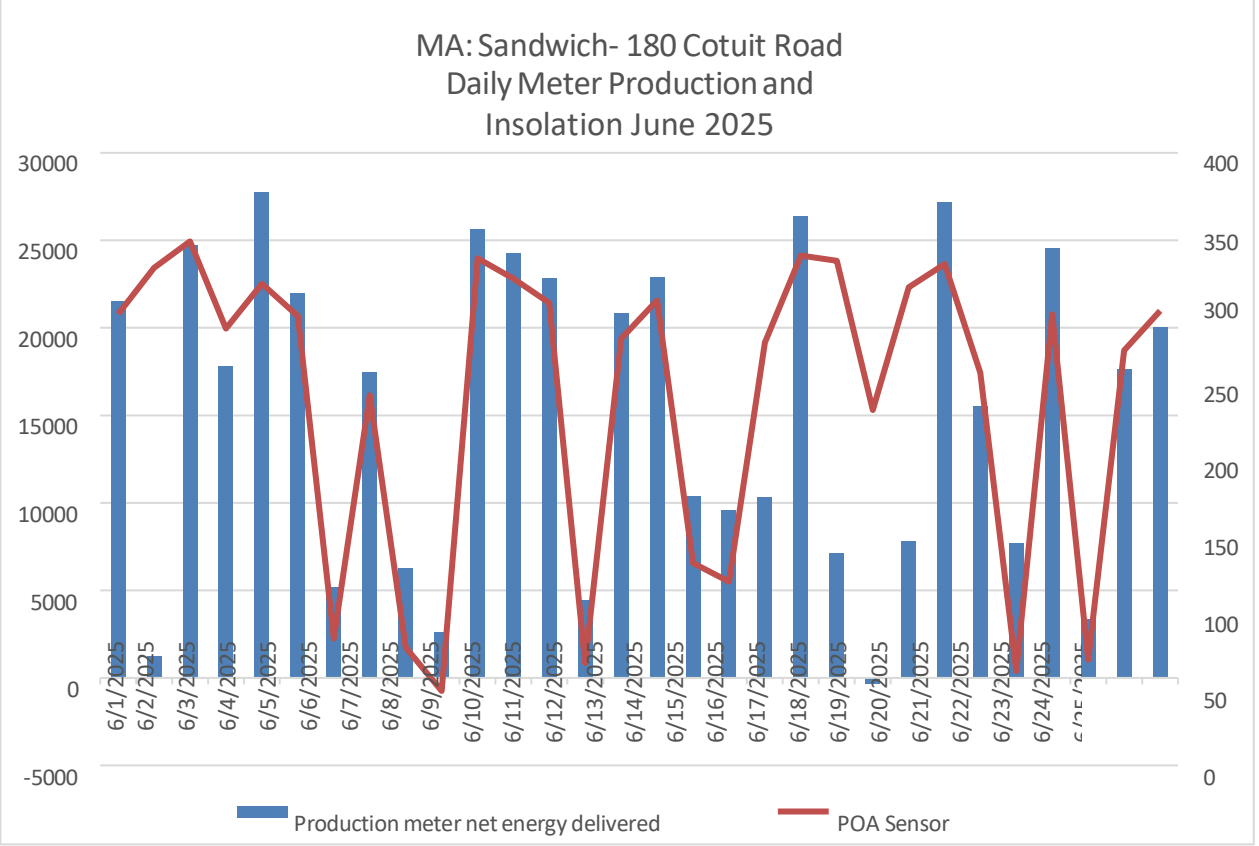
MA: Sandwich - 180 Cotuit Road June Production

1. Site tripped offline on 06/02 at 08:45 and back online on 06/03 at 08:00. **SR102295**
2. Invertertripped offline at 18:00 on 06/03 and back online on 06/04 at 05:30. **SR102429**
3. The site was offline from 09:30 to 13:45 on 06/19. It was offline again from 08:45 to 11:45 on 06/21 and then went offline once more at 15:15 on the same day. It came back online on 06/23 at 09:00 but experienced another outage from 11:45 to 15:45 on the same day. **SR103172**

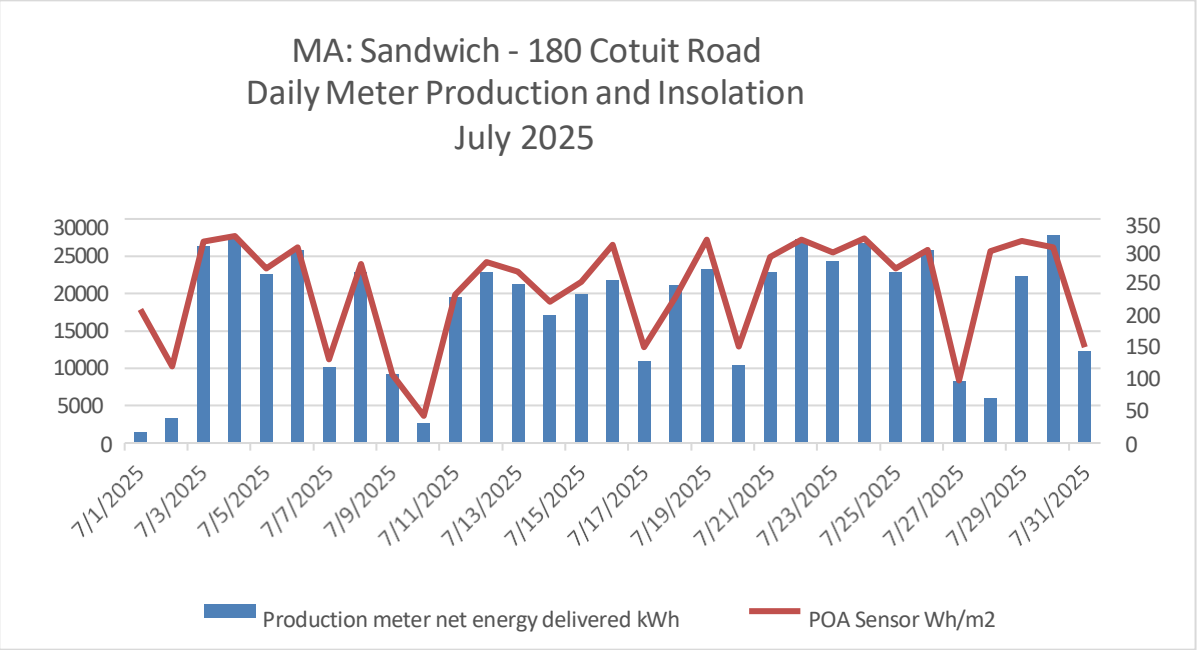
MA: Sandwich - 180 Cotuit Road July Production

1. Inverter tripped offline 10:30 on 07/01 and it came back online at 14:45 on 07/02. PM9454
2. Site tripped offline from 10:30 to 16:00 on 07/28. SR105163

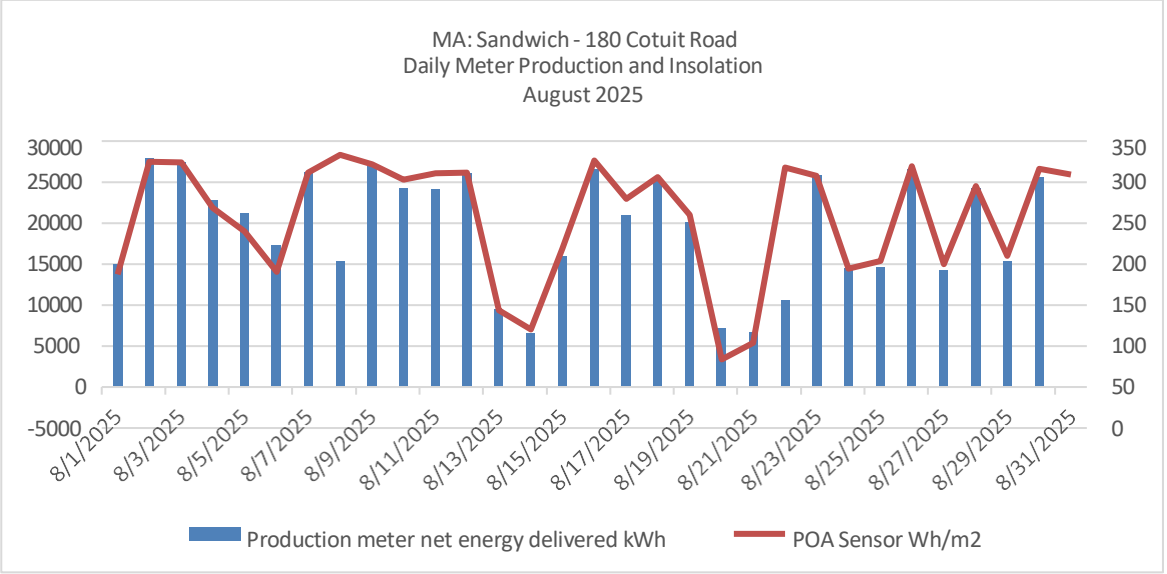
MA: Sandwich - 180 Cotuit Road August Production

1. Site was offline from 04:30 to 11:45 on 08/08. SR105884
2. Inverter offline from 07:00 to 07:34 on 08/13. SR106182
3. Inverter started late for production at 13:00 on 08/22. SR106742
4. Inverter has dropped from over 2MW to grid/Bess to 0 twice in a day on 08/29 and again Inverter tripped offline at 07:45 on 08/31. SR107206

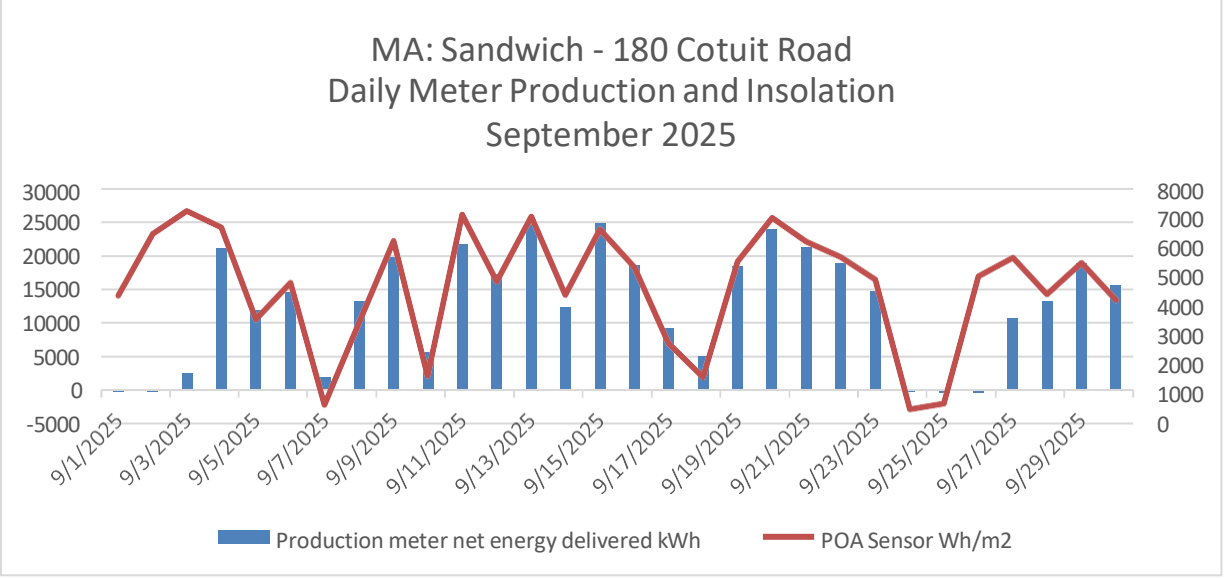
MA: Sandwich - 180 Cotuit Road September Production

1. Site came back online at 15:30 on 09/03. SR107206, SR107304
2. Inverter offline from 10:47 to 11:00 on 09/09. SR107686
3. Inverter offline due to low irradiance at 11:00 on 09/24 and it came back online at 11:15 on 09/27. SR108530

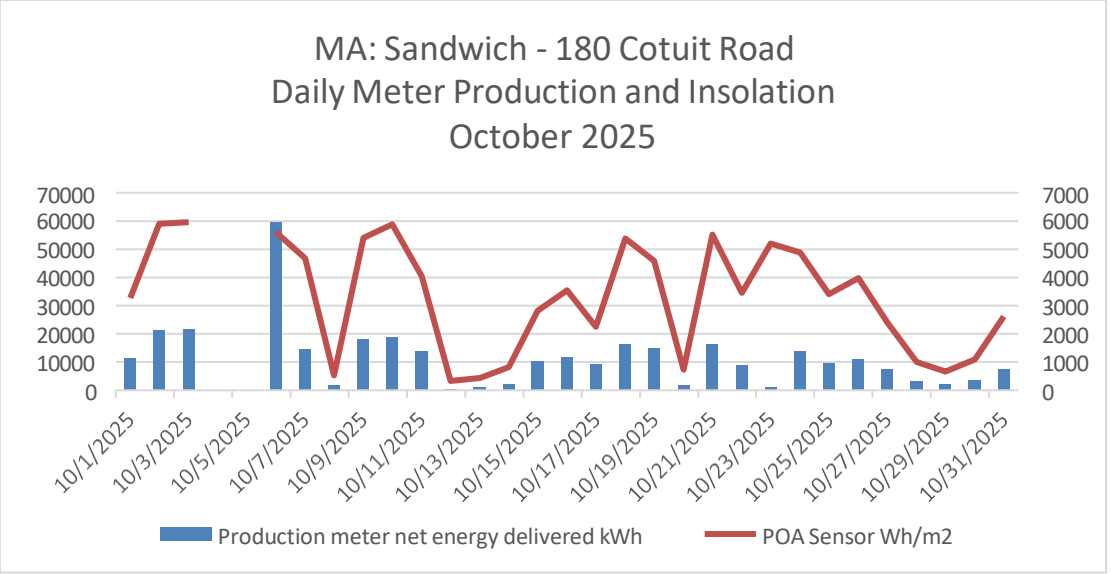
MA: Sandwich - 180 Cotuit Road October Production

1. Site was offline from 09:00 to 14:30 on 10/23. SR109890

2. Site stopped communicating on 10/03 at 18:30 and it came back online on 10/06 at 08:15. SR109055

3.Inverters started production at 10:45 on 10/14. SR109476

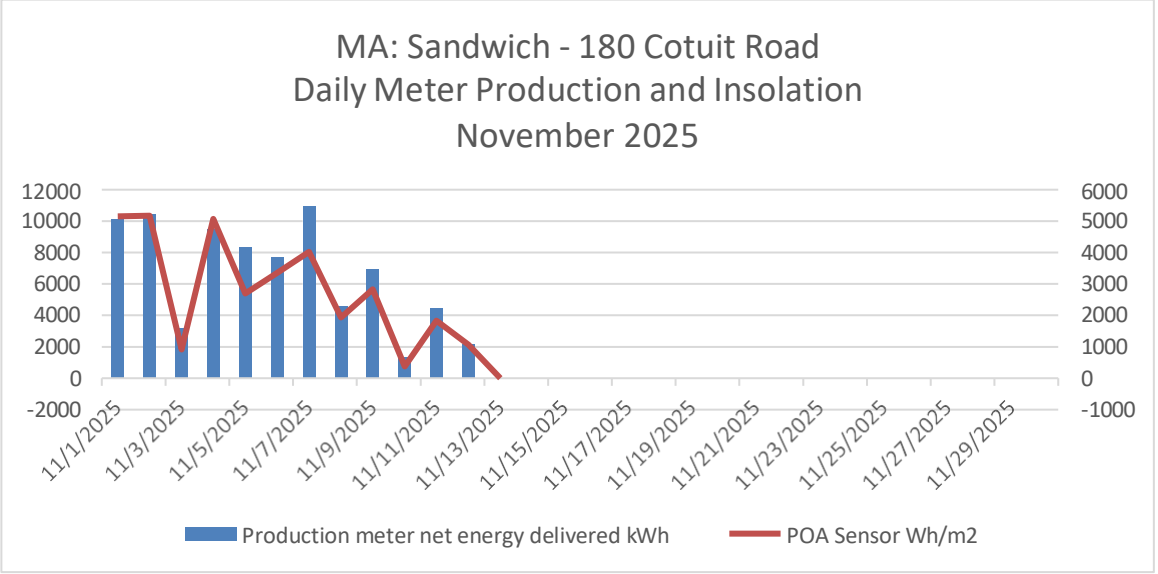
MA: Sandwich - 180 Cotuit Road November Production

1.Site was offline at 17:45 on 11/12 throughout the month due to utility outage. SR111021.

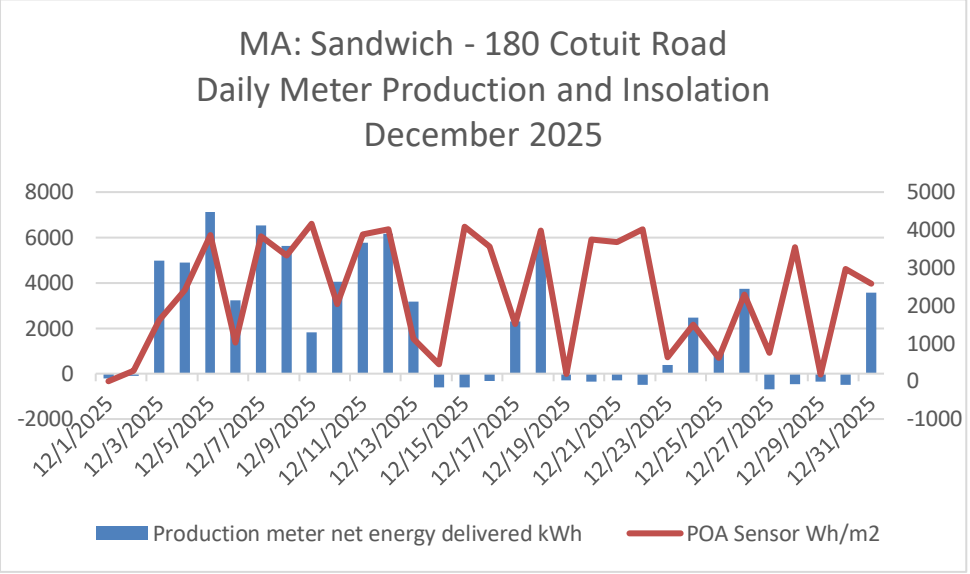
MA: Sandwich - 180 Cotuit Road December Production

1. Site was offline at 17:45 on 11/12 and back online at 16:00 on 12/01 due to utility outage. SR111021.
2. Site was offline at 03:30 on 12/19 and back online at 11:45 on 12/23 due to thermal damage. SR113248
3. Inverter 1 was offline at 07:00 on 12/29 after PE reset the inverter is back online at 10:15 on 12/31.
