MA: Sandwich - 180 Cotuit Road Performance report

Q2 2025

Name: Sandwich - 180 Cotuit Road
Location: Sandwich, MA
Size AC: 3111 kW
Size DC: 4357 kWp
Period: Jan 1, 2025 – May 31, 2025
Report Date: 06/09/25

Prepared by:
Ameresco
117 Flanders Road, Unit 100
Westborough, MA 01581

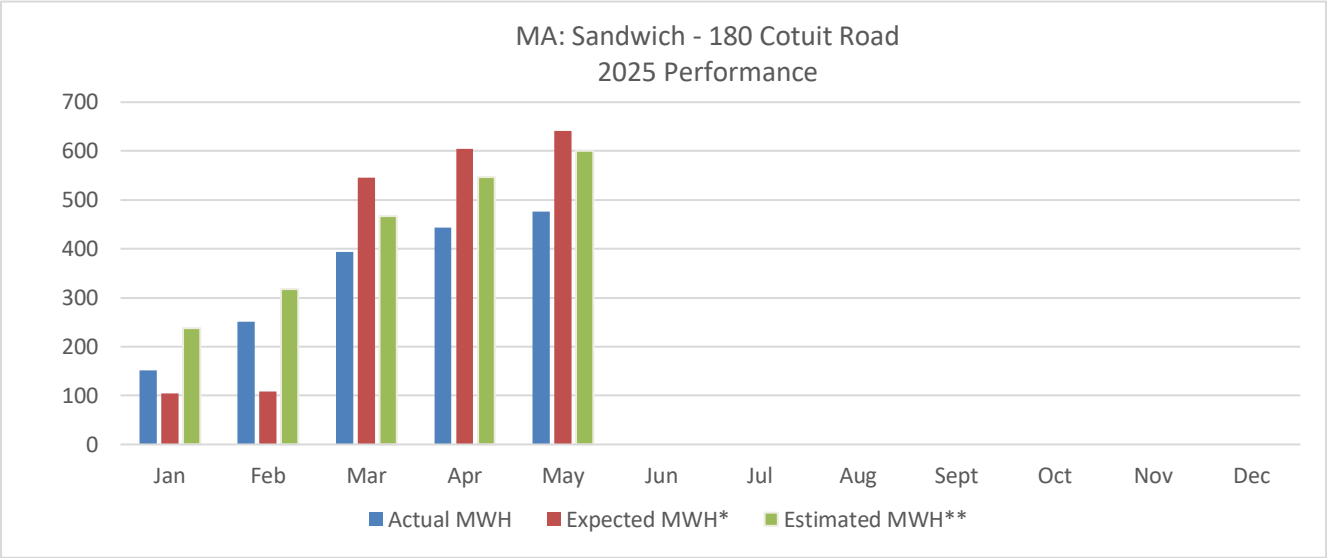
MA: Sandwich - 180 Cotuit Road Performance

Q1	Q2	Q3	Q4	YTD
Actual Production MWH	796	920			1240
Expected Energy MWH*	757	1247			1362
Estimated Production MWH**	1024	1148			1571
Actual vs Expected	105%	74%			91%
Actual vs Estimated	78%	80%			79%

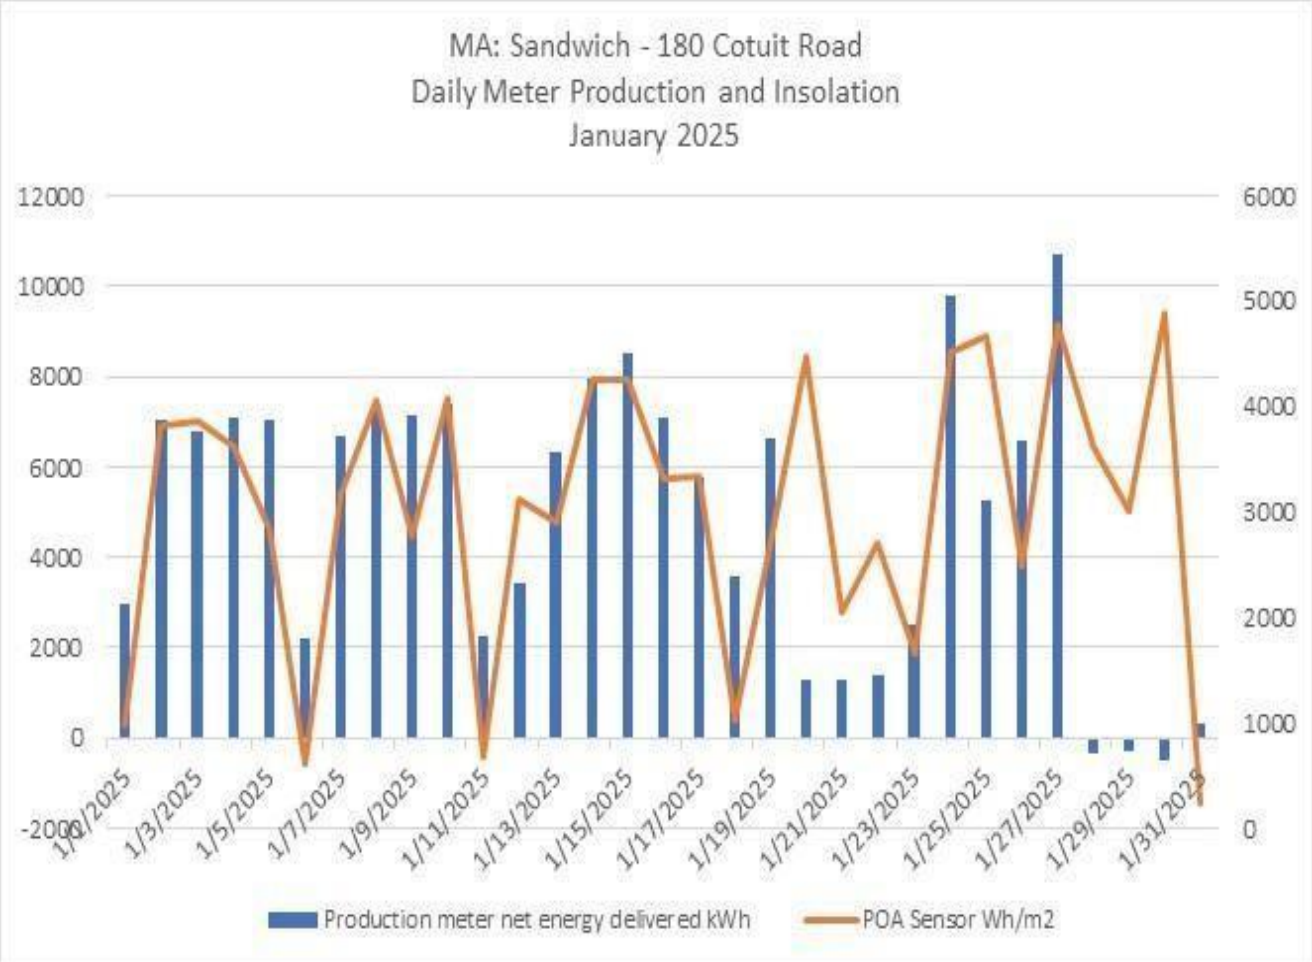
MA: Sandwich - 180 Cotuit Road January Production

1. The site was ofline from 01/28 due to an inverter fault. Later, Power Electronics brought the site back online on 01/31 by pulling the logs. SR096048

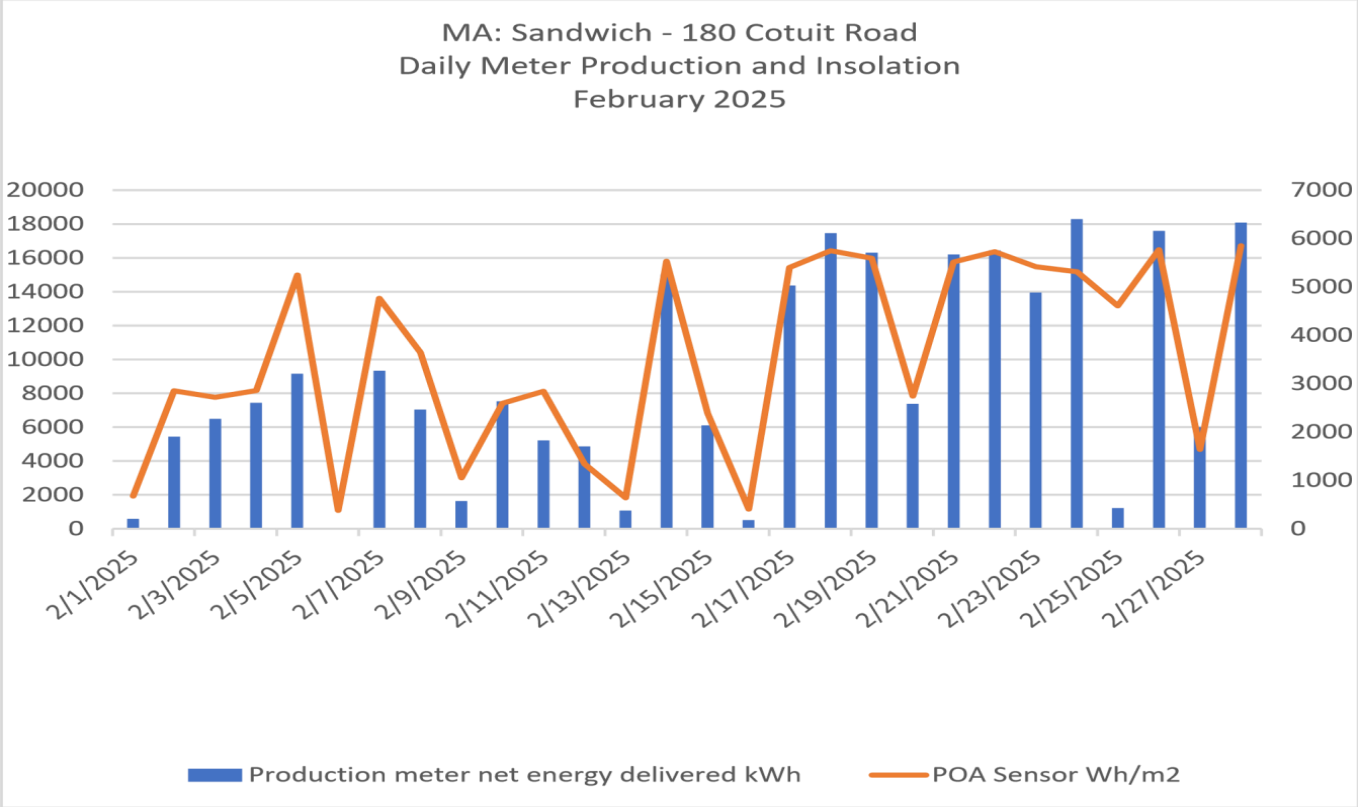
MA: Sandwich - 180 Cotuit Road February Production

1. On 02/18/25, the technician found CB 15 strings 19 & 20 carrying 4 amps. Further investigation is needed to check for a ground fault or module issue. SR096077, SR097256.
2. The site was offline from 6:30 to 14:15 on 02/25/25 due to an inverter fault. The PE technician enabled all modules, put them in start mode, and brought the site back online. SR097746.

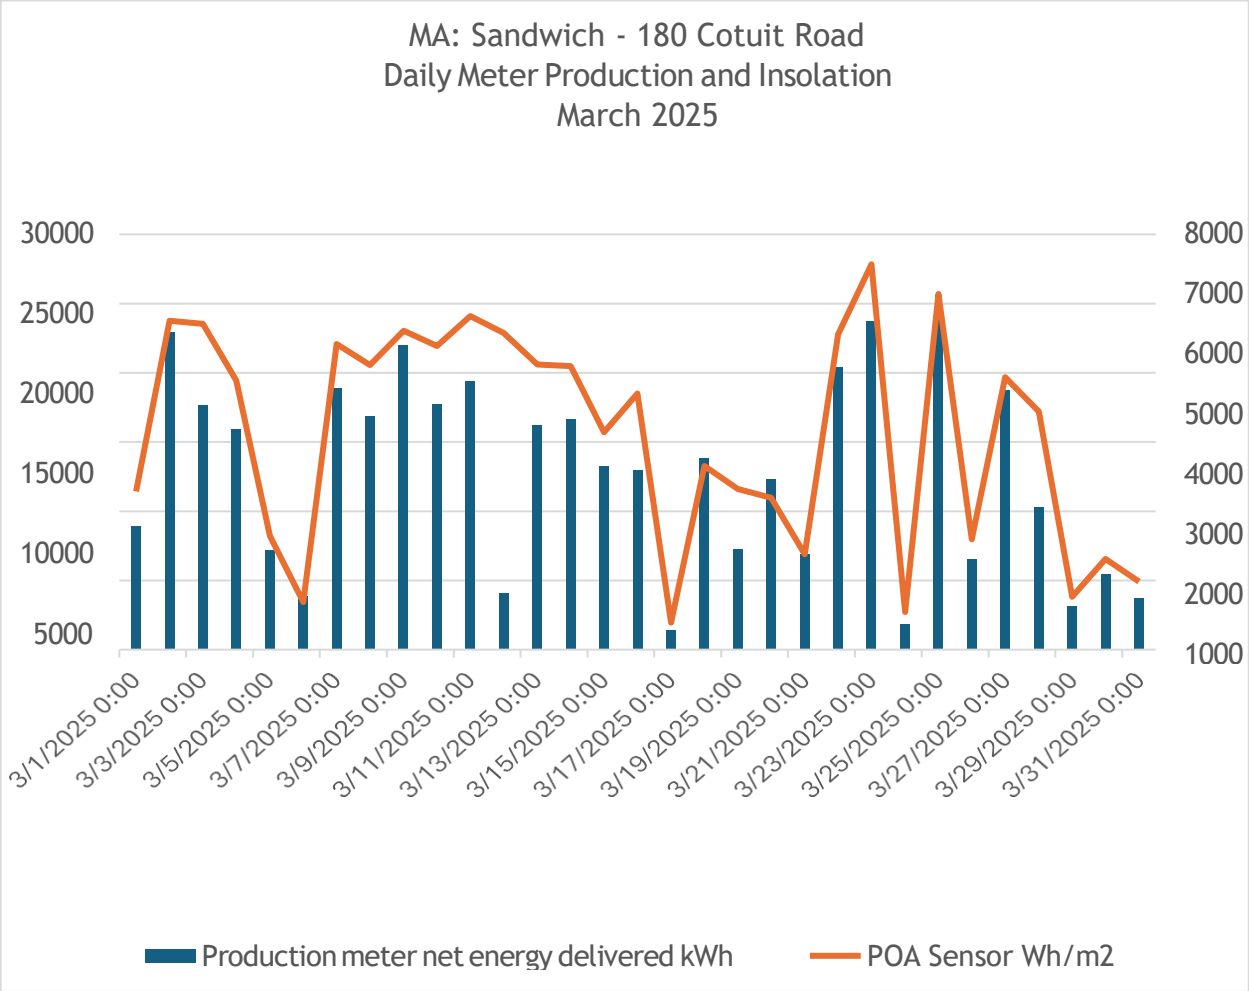
MA: Sandwich - 180 Cotuit Road March Production

1. The site was taken offline from 08:30 to 14:45 on 03/12 due to an HVAC technician being on-site to check the site camera. SR098449
2. Power Electronics on site to perform retrospective ventilation. The Inverter will be taken offline from 11:30 to 13:15 on 03/28. SR099079
3. On 02/18/25, the technician found CB 15 strings 19 & 20 carrying 4 amps. Further investigation is needed to check for a ground fault or module issue. SR096077, SR097256, SR099474

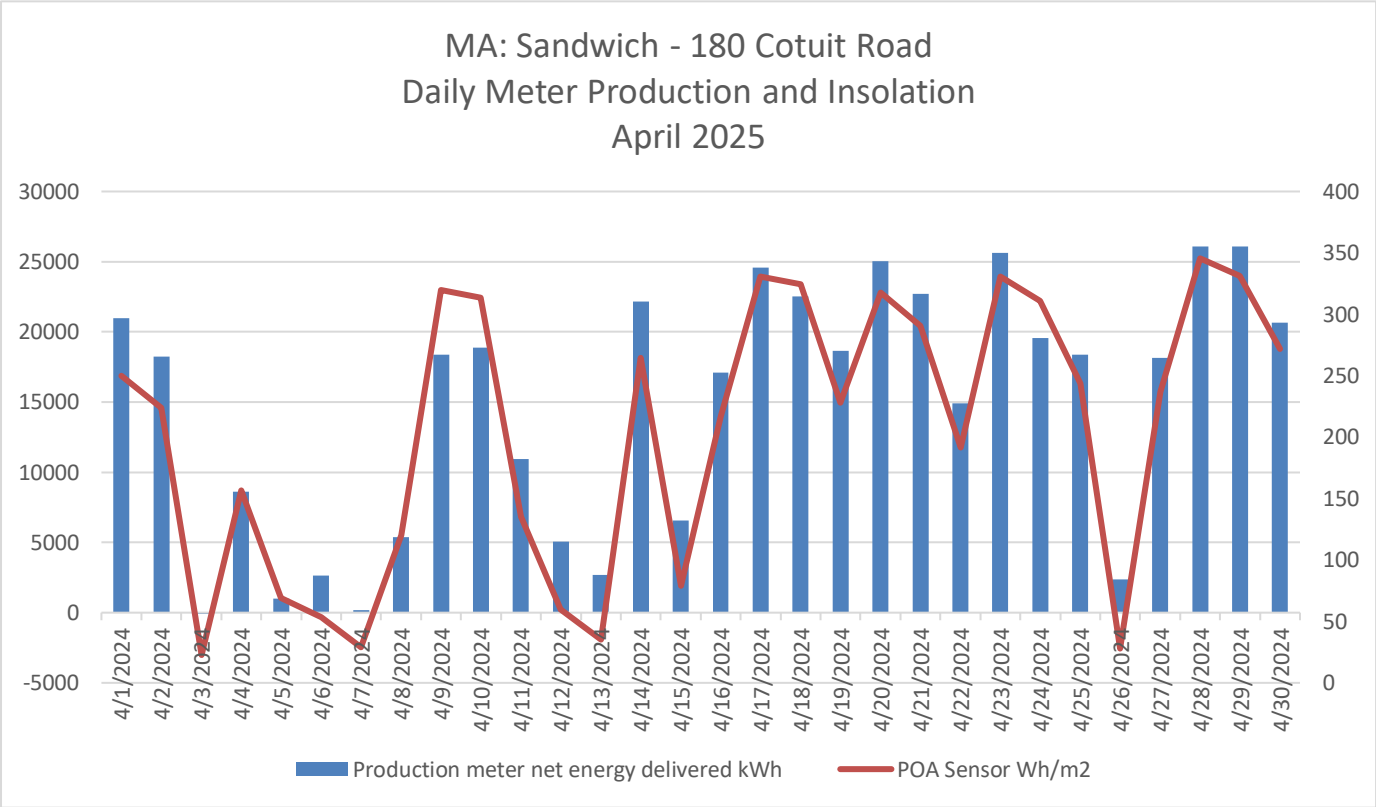
MA: Sandwich - 180 Cotuit Road April Production

1. The site was de-energized from 12:45 PM to 2:45 PM on 04/02 while PE was onsite to inspect inverter settings. **SR099316**
2. On 04/03 and 04/05, the inverter failed to start production but was brought back online after a technician performed a remote reset**. SR099371**

3. On 04/04, a technician checked in to investigate DC strings 19 and 20 in CB15 and discovered reverse polarity in jumper connections to a Northern Row. The jumpers were rewired with correct polarity, and final testing confirmed both strings were producing normally. **SR097256, SR099474 & SR099475.**

4. On 04/11/25, discrepancies were noted between meter and inverter readings, with the meter peaking at 3 MW while the inverter maxed at 2.2 MW. AE responded on 04/15/25, suggesting potential bin size logging or data latency issues and implemented logger setting changes. The issue now appears resolved, though the root cause remains unknown. PowerTrack still needs BESS data configured for accurate PV monitoring. **SR099700**

5. On 04/18, the inverter began production at 10:00 AM after experiencing a Softcharge DC5 fault. **SR099978**
6. Inverter tripped offline at 17:00 on 04/24 due to BW BF. PS. 151 fault and back online at 10Am on 04/25 after PE technician initiated the wake-up and soft charge process. **SR10036**

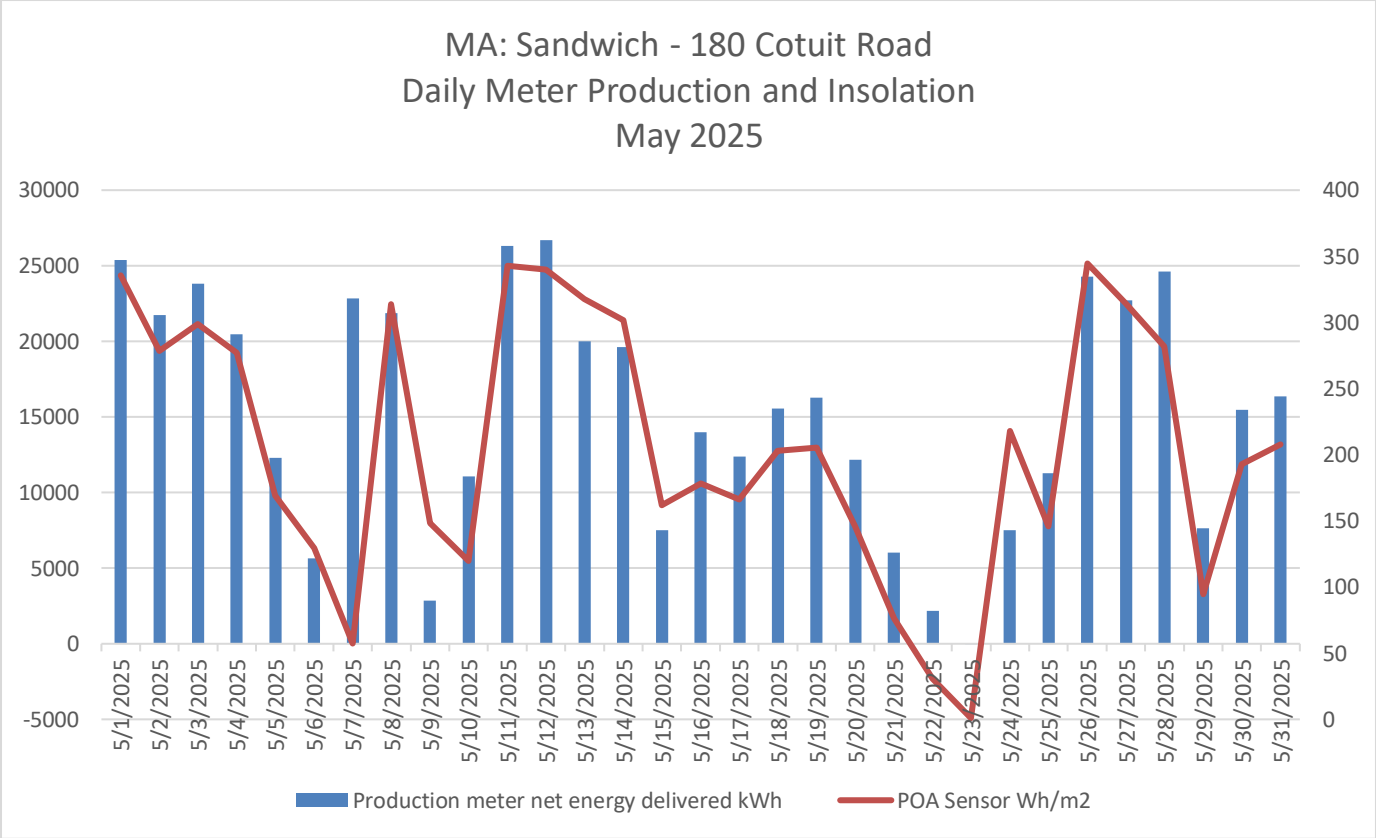
MA: Sandwich - 180 Cotuit Road May Production

1. The site was offline from 09:15 to 13:15 on 05/09. On 05/09, a technician reached out to Power Electronics and worked remotely with Pedro. Pedro was able to make changes to the parameters and get the inverter online. **SR101226**

2. Inverter 1 was offline from 18:15 on 05/13 to 09:45 on 05/14. Inverter was back online after technician with Remote support cleared fault and restarted inverter. **SR101418**

3. The site was offline from 10:30 to 11:45 on 05/15 as Power electronics technicians were on site to replace the main control board in an inverter 1 module. **SR101464**

4. Site was offline from 06:15 on 05/23 to 11:00 on 05/24. On 05/24, a technician was onsite and re-energized the site. The site was back online at 11:00 on 05/24. **SR101873**

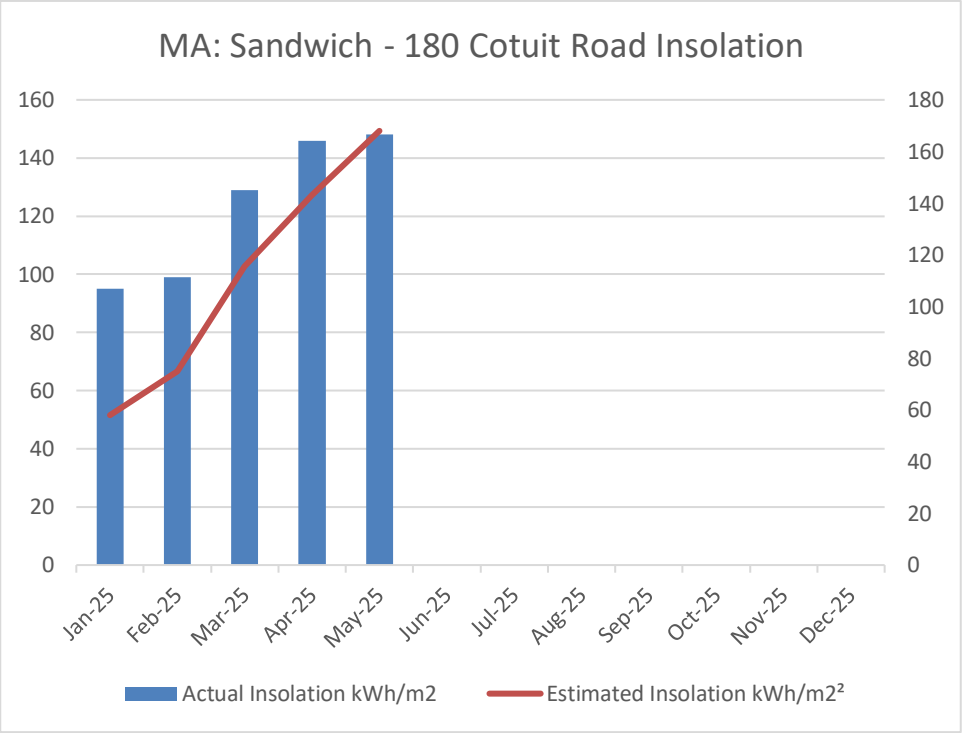
MA: Sandwich - 180 Cotuit Road Insolation

Jan	Feb	Mar	Apr	May	Jun	Jul	Aug	Sep	Oct	Nov	Dec
Actual	95	99	129	146	148							
Est	58	75	115.5	143	168							
Act vs Est	162%	132%	112%	102%	88%
