MA: Sandwich - 180 Cotuit Road Performance report

Q3 2025

Name: Sandwich – 180 Cotuit
Road Location: Sandwich, MA
Size AC: 3111 kW
Size DC: 4357 kWp
Period: Sep 1, 2025 – Sep 30, 2025
Report Date: 09/10/25

Prepared by:
Ameresco
117 Flanders Road, Unit 100
Westborough, MA 01581

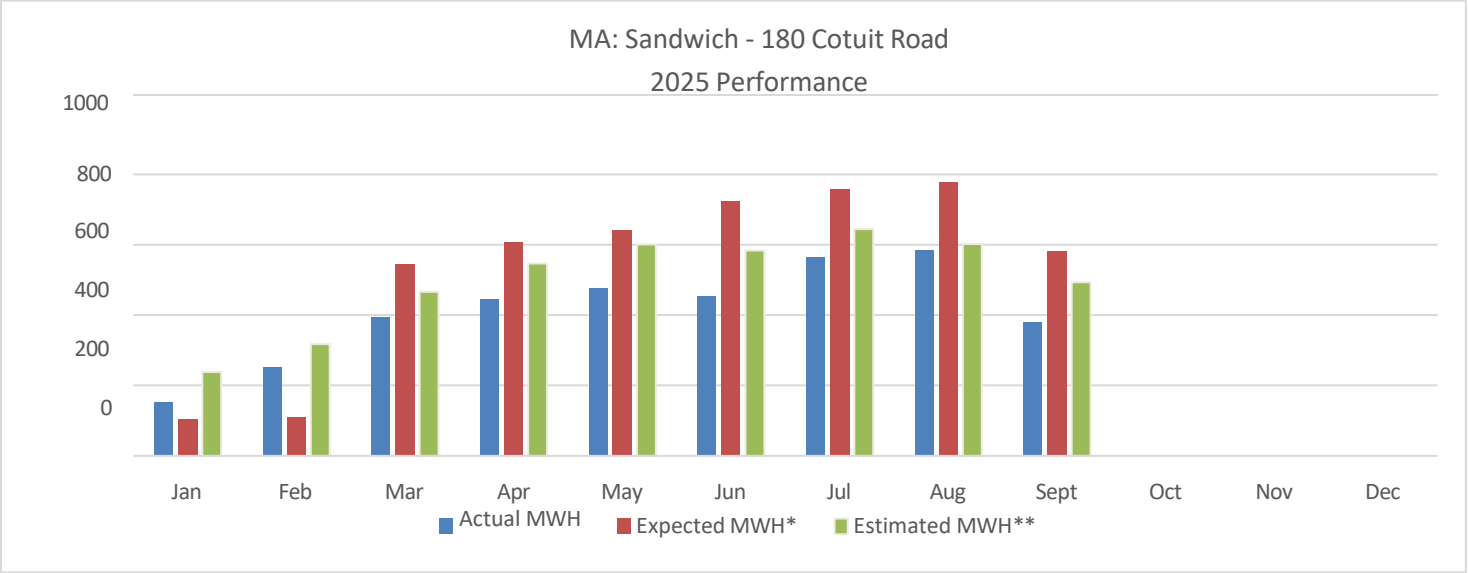
MA: Sandwich – 180 Cotuit Road Performance

Q1	Q2	Q3	Q4	YTD
Actual Production MWH	796	1374	1527		3697
Expected Energy MWH*	757	1971	2117		4845
Estimated Production MWH**	1024	1732	1741		4497
Actual vs Expected	105%	70%	72%		76%
Actual vs Estimated	78%	79%	77%		82%

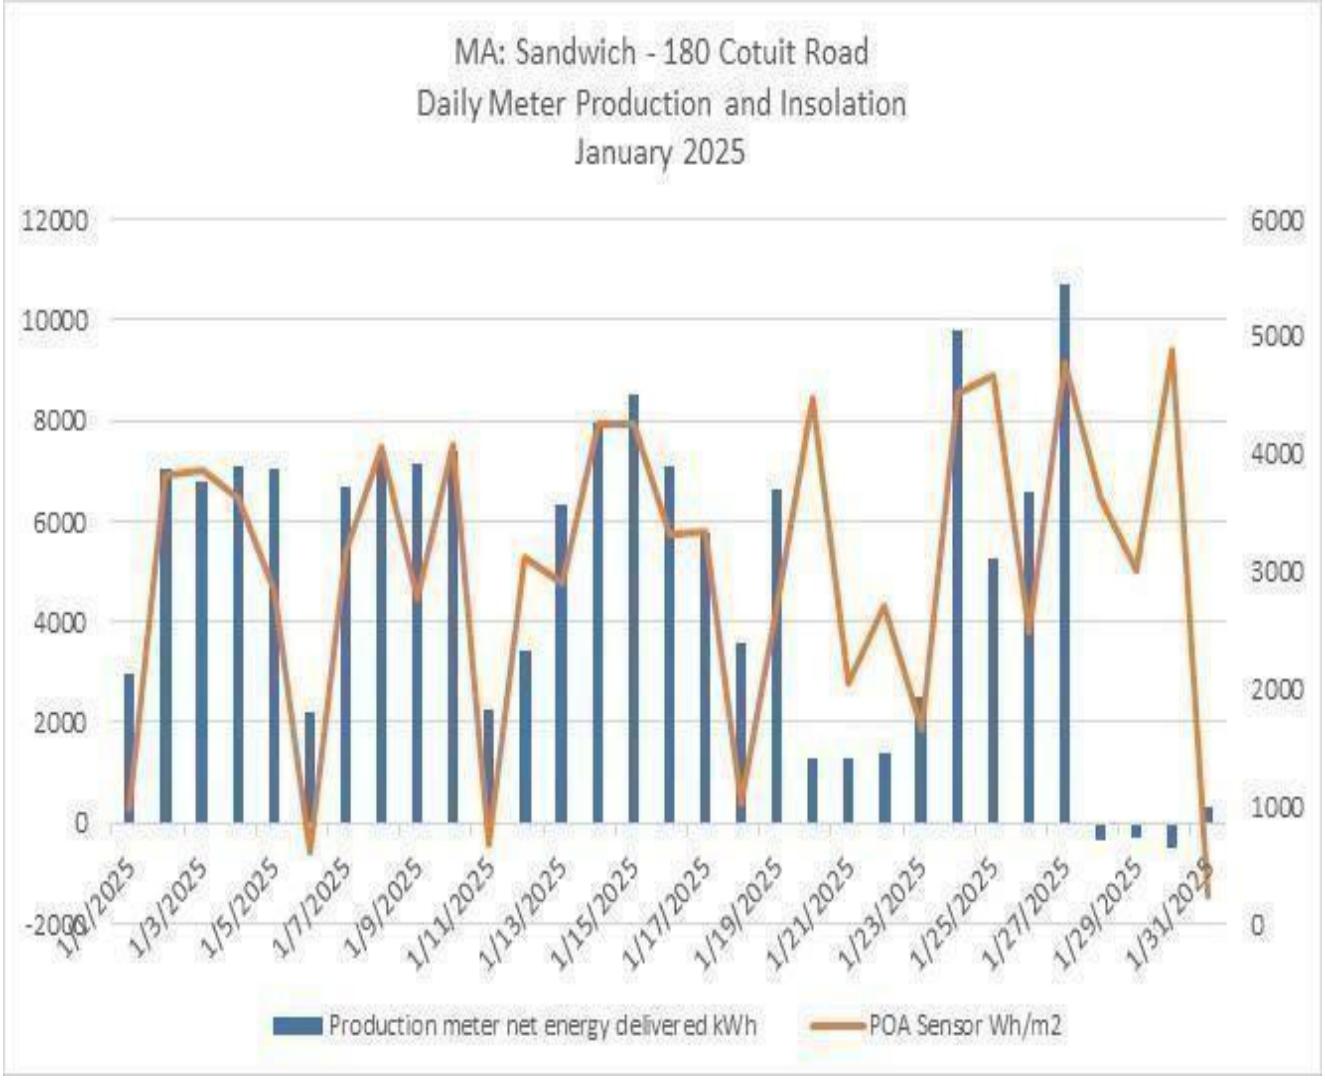
MA: Sandwich - 180 Cotuit Road January Production

1. The site was offline from 01/28 due to an inverter fault. Later, Power Electronics brought the site back online on 01/31 by pulling the logs. SR096048

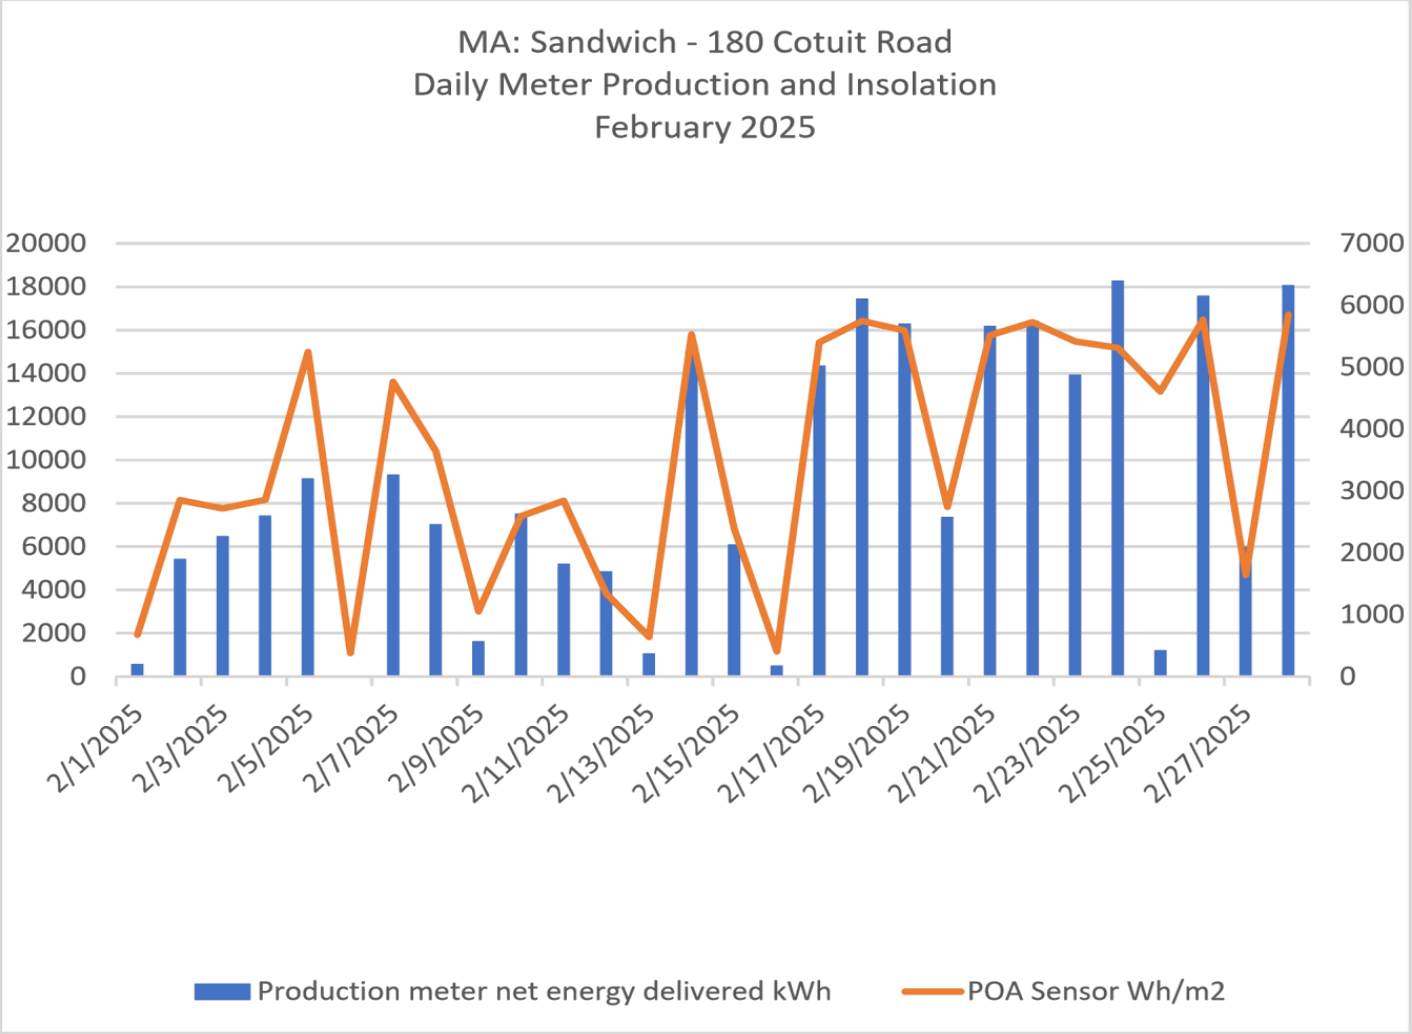
MA: Sandwich - 180 Cotuit Road February Production

1. On 02/18/25, the technician found CB 15 strings 19 & 20 carrying 4 amps. Further investigation is needed to check for a ground fault or module issue. SR096077, SR097256.
2. The site was offline from 6:30 to 14:15 on 02/25/25 due to an inverter fault. The PE technician enabled all modules, put them in startmode, and brought the site back online. SR097746.

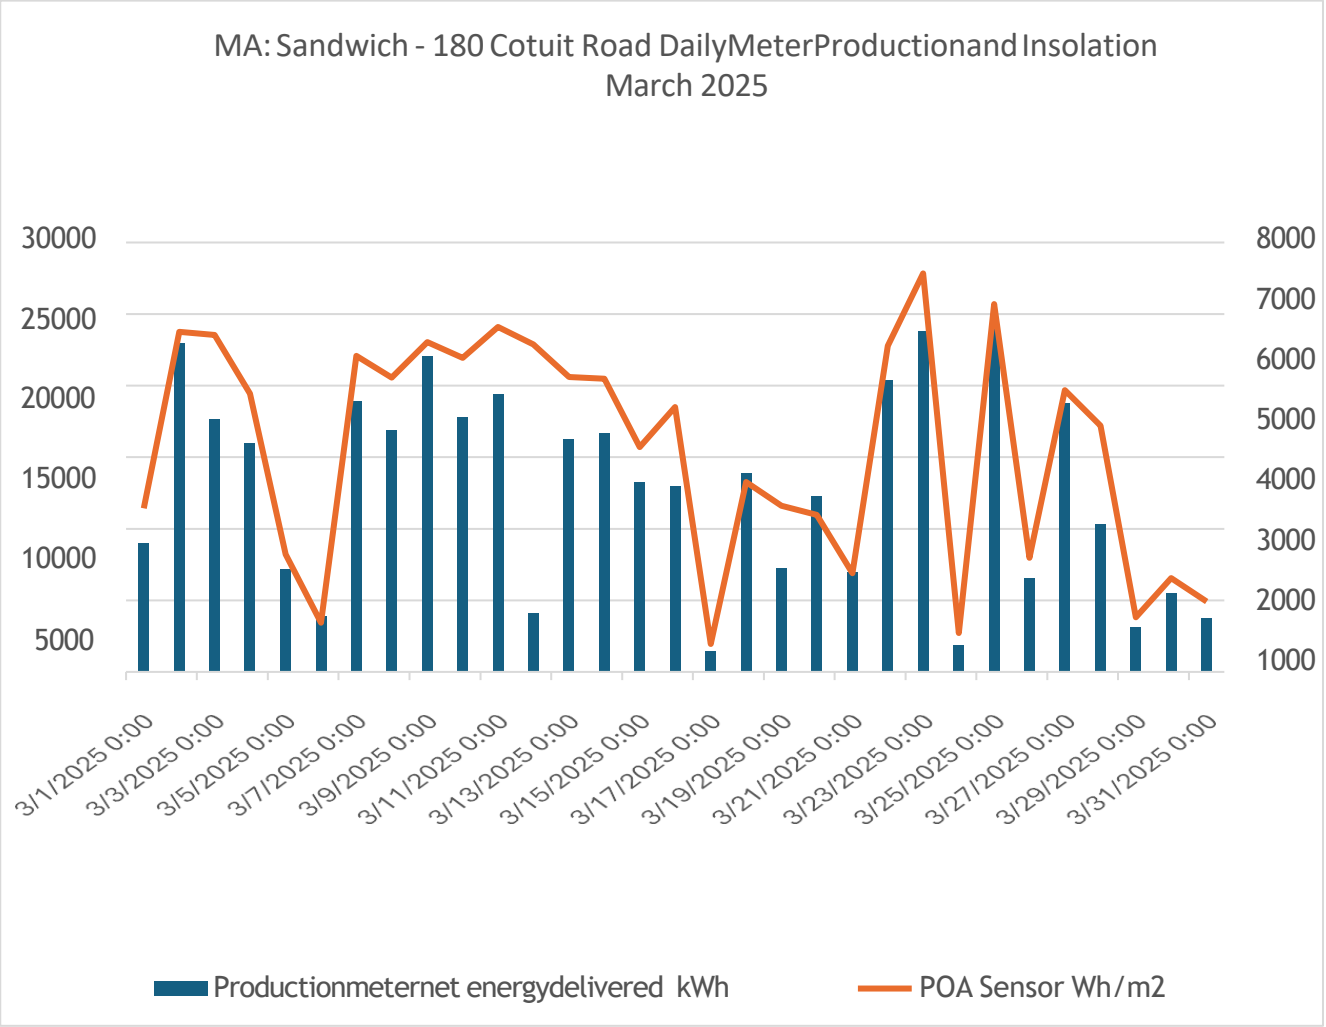
MA: Sandwich - 180 Cotuit Road March Production

1. The site was taken offline from 08:30 to 14:45 on 03/12 due to an HVAC technician being on-site to check the site camera. SR098449
2. Power Electronics on site to perform retrospective ventilation. The Inverter will be taken offline from 11:30 to 13:15 on 03/28. SR099079
3. On 02/18/25, the technician found CB 15 strings 19 & 20 carrying 4 amps. Further investigation is needed to check for a ground fault or module issue. SR096077, SR097256, SR099474

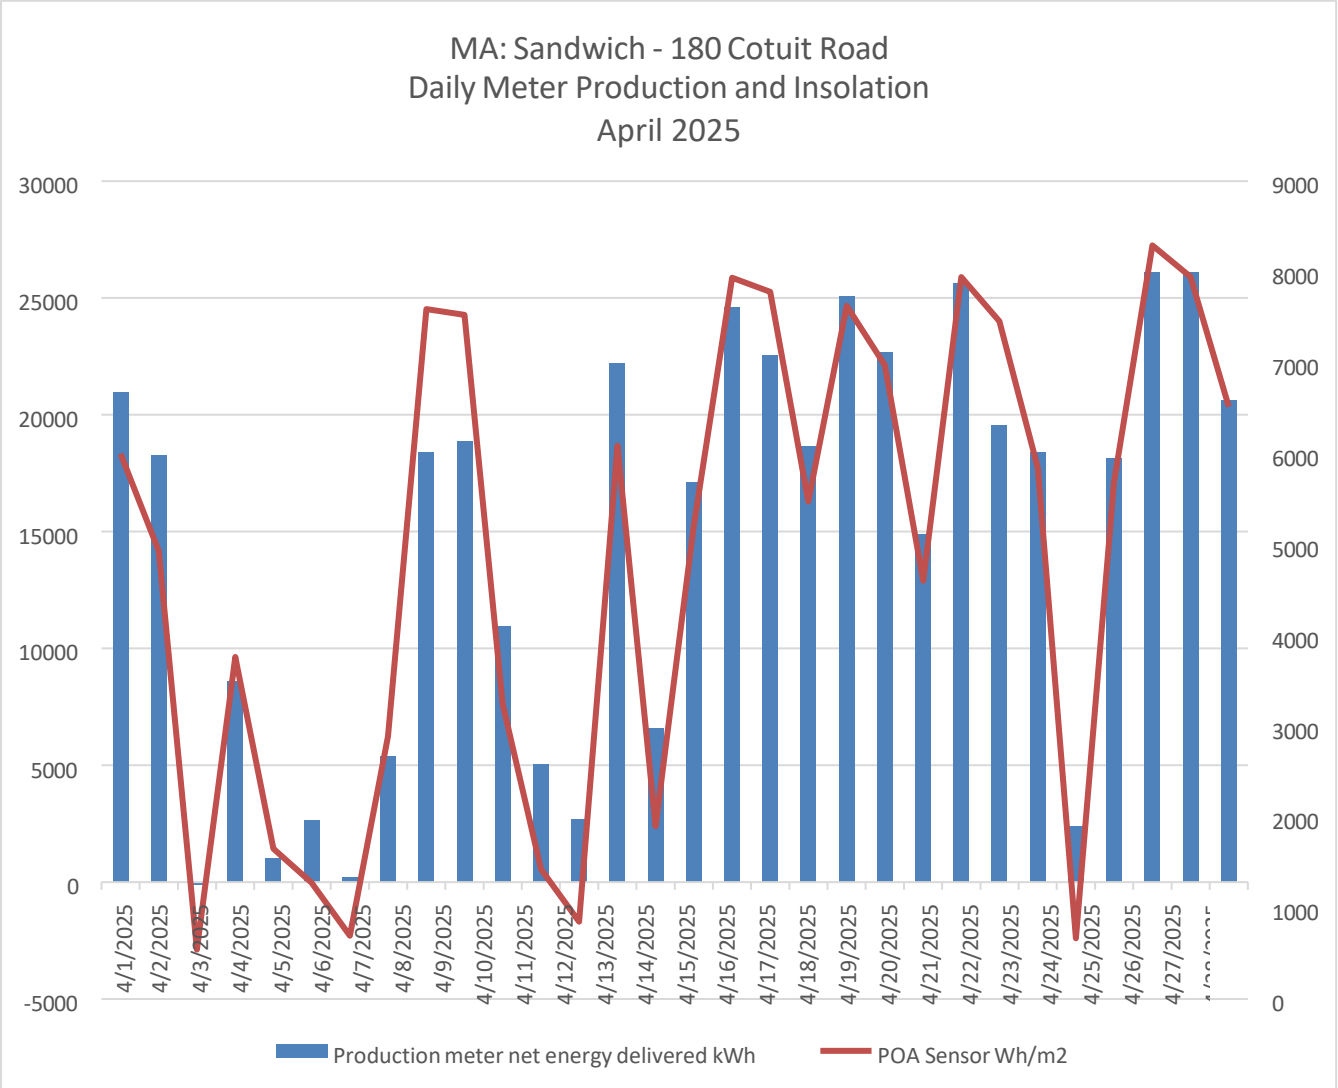
MA: Sandwich - 180 Cotuit Road April Production

1. The site was de-energized from 12:45 PM to 2:45 PM on 04/02 while PE was onsite to inspect inverter settings. **SR099316**
2. On 04/03 and 04/05, the inverter failed to start production but was brought back online after a technician performed a remote reset**. SR099371**

3. On 04/04, a technician checked in to investigate DC strings 19 and 20 in CB15 and discovered reverse polarity in jumper connections to a Northern Row. The jumpers were rewired with correct polarity, and final testing confirmed both strings were producing normally. **SR097256, SR099474 & SR099475.**

4. On 04/11/25, discrepancies were noted between meter and inverter readings, with the meter peaking at 3 MW while the inverter maxed at 2.2 MW. AE responded on 04/15/25, suggesting potential bin size logging or data latency issues and implemented logger setting changes. The issue now appears resolved, though the root cause remains unknown. PowerTrack still needs BESS data configured for accurate PV monitoring. **SR099700**

5. On 04/18, the inverter began production at 10:00 AM after experiencing a Softcharge DC5 fault. **SR099978**

6. Inverter tripped offline at 17:00 on 04/24 due to BW BF. PS. 151 fault and back online at 10Am on 04/25 after PE technician initiated the wake-up and soft charge process. **SR10036**

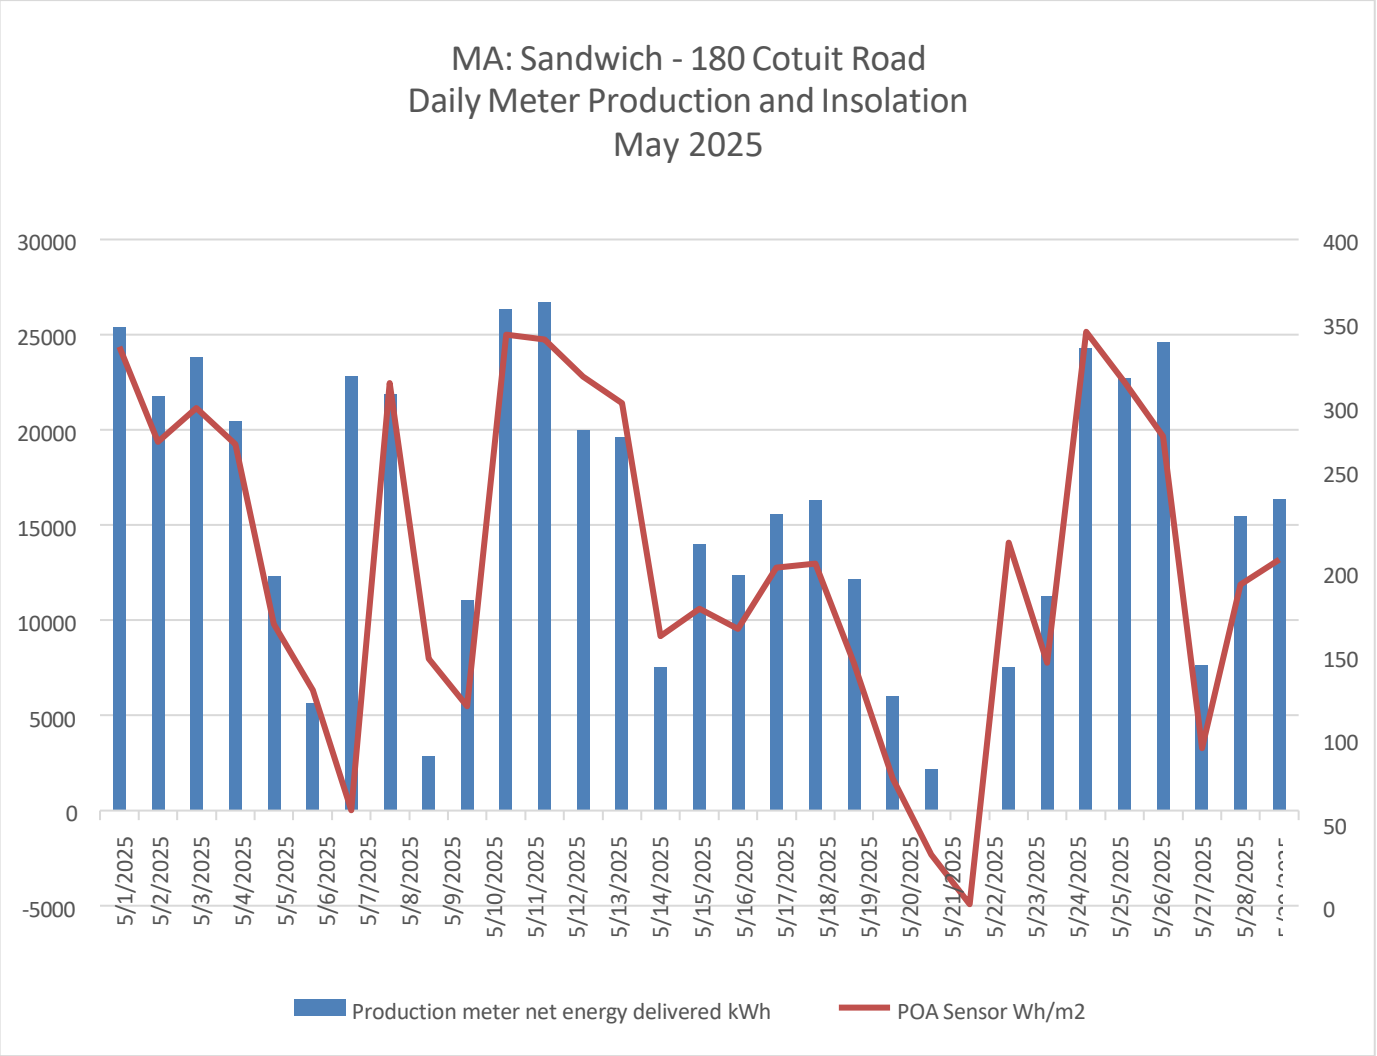
MA: Sandwich - 180 Cotuit Road May Production

1. The site was offline from 09:15 to 13:15 on 05/09. On 05/09, a technician reached out to Power Electronics and worked remotely with Pedro. Pedro was able to make changes to the parameters and get the inverter online. **SR101226**

2. Inverter 1 was offline from 18:15 on 05/13 to 09:45 on 05/14. Inverter was back online after technician with Remote support cleared fault and restarted inverter. **SR101418**

3. The site was offline from 10:30 to 11:45 on 05/15 as Power electronics technicians were on site to replace the main control board in an inverter 1 module. **SR101464**

4. Site was offline from 06:15 on 05/23 to 11:00 on 05/24. On 05/24, a technician was onsite and re-energized the site. The site was back online at 11:00 on 05/24. **SR101873**

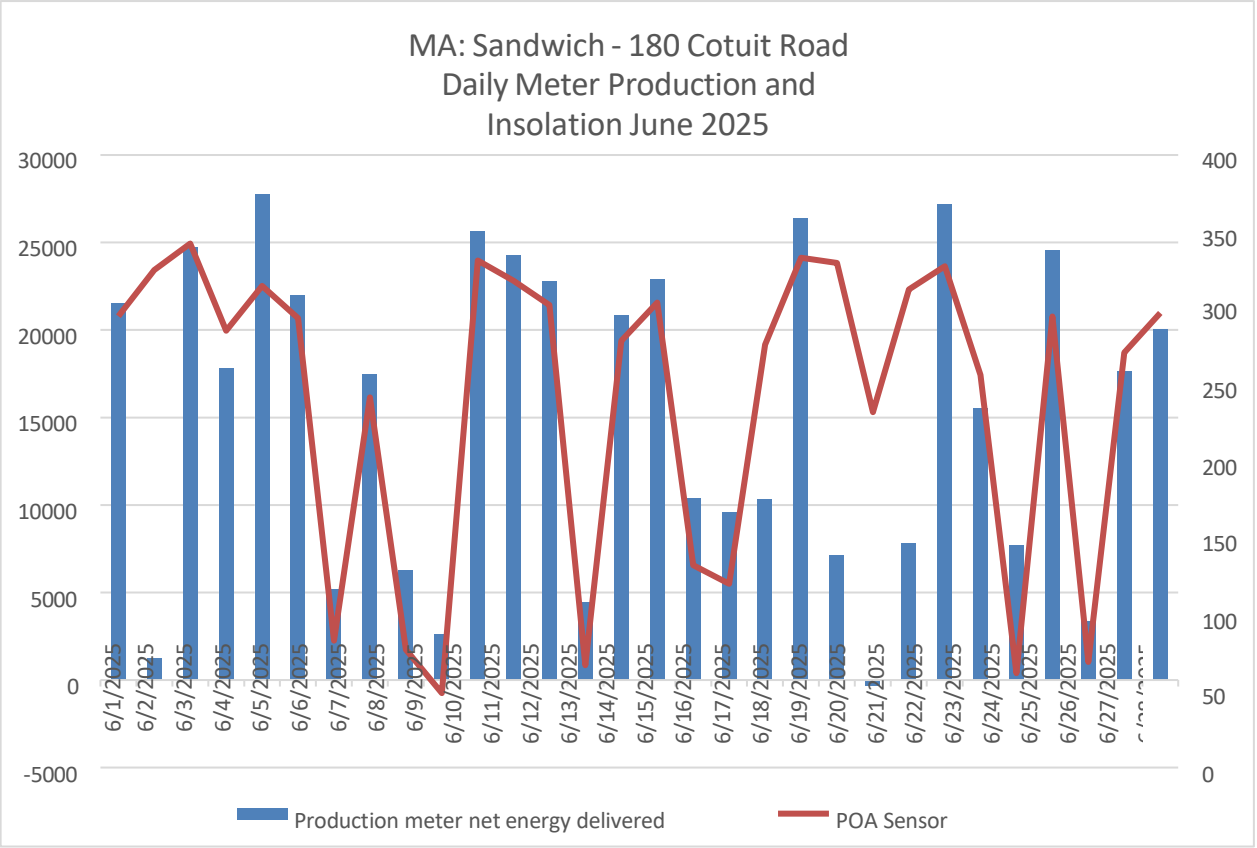
MA: Sandwich - 180 Cotuit Road June Production

1. Site tripped offline on 06/02 at 08:45 and back online on 06/03 at 08:00. **SR102295**
2. Inverter tripped offline at 18:00 on 06/03 and back online on 06/04 at 05:30. **SR102429**
3. The site was offline from 09:30 to 13:45 on 06/19. It was offline again from 08:45 to 11:45 on 06/21 and then went offline once more at 15:15 on the same day. It came back online on 06/23 at 09:00 but experienced another outage from 11:45 to 15:45 on the same day. **SR103172**

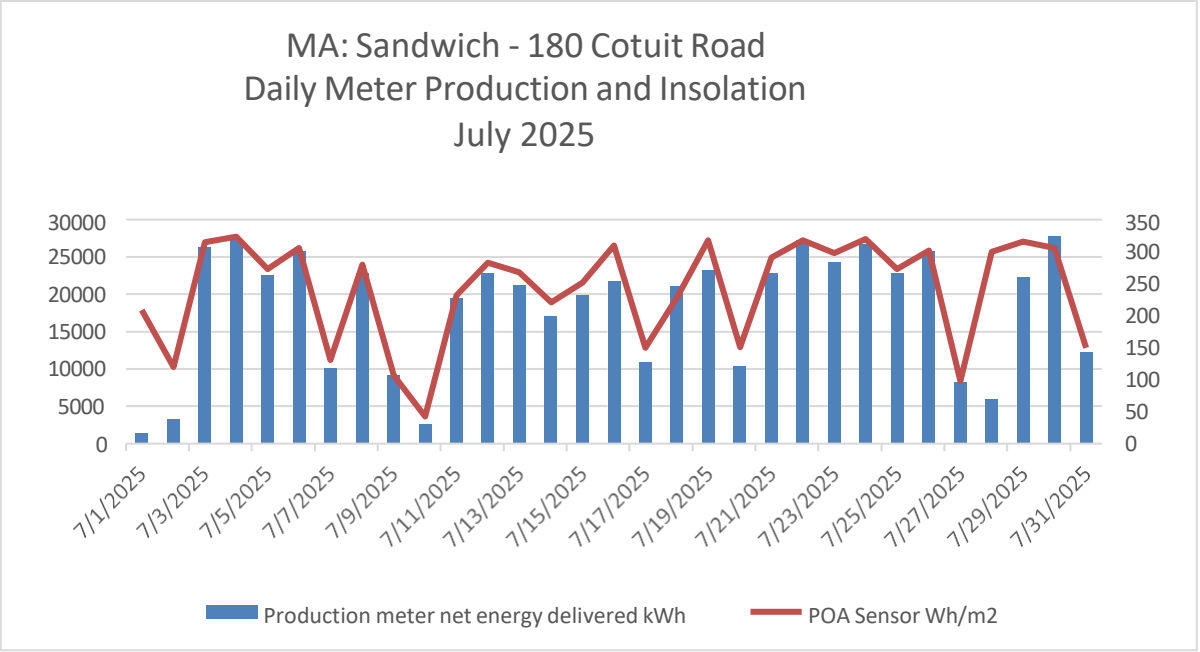
MA: Sandwich - 180 Cotuit Road July Production

1. Inverter tripped offline 10:30 on 07/01 and it came back online at 14:45 on 07/02. PM9454
2. Site tripped offline from 10:30 to 16:00 on 07/28. SR105163

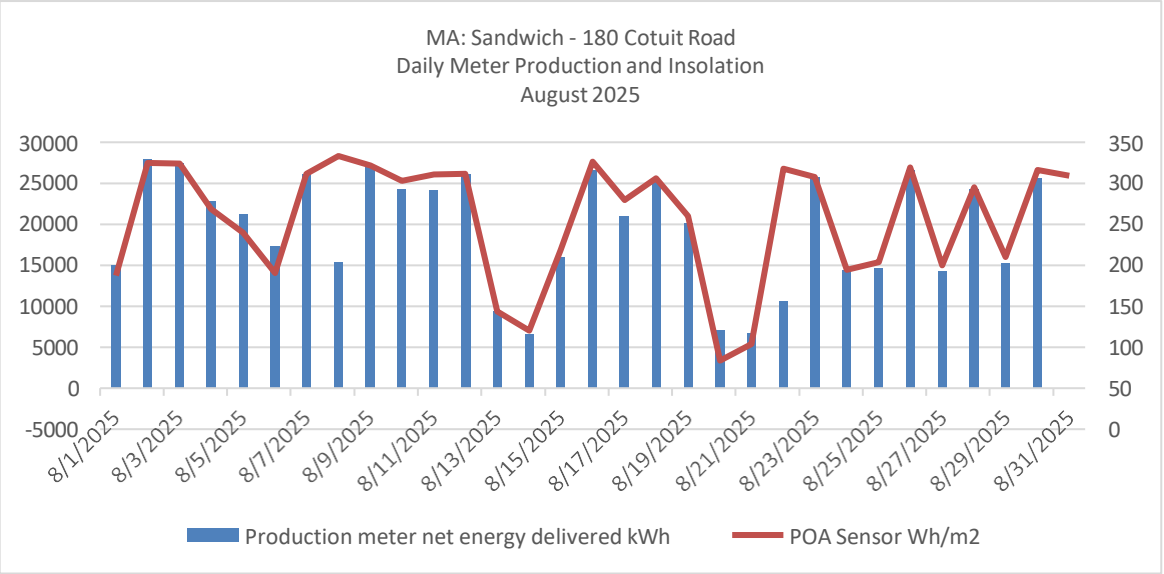
MA: Sandwich - 180 Cotuit Road August Production

1. Site was offline from 04:30 to 11:45 on 08/08. SR105884
2. Inverter offline from 07:00 to 07:34 on 08/13. SR106182
3. Inverter started late for production at 13:00 on 08/22. SR106742
4. Inverter has dropped from over 2MW to grid/Bess to 0 twice in a day on 08/29 and again Inverter tripped offline at 07:45 on 08/31. SR107206

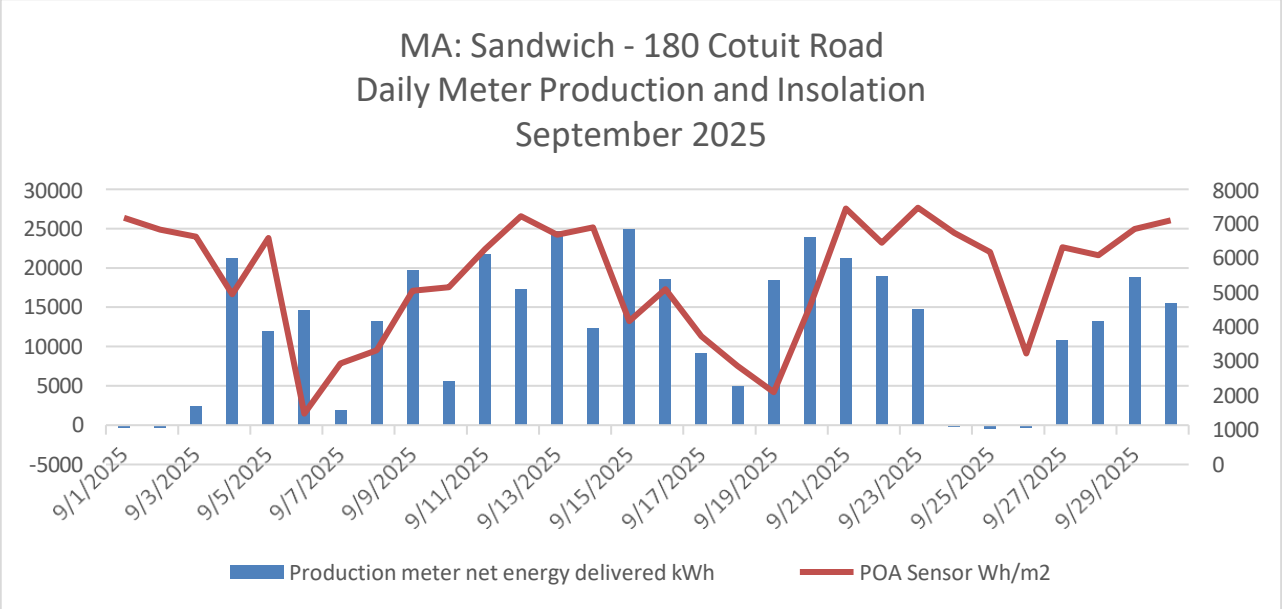
MA: Sandwich - 180 Cotuit Road September Production

1.Site came back online at 15:30 on 09/03. SR107206, SR107304
2.Inverter offline from 10:47 to 11:00 on 09/09. SR107686
3.Inverter offline due to low irradiance at 11:00 on 09/24 and it came back online at 11:15 on 09/27. SR108530
