MA: Sandwich - 180 Cotuit Road Performance report

Q1 2025

Name: Sandwich - 180 Cotuit Road
Location: Sandwich, MA
Size AC: 3111 kW
Size DC: 4357 kWp
Period: Jan 1, 2025 – April 30, 2025
Report Date: 05/06/25

Prepared by:
Ameresco
117 Flanders Road, Unit 100
Westborough, MA 01581

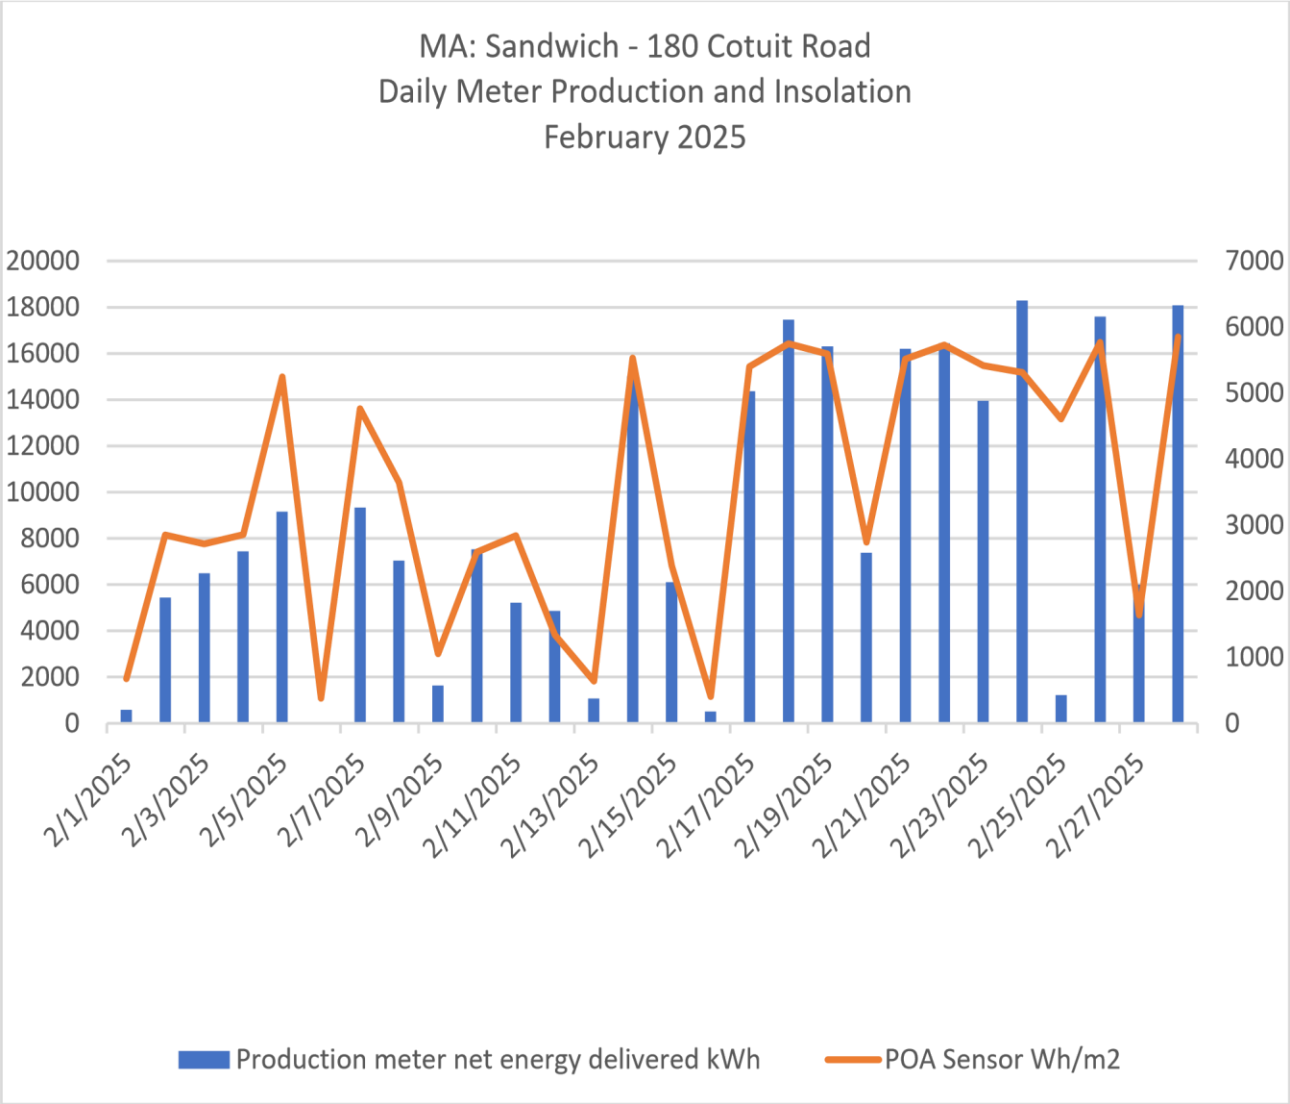
MA: Sandwich - 180 Cotuit Road February Production

1. On 02/18/25, the technician found CB 15 strings 19 & 20 carrying 4 amps. Further investigation is needed to check for a ground fault or module issue. SR096077, SR097256.
2. The site was offline from 6:30 to 14:15 on 02/25/25 due to an inverter fault. The PE technician enabled all modules, put them in start mode, and brought the site back online. SR097746.

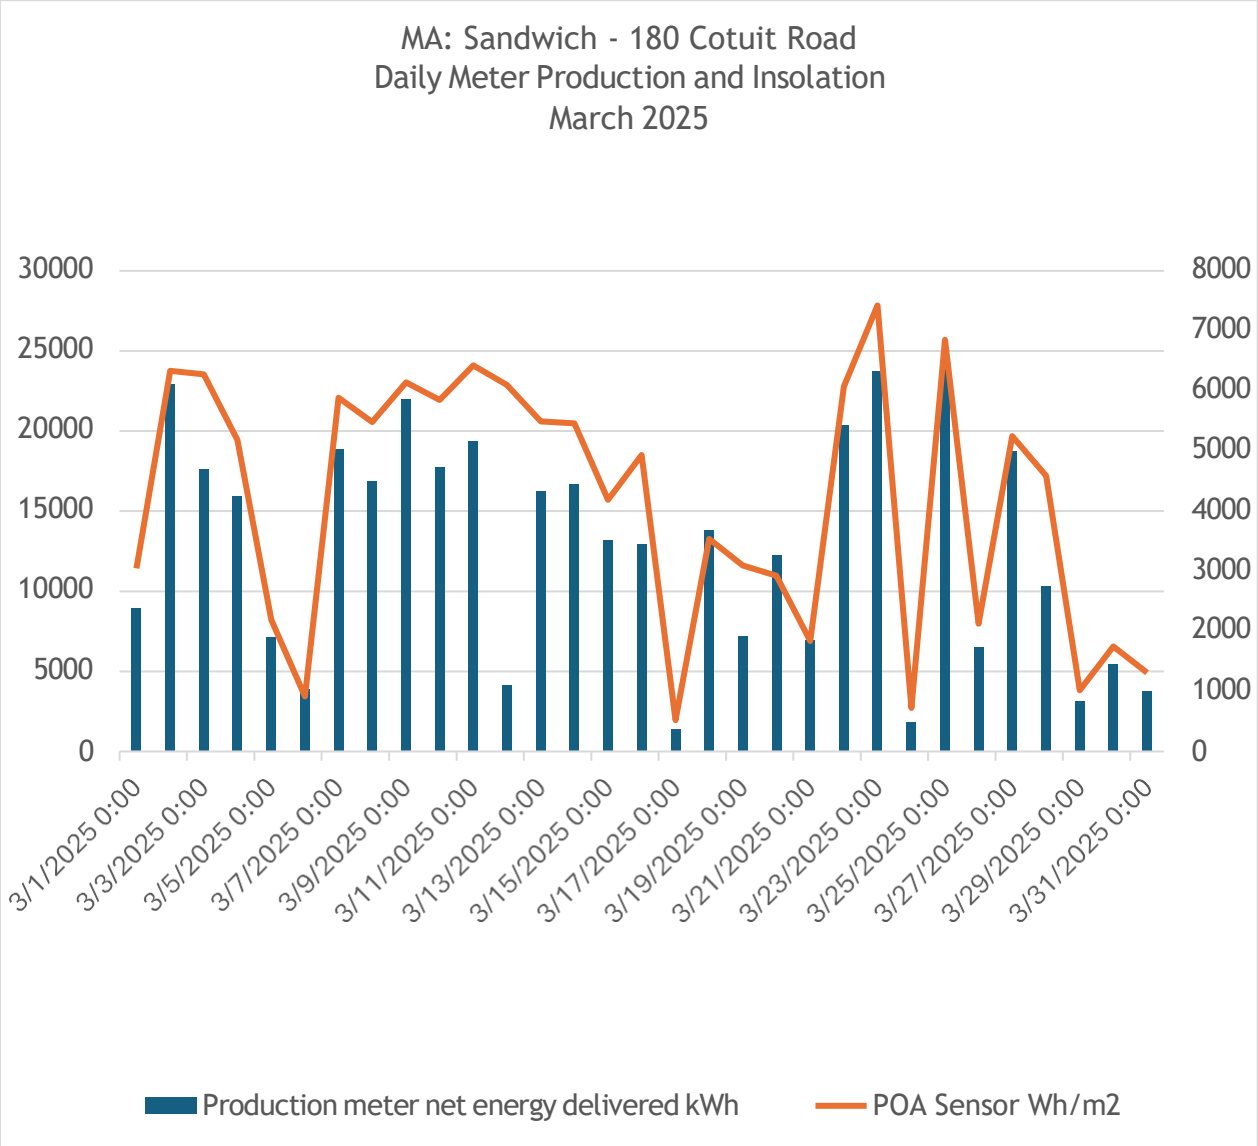
MA: Sandwich - 180 Cotuit Road March Production

1. The site was taken ofline from 08:30 to 14:45 on 03/12 due to an HVAC technician being on-site to check the site camera. SR098449
2. Power Electronics on site to perform retrospective ventilation. The Inverter will be taken ofline from 11:30 to 13:15 on 03/28. SR099079
3. On 02/18/25, the technician found CB 15 strings 19 & 20 carrying 4 amps. Further investigation is needed to check for a ground fault or module issue. SR096077, SR097256, SR099474

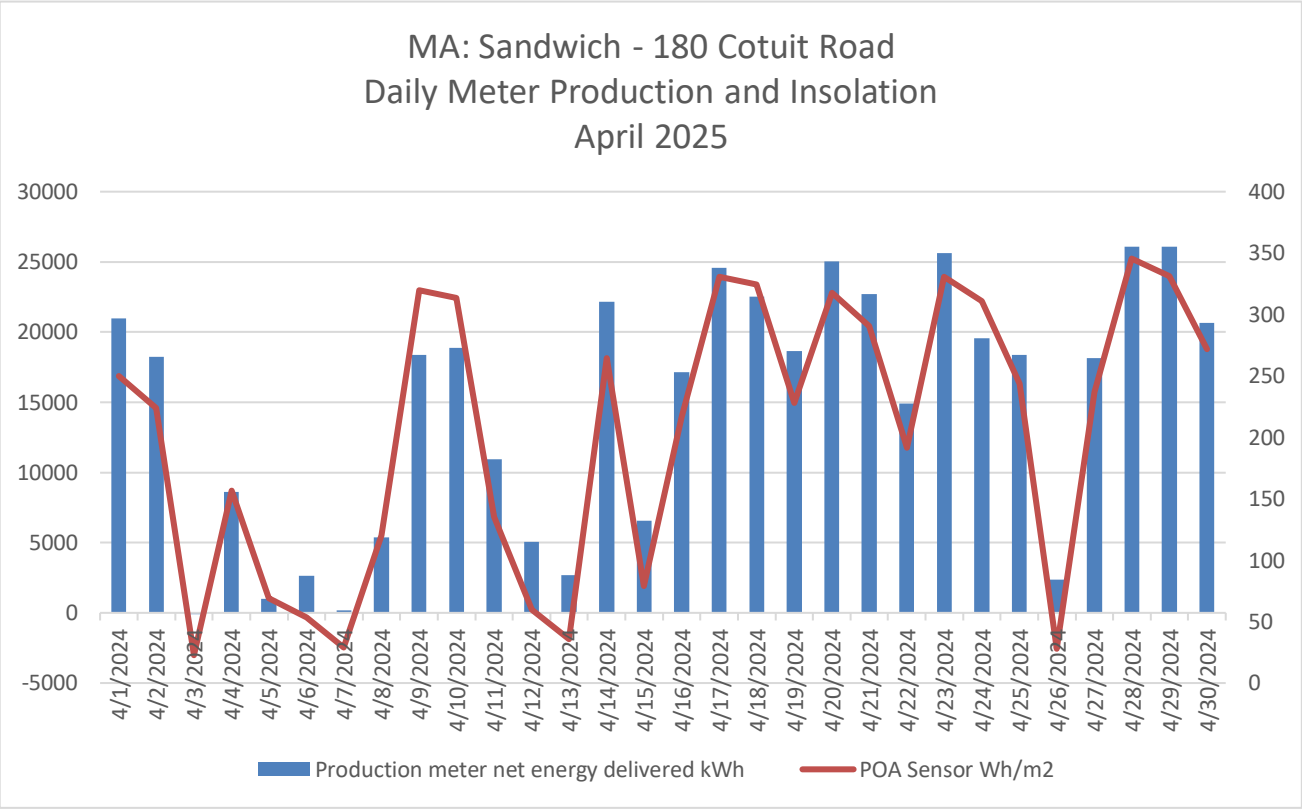
MA: Sandwich - 180 Cotuit Road April Production

1. The site was de-energized from 12:45 PM to 2:45 PM on 04/02 while PE was onsite to inspect inverter settings. **SR099316**
2. On 04/03 and 04/05, the inverter failed to start production but was brought back online after a technician performed a remote reset**. SR099371**

4. On 04/11/25, discrepancies were noted between meter and inverter readings, with the meter peaking at 3 MW while the inverter maxed at 2.2 MW. AE responded on 04/15/25, suggesting potential bin size logging or data latency issues and implemented logger setting changes. The issue now appears resolved, though the root cause remains unknown. PowerTrack still needs BESS data configured for accurate PV monitoring. **SR099700**

5. On 04/18, the inverter began production at 10:00 AM after experiencing a Softcharge DC5 fault. **SR099978**
6. Inverter tripped offline at 17:00 on 04/24 due to BW BF. PS. 151 fault and back online at 10Am on 04/25 after PE technician initiated the wake-up and soft charge process. **SR100365**

3. On 04/04, a technician checked in to investigate DC strings 19 and 20 in CB15 and discovered reverse polarity in jumper connections to a Northern Row. The jumpers were rewired with correct polarity, and final testing confirmed both strings were producing normally. **SR097256, SR099474 & SR099475.**
