MA: Sandwich - 180 Cotuit Road Performance report

Q3 2025

Name: Sandwich – 180 Cotuit
Road Location: Sandwich, MA
Size AC: 3111 kW
Size DC: 4357 kWp
Period: Aug 1, 2025 – Aug 31, 2025
Report Date: 08/09/25

Prepared by:
Ameresco
117 Flanders Road, Unit 100
Westborough, MA 01581

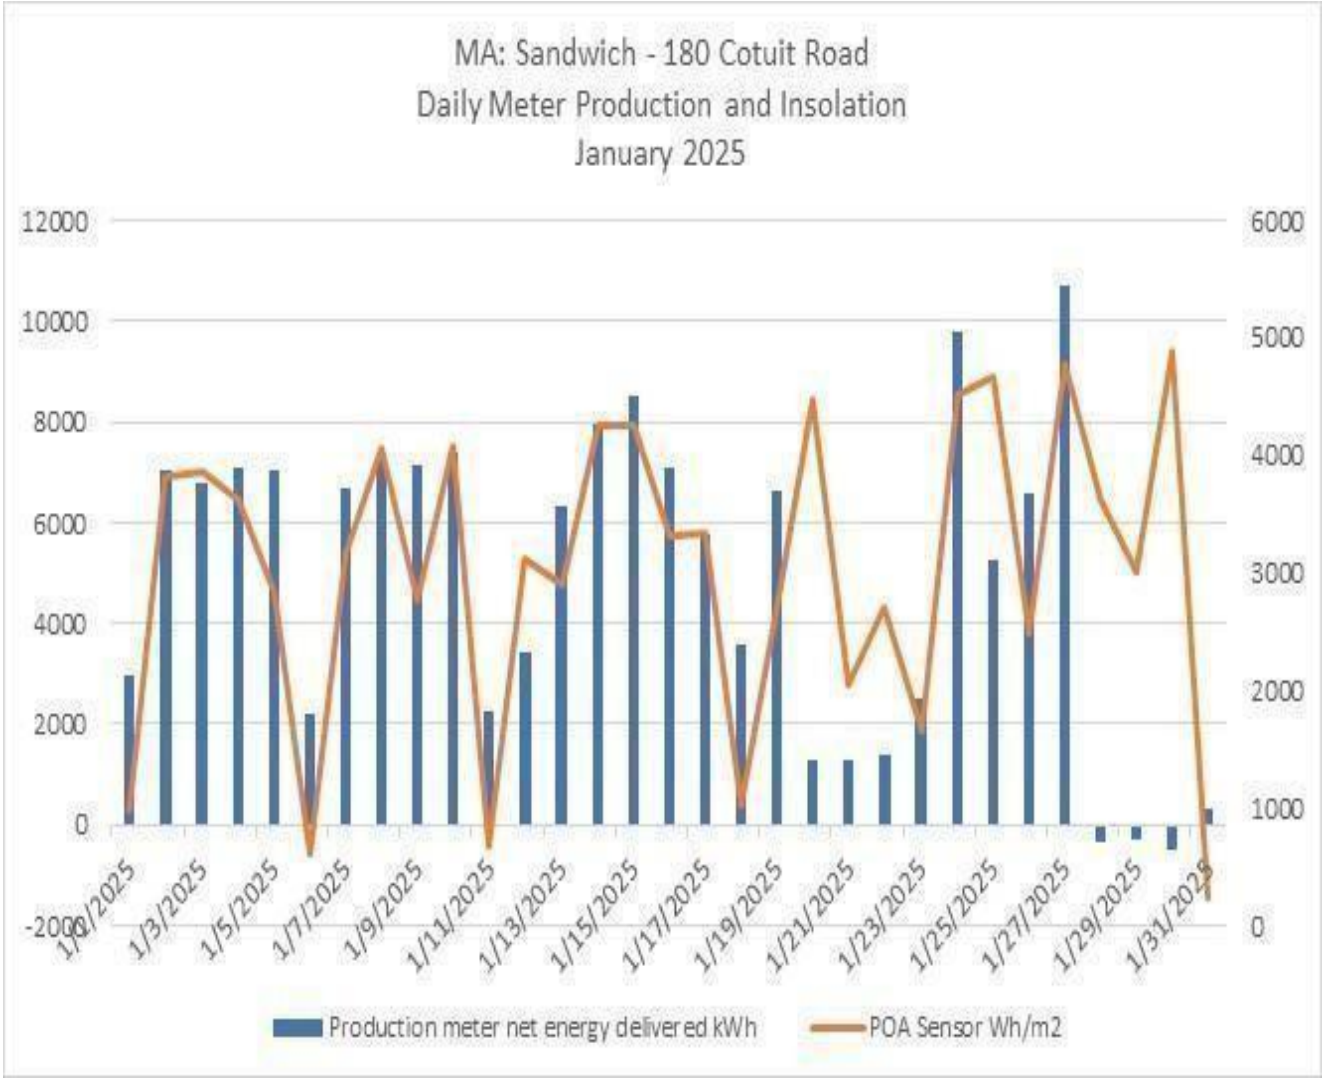
MA: Sandwich - 180 Cotuit Road January Production

1. The site was offline from 01/28 due to an inverter fault. Later, Power Electronics brought the site back online on 01/31 by pulling the logs. SR096048

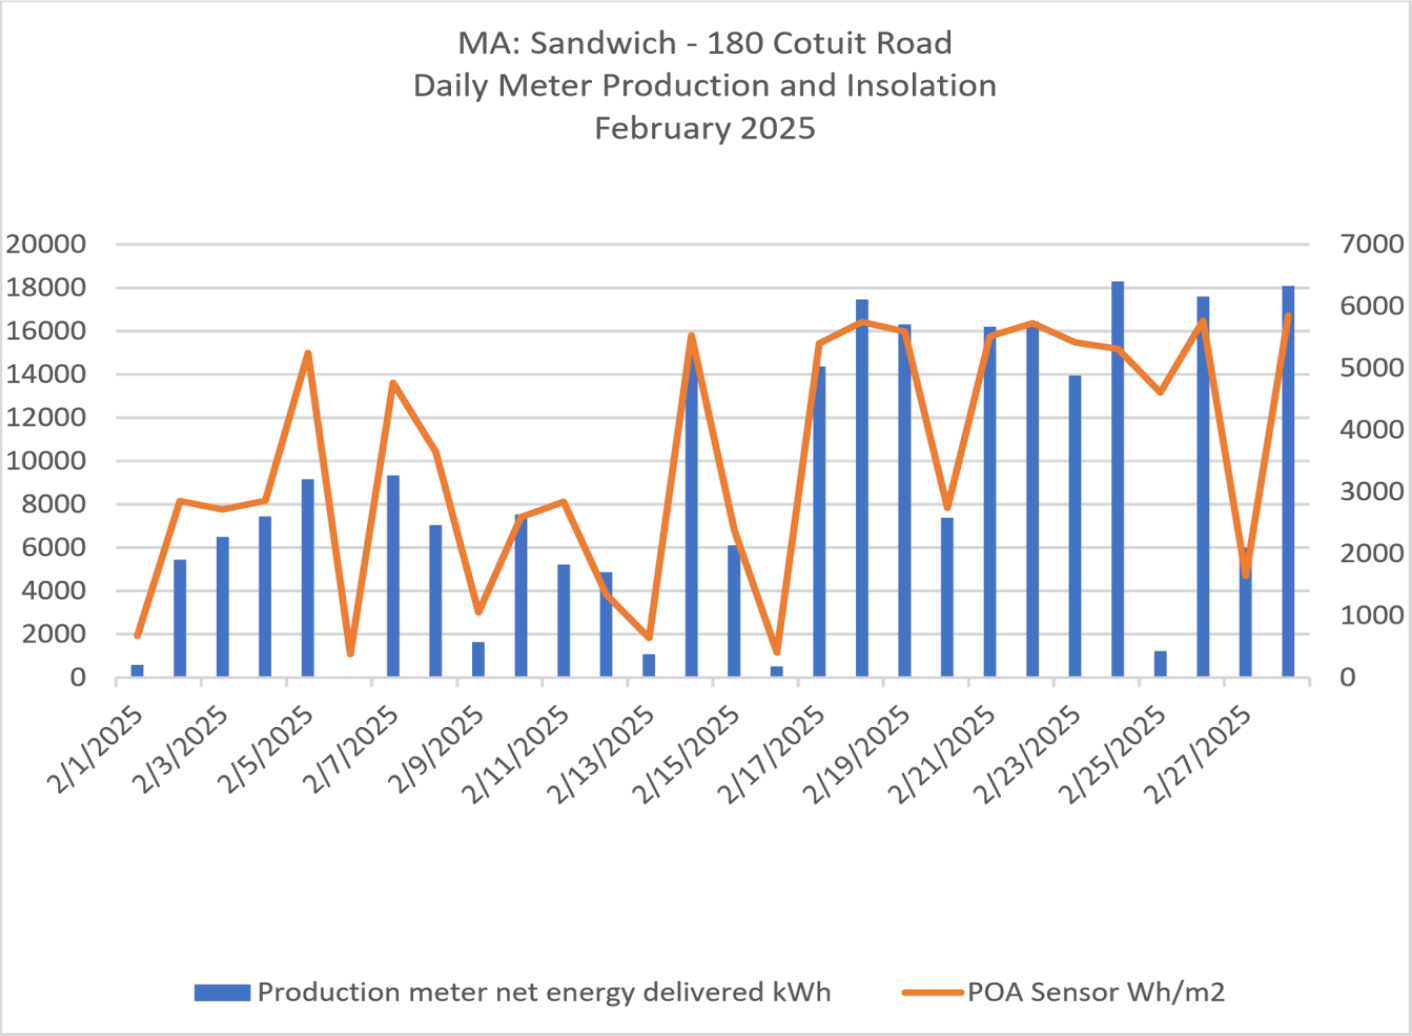
MA: Sandwich - 180 Cotuit Road February Production

1. On 02/18/25, the technician found CB 15 strings 19 & 20 carrying 4 amps. Further investigation is needed to check for a ground fault or module issue. SR096077, SR097256.
2. The site was offline from 6:30 to 14:15 on 02/25/25 due to an inverter fault. The PE technician enabled all modules, put them in start mode, and brought the site back online. SR097746.

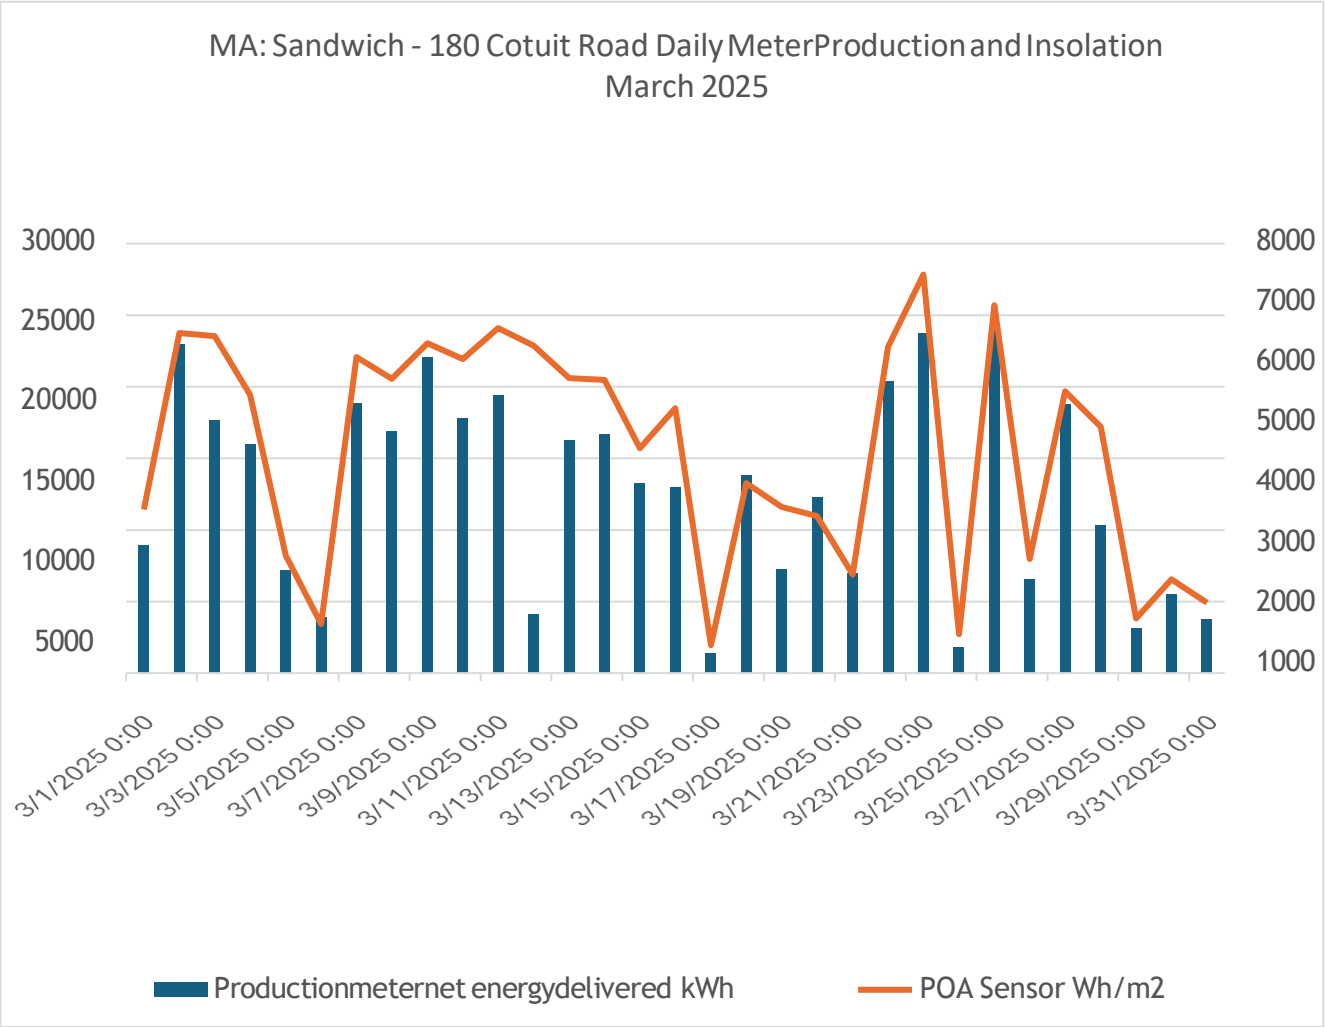
MA: Sandwich - 180 Cotuit Road March Production

1. The site was taken offline from 08:30 to 14:45 on 03/12 due to an HVAC technician being on-site to check the site camera. SR098449
2. Power Electronics on site to perform retrospective ventilation. The Inverter will be taken offline from 11:30 to 13:15 on 03/28. SR099079
3. On 02/18/25, the technician found CB 15 strings 19 & 20 carrying 4 amps. Further investigation is needed to check for a ground fault or module issue. SR096077, SR097256, SR099474

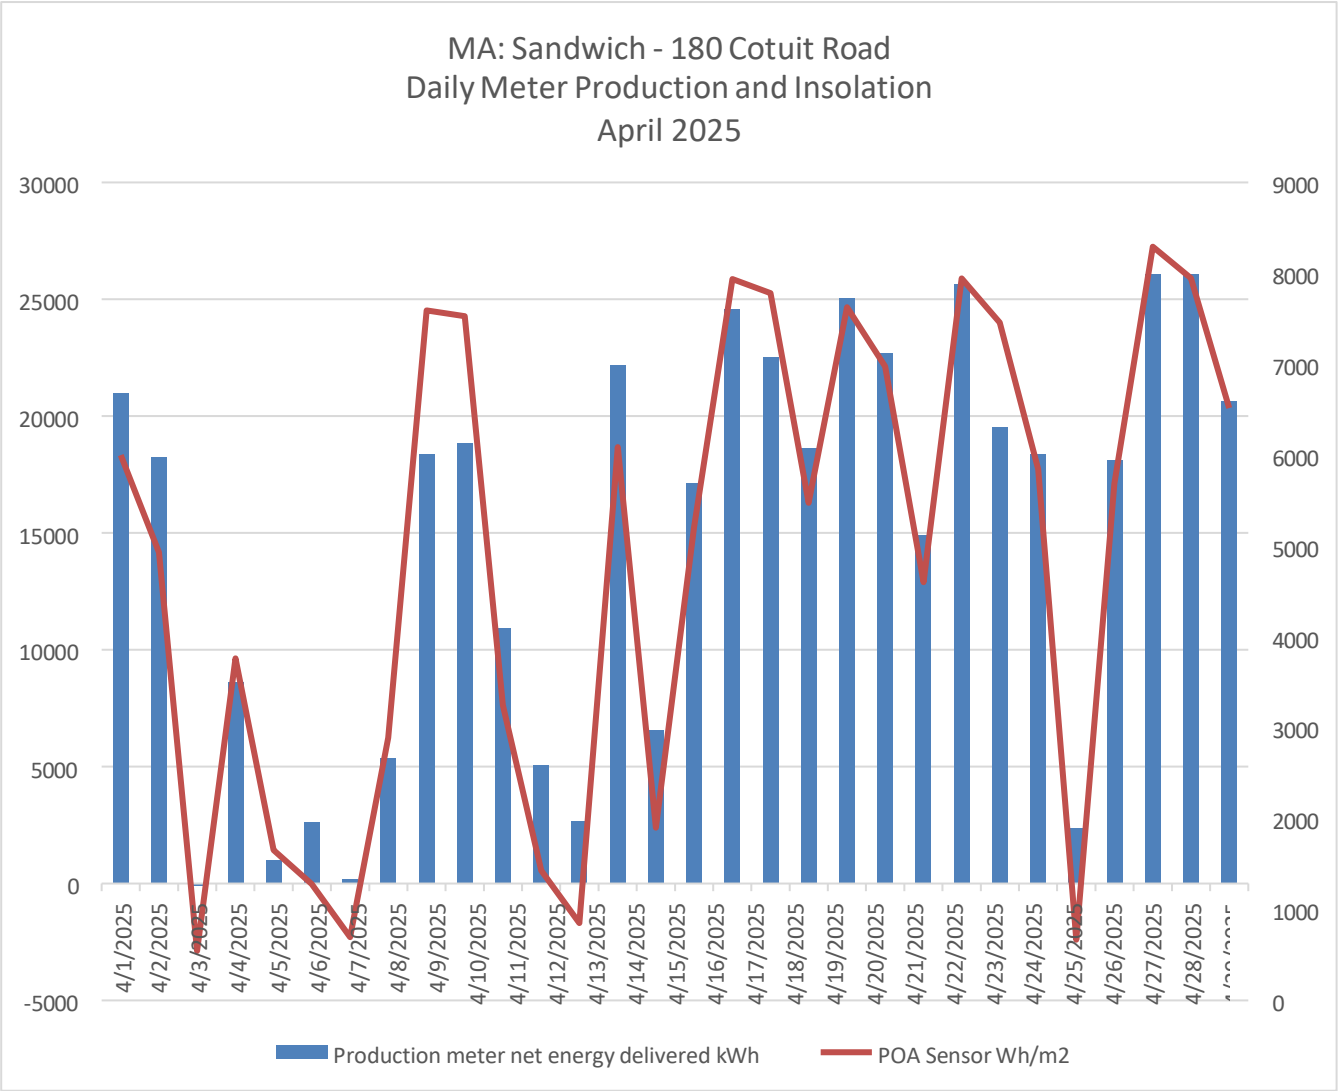
MA: Sandwich - 180 Cotuit Road April Production

1. The site was de-energized from 12:45 PM to 2:45 PM on 04/02 while PE was onsite to inspect inverter settings. **SR099316**
2. On 04/03 and 04/05, the inverter failed to start production but was brought back online after a technician performed a remote reset**. SR099371**

3. On 04/04, a technician checked in to investigate DC strings 19 and 20 in CB15 and discovered reverse polarity in jumper connections to a Northern Row. The jumpers were rewired with correct polarity, and final testing confirmed both strings were producing normally. **SR097256, SR099474 & SR099475.**

4. On 04/11/25, discrepancies were noted between meter and inverter readings, with the meter peaking at 3 MW while the inverter maxed at 2.2 MW. AE responded on 04/15/25, suggesting potential bin size logging or data latency issues and implemented logger setting changes. The issue now appears resolved, though the root cause remains unknown. PowerTrack still needs BESS data configured for accurate PV monitoring. **SR099700**

5. On 04/18, the inverter began production at 10:00 AM after experiencing a Softcharge DC5 fault. **SR099978**

6. Inverter tripped offline at 17:00 on 04/24 due to BW BF. PS. 151 fault and back online at 10Am on 04/25 after PE technician initiated the wake-up and soft charge process. **SR10036**

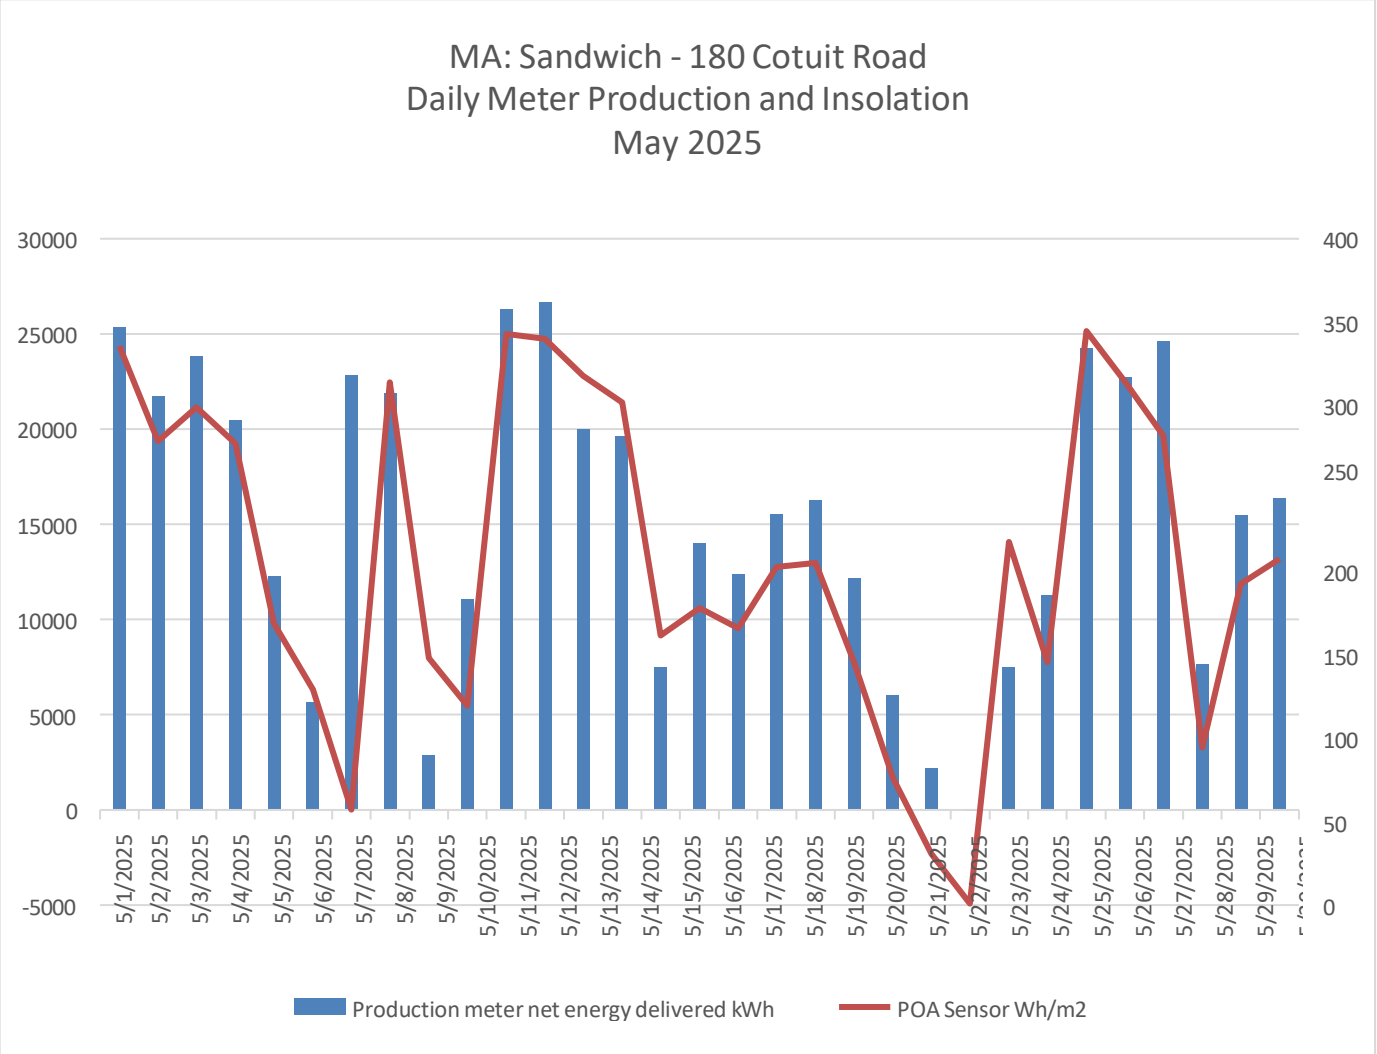
MA: Sandwich - 180 Cotuit Road May Production

1. The site was offline from 09:15 to 13:15 on 05/09. On 05/09, a technician reached out to Power Electronics and worked remotely with Pedro. Pedro was able to make changes to the parameters and get the inverter online. **SR101226**

2. Inverter 1 was offline from 18:15 on 05/13 to 09:45 on 05/14. Inverter was back online after technician with Remote support cleared fault and restarted inverter. **SR101418**

3. The site was offline from 10:30 to 11:45 on 05/15 as Power electronics technicians were on site to replace the main control board in an inverter 1 module. **SR101464**

4. Site was offline from 06:15 on 05/23 to 11:00 on 05/24. On 05/24, a technician was onsite and re-energized the site. The site was back online at 11:00 on 05/24. **SR101873**

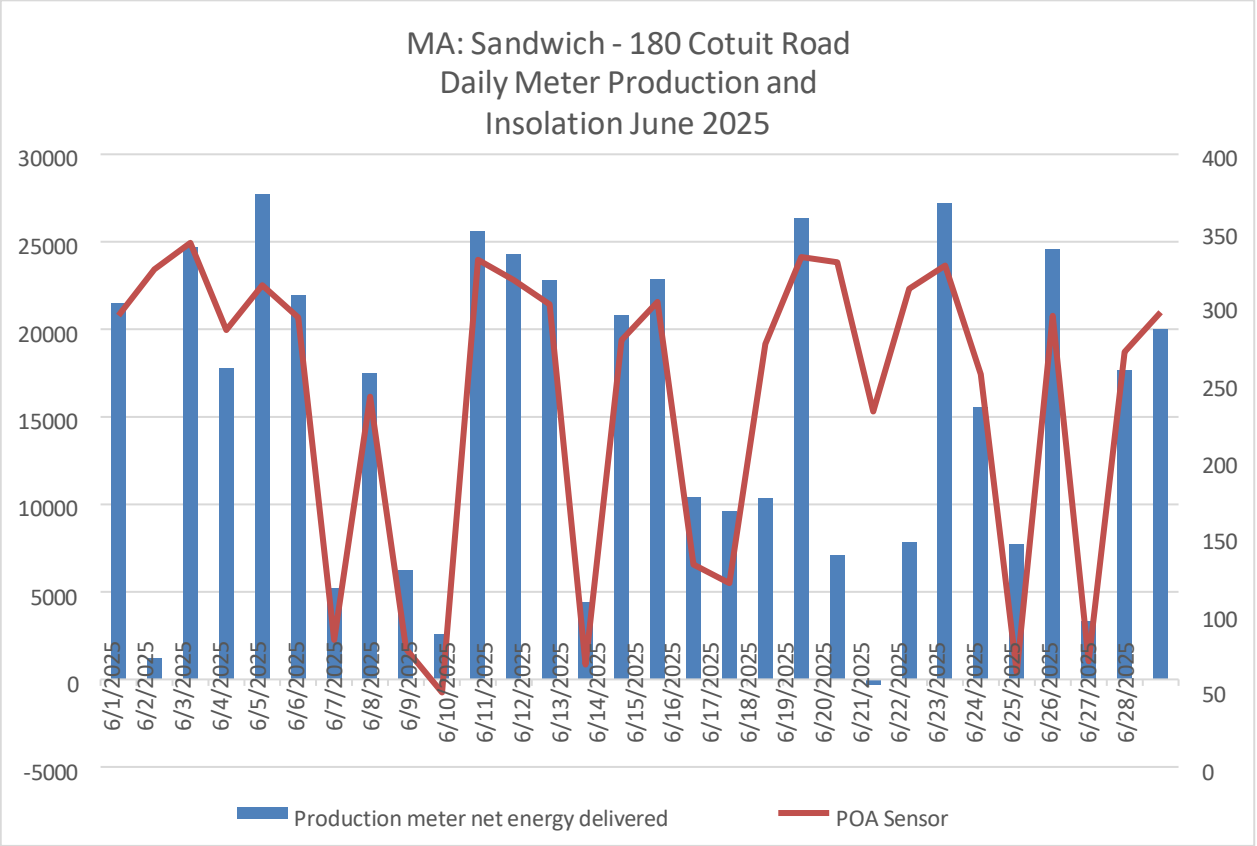
MA: Sandwich - 180 Cotuit Road June Production

1. Site tripped offline on 06/02 at 08:45 and back online on 06/03 at 08:00. **SR102295**
2. Inverter tripped offline at 18:00 on 06/03 and back online on 06/04 at 05:30. **SR102429**
3. The site was offline from 09:30 to 13:45 on 06/19. It was offline again from 08:45 to 11:45 on 06/21 and then went offline once more at 15:15 on the same day. It came back online on 06/23 at 09:00 but experienced another outage from 11:45 to 15:45 on the same day. **SR103172**

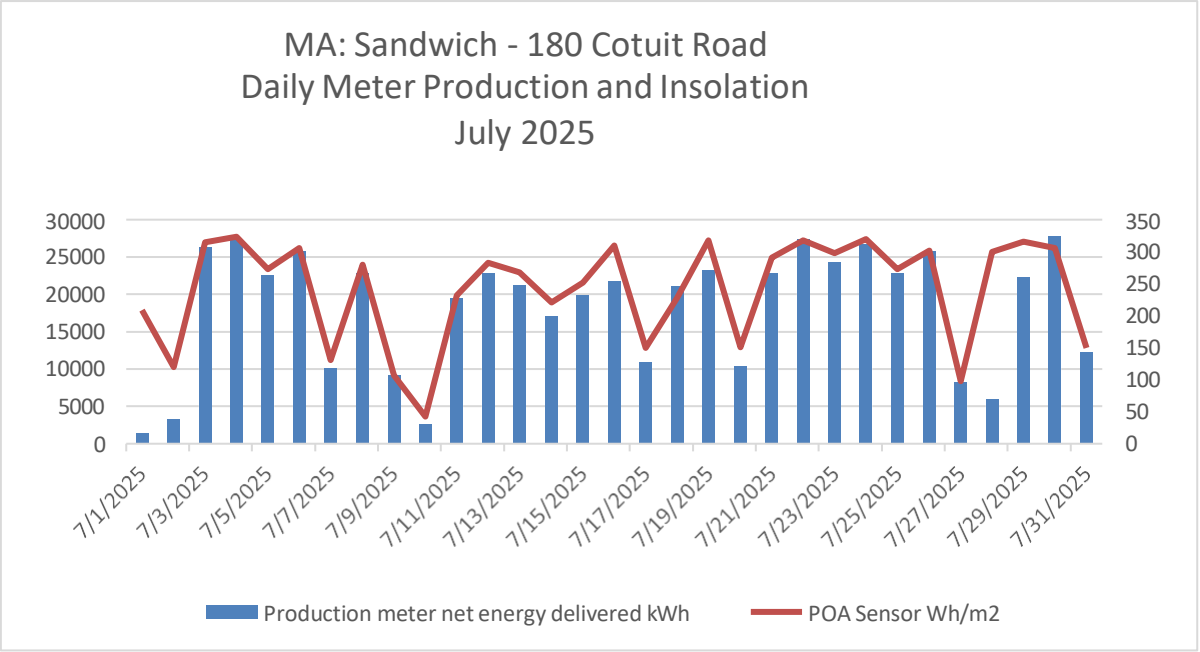
MA: Sandwich - 180 Cotuit Road July Production

1. Inverter tripped offline 10:30 on 07/01 and it came back online at 14:45 on 07/02. PM9454
2. Site tripped offline from 10:30 to 16:00 on 07/28. SR105163

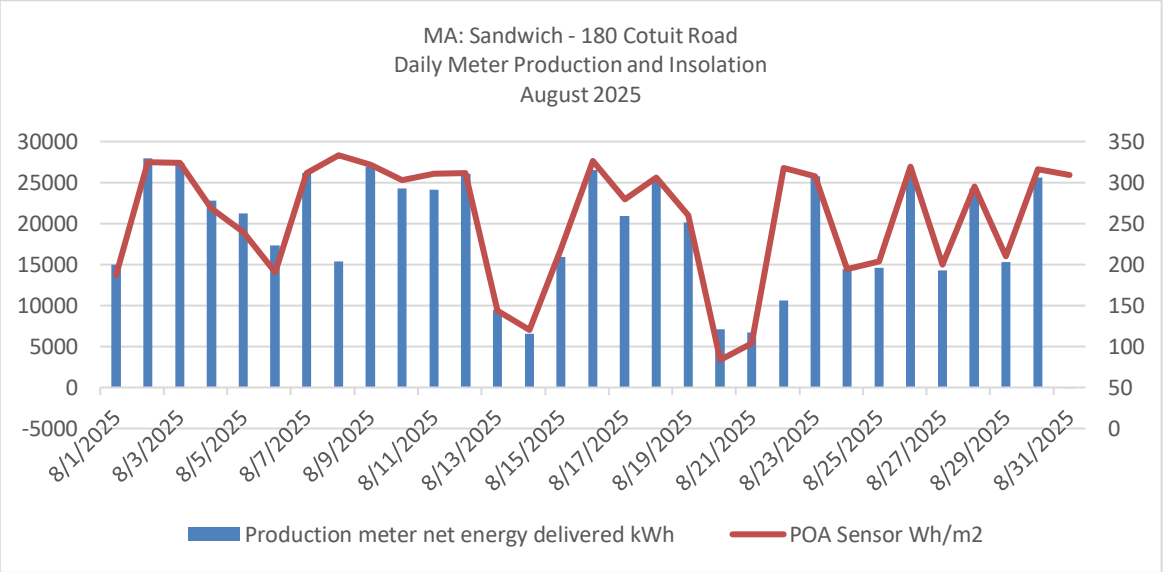
MA: Sandwich - 180 Cotuit Road August Production

1.Site was offline from 04:30 to 11:45 on 08/08. SR105884

2.Inverter offline from 07:00 to 07:34 on 08/13. SR106182

3.Inverter started late for production at 13:00 on 08/22. SR106742

4. Inverter has dropped from over 2MW to grid/Bess to 0 twice in a day on 08/29 and again Inverter tripped offline at 07:45 on 08/31. SR107206
