MA: Sandwich - 180 Cotuit Road Performance report

Q3 2025

Name: Sandwich – 180 Cotuit
Road Location: Sandwich, MA
Size AC: 3111 kW
Size DC: 4357 kWp
Period: July 1, 2025 – July 31, 2025
Report Date: 08/10/25

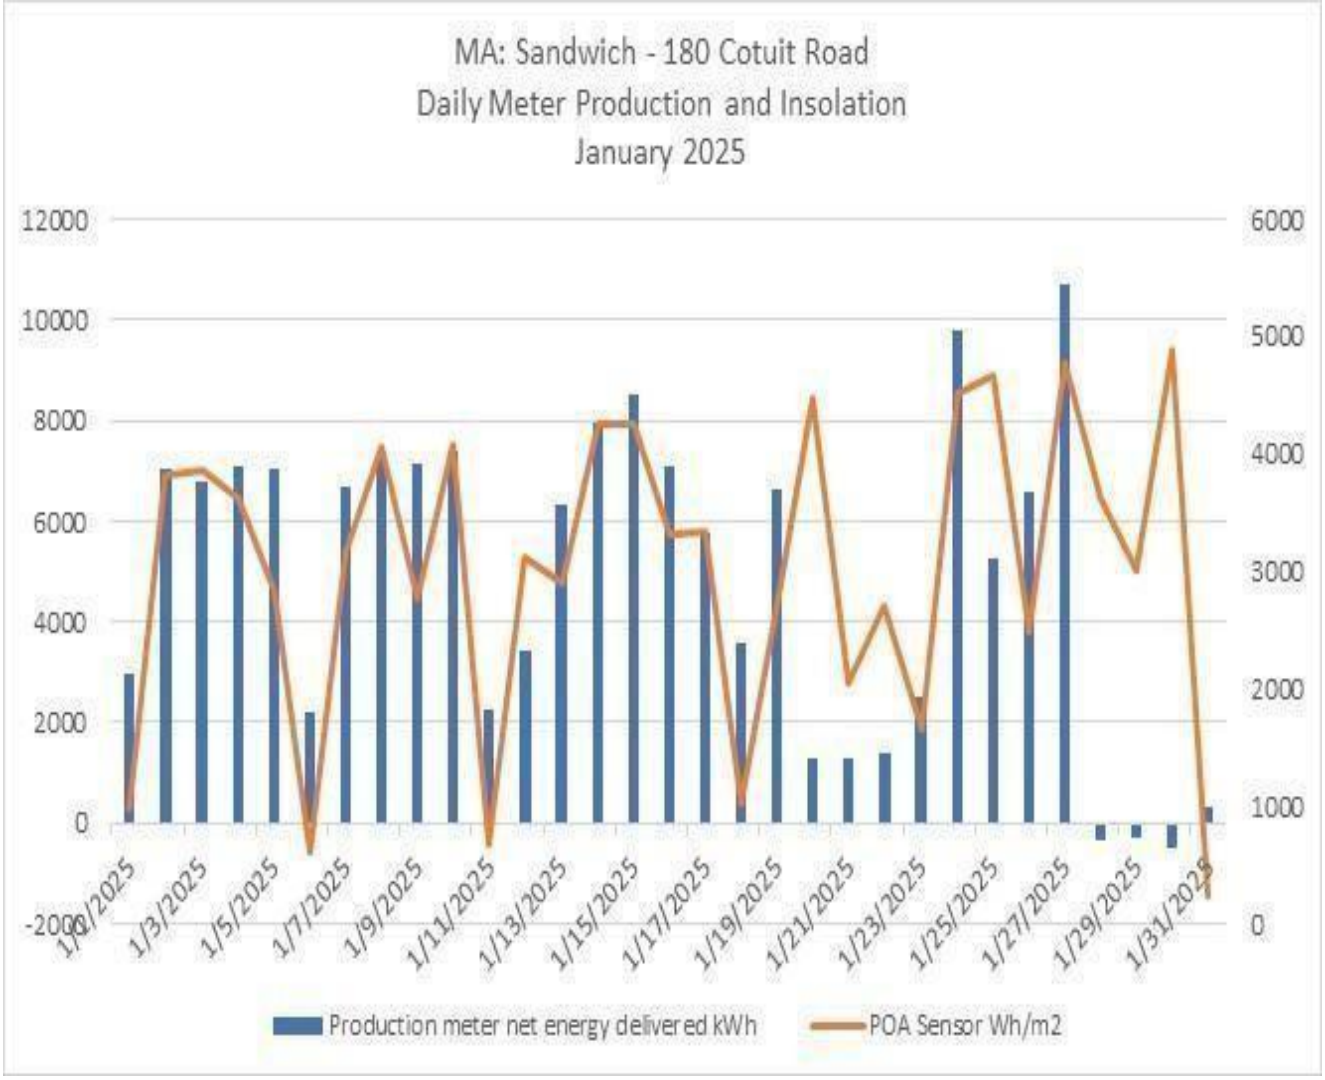
MA: Sandwich - 180 Cotuit Road January Production

1. The site was offline from 01/28 due to an inverter fault. Later, Power Electronics brought the site back online on 01/31 by pulling the logs. SR096048

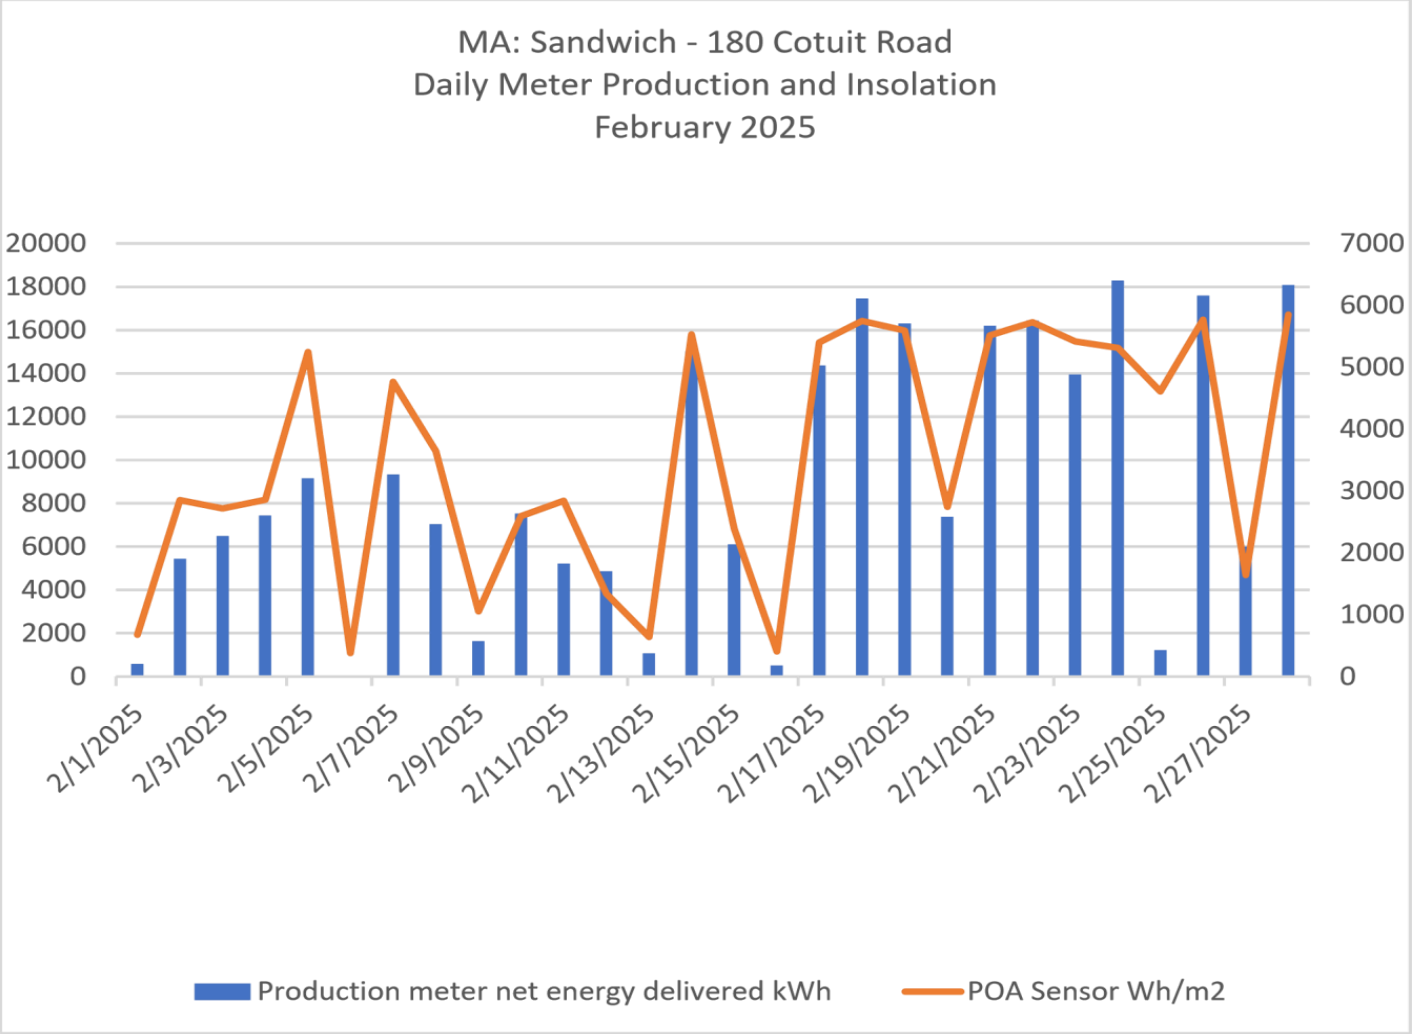
MA: Sandwich - 180 Cotuit Road February Production

1. On 02/18/25, the technician found CB 15 strings 19 & 20 carrying 4 amps. Further investigation is needed to check for a ground fault or module issue. SR096077, SR097256.
2. The site was offline from 6:30 to 14:15 on 02/25/25 due to an inverter fault. The PE technician enabled all modules, put them in start mode, and brought the site back online. SR097746.

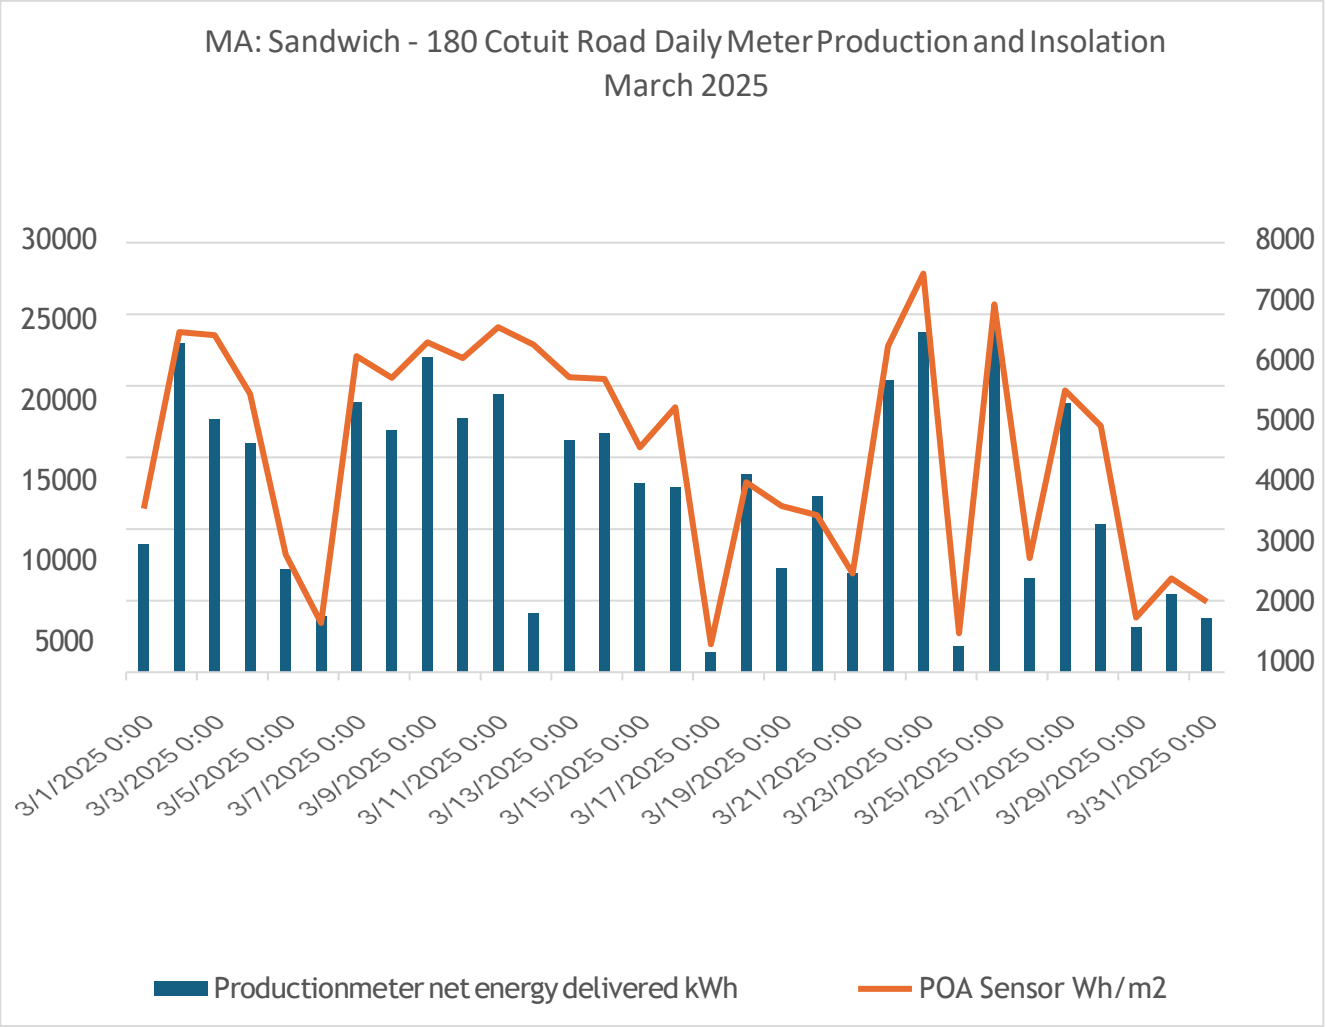
MA: Sandwich - 180 Cotuit Road March Production

1. The site was taken offline from 08:30 to 14:45 on 03/12 due to an HVAC technician being on-site to check the site camera. SR098449
2. Power Electronics on site to perform retrospective ventilation. The Inverter will be taken offline from 11:30 to 13:15 on 03/28. SR099079
3. On 02/18/25, the technician found CB 15 strings 19 & 20 carrying 4 amps. Further investigation is needed to check for a ground fault or module issue. SR096077, SR097256, SR099474

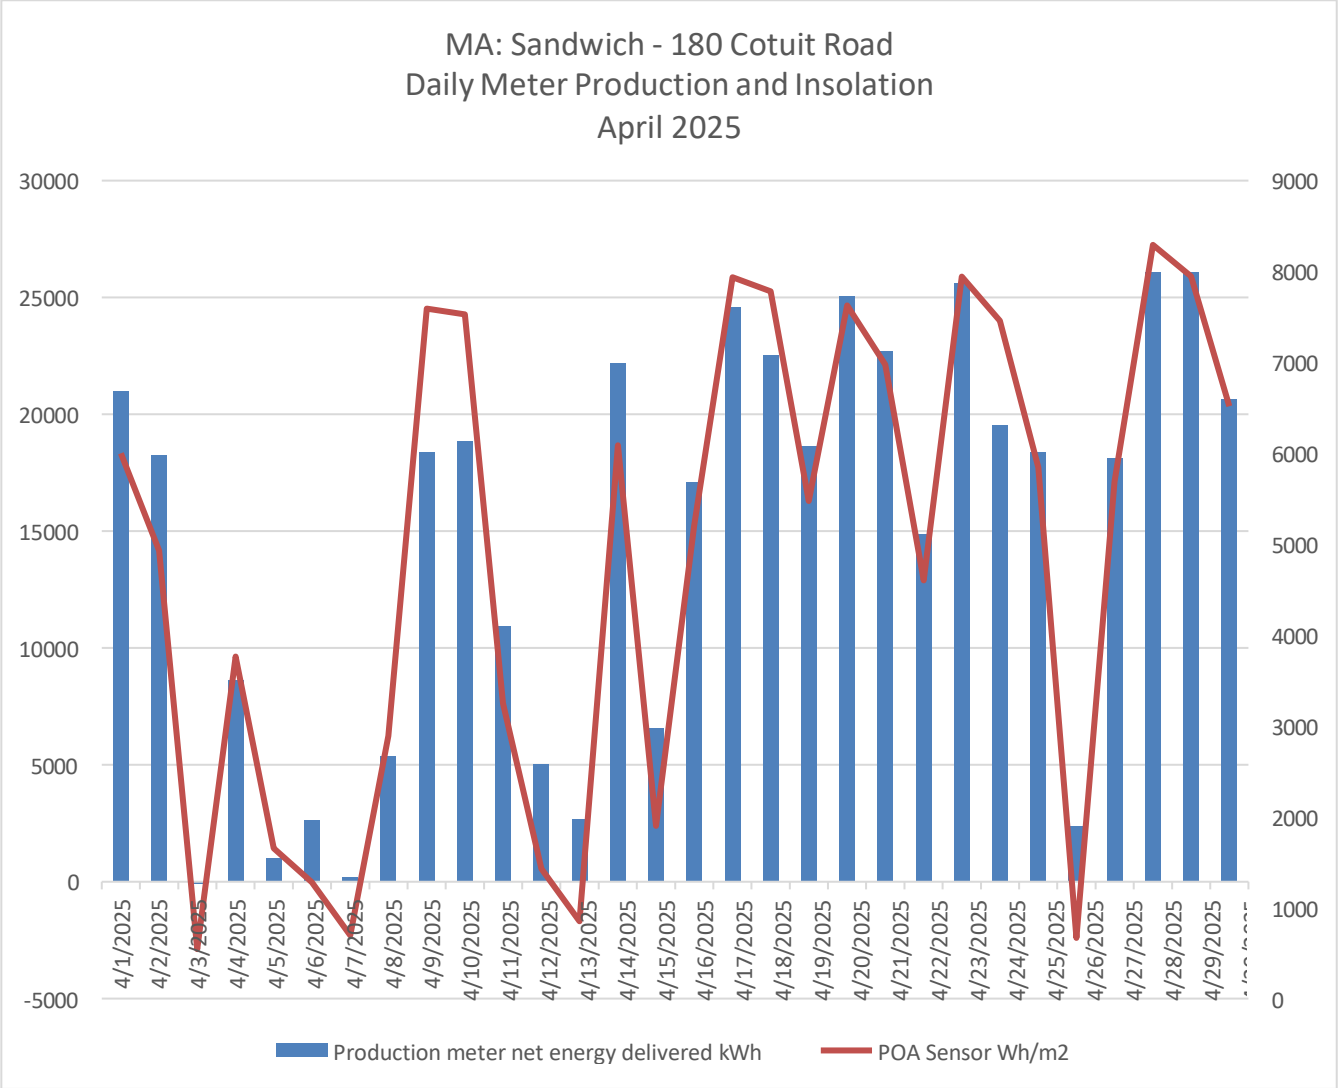
MA: Sandwich - 180 Cotuit Road April Production

1. The site was de-energized from 12:45 PM to 2:45 PM on 04/02 while PE was onsite to inspect inverter settings. **SR099316**
2. On 04/03 and 04/05, the inverter failed to start production but was brought back online after a technician performed a remote reset**. SR099371**

3. On 04/04, a technician checked in to investigate DC strings 19 and 20 in CB15 and discovered reverse polarity in jumper connections to a Northern Row. The jumpers were rewired with correct polarity, and final testing confirmed both strings were producing normally. **SR097256, SR099474 & SR099475.**

4. On 04/11/25, discrepancies were noted between meter and inverter readings, with the meter peaking at 3 MW while the inverter maxed at 2.2 MW. AE responded on 04/15/25, suggesting potential bin size logging or data latency issues and implemented logger setting changes. The issue now appears resolved, though the root cause remains unknown. PowerTrack still needs BESS data configured for accurate PV monitoring. **SR099700**

5. On 04/18, the inverter began production at 10:00 AM after experiencing a Softcharge DC5 fault. **SR099978**

6. Inverter tripped offline at 17:00 on 04/24 due to BW BF. PS. 151 fault and back online at 10Am on 04/25 after PE technician initiated the wake-up and soft charge process. **SR10036**

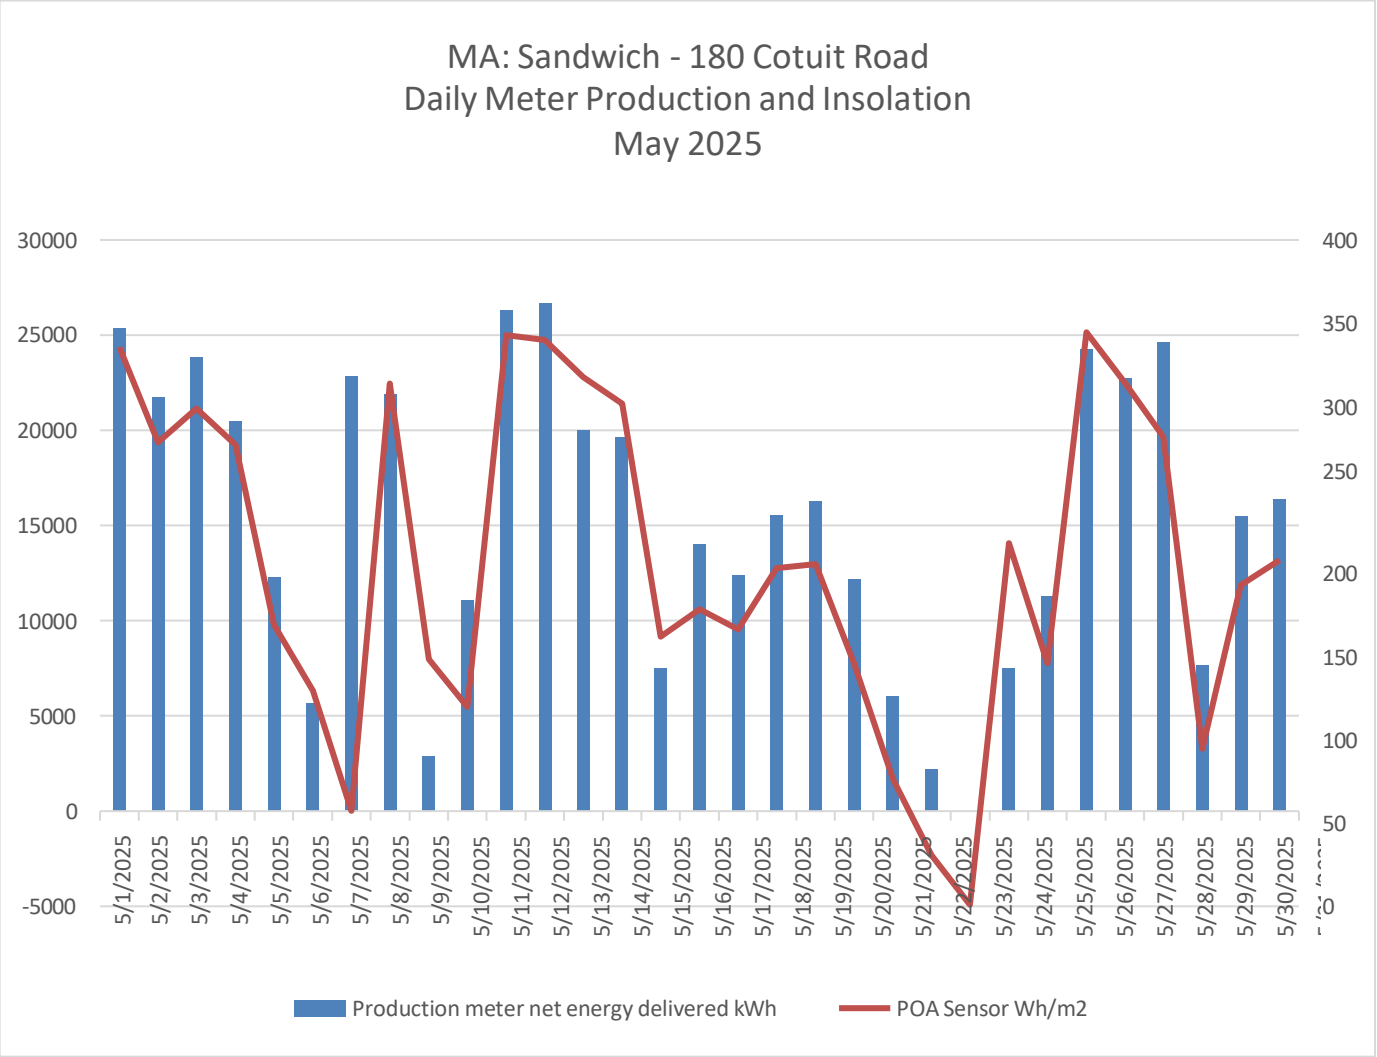
MA: Sandwich - 180 Cotuit Road May Production

1. The site was offline from 09:15 to 13:15 on 05/09. On 05/09, a technician reached out to Power Electronics and worked remotely with Pedro. Pedro was able to make changes to the parameters and get the inverter online. **SR101226**

2. Inverter 1 was offline from 18:15 on 05/13 to 09:45 on 05/14. Inverter was back online after technician with Remote support cleared fault and restarted inverter. **SR101418**

3. The site was offline from 10:30 to 11:45 on 05/15 as Power electronics technicians were on site to replace the main control board in an inverter 1 module. **SR101464**

4. Site was offline from 06:15 on 05/23 to 11:00 on 05/24. On 05/24, a technician was onsite and re-energized the site. The site was back online at 11:00 on 05/24. **SR101873**

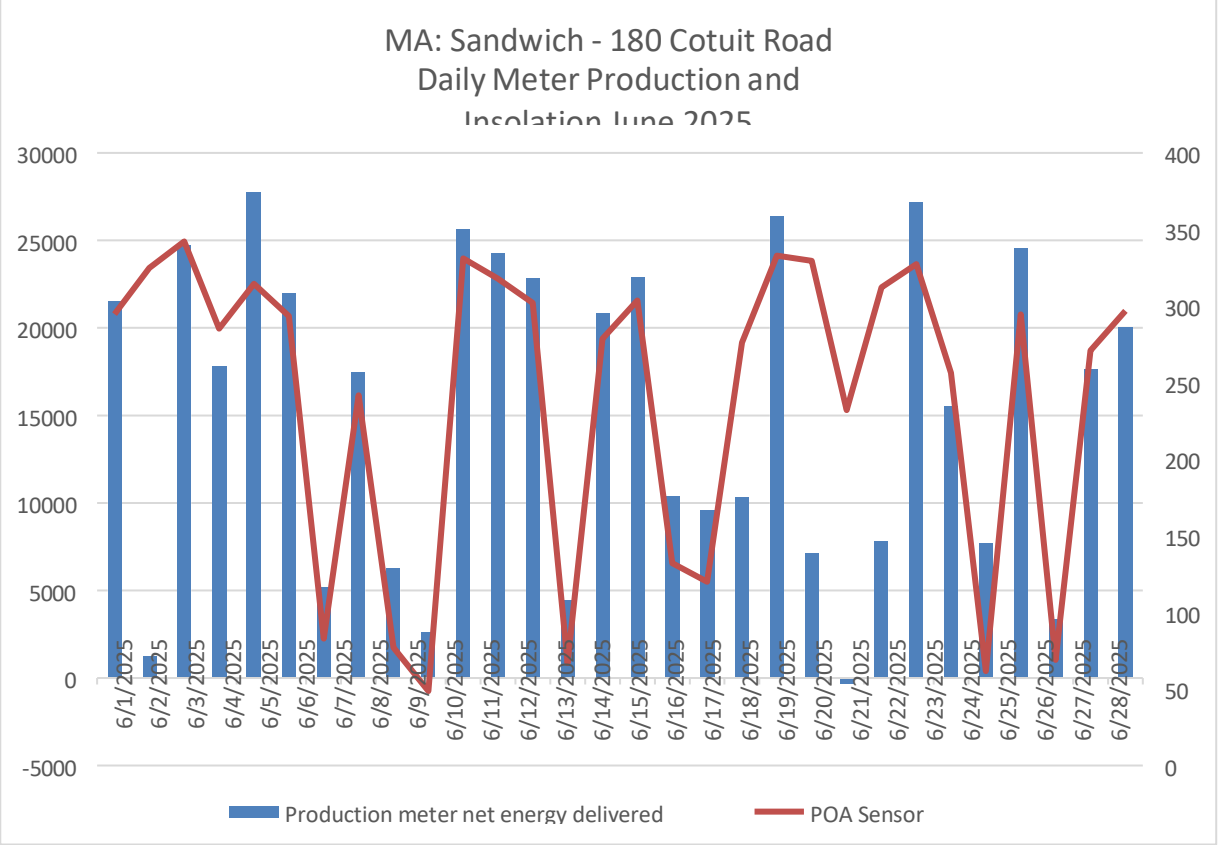
MA: Sandwich - 180 Cotuit Road June Production

1. Site tripped offline on 06/02 at 08:45 and back online on 06/03 at 08:00. **SR102295**
2. Inverter tripped offline at 18:00 on 06/03 and back online on 06/04 at 05:30. **SR102429**
3. The site was offline from 09:30 to 13:45 on 06/19. It was offline again from 08:45 to 11:45 on 06/21 and then went offline once more at 15:15 on the same day. It came back online on 06/23 at 09:00 but experienced another outage from 11:45 to 15:45 on the same day. **SR103172**

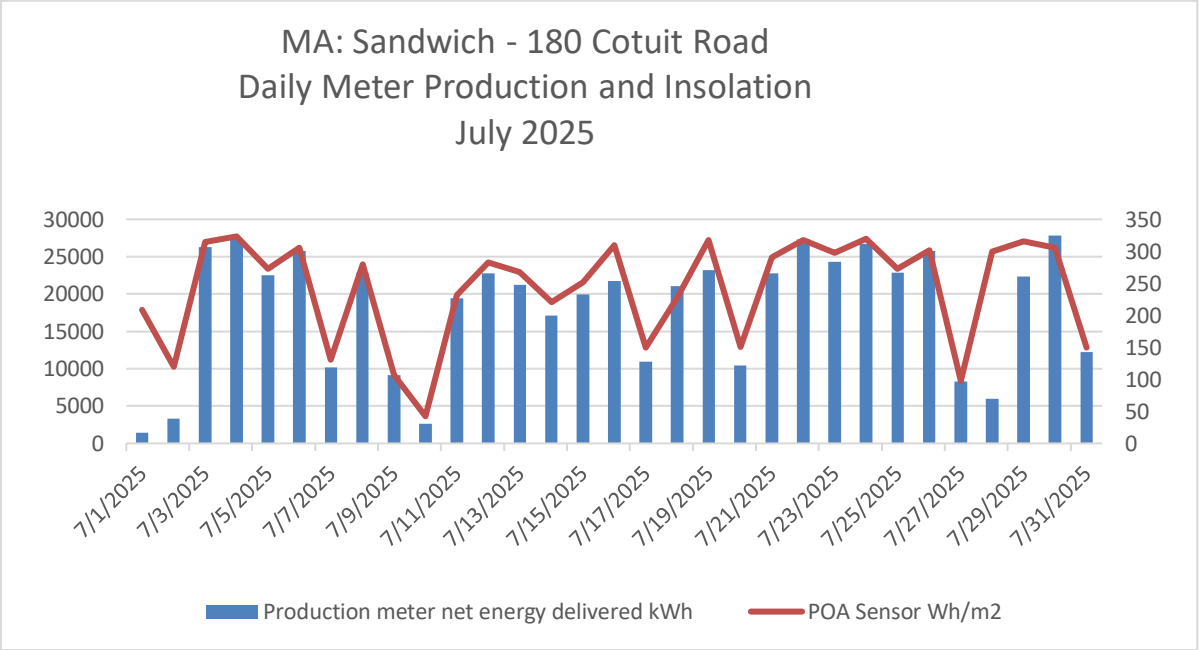
MA: Sandwich - 180 Cotuit Road July Production

1.Inverter tripped offline 10:30 on 07/01 and it came back online at 14:45 on 07/02. PM9454
2.Site tripped offline from 10:30 to 16:00 on 07/28. SR105163
