MA: Sandwich - 180 Cotuit Road Performance report

Q2 2025

Name: Sandwich - 180 Cotuit Road
Location: Sandwich, MA
Size AC: 3111 kW
Size DC: 4357 kWp
Period: June 1, 2025 – June 30, 2025
Report Date: 07/09/25

Prepared by:
Ameresco
117 Flanders Road, Unit 100
Westborough, MA 01581

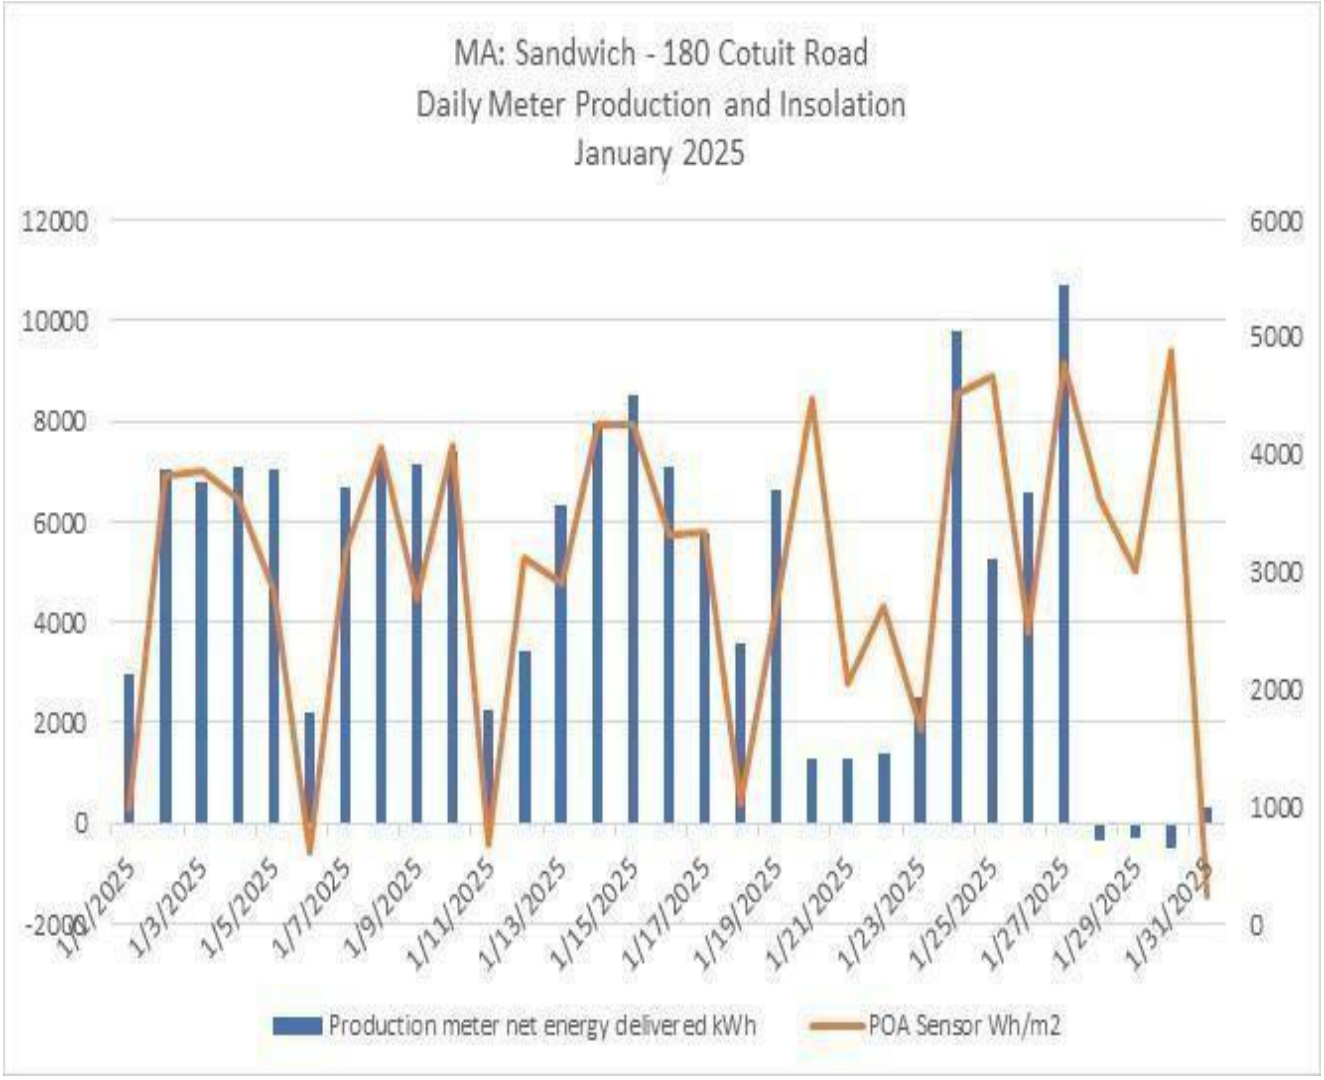
MA: Sandwich - 180 Cotuit Road January Production

1. The site was ofline from 01/28 due to an inverter fault. Later, Power Electronics brought the site back online on 01/31 by pulling the logs. SR096048

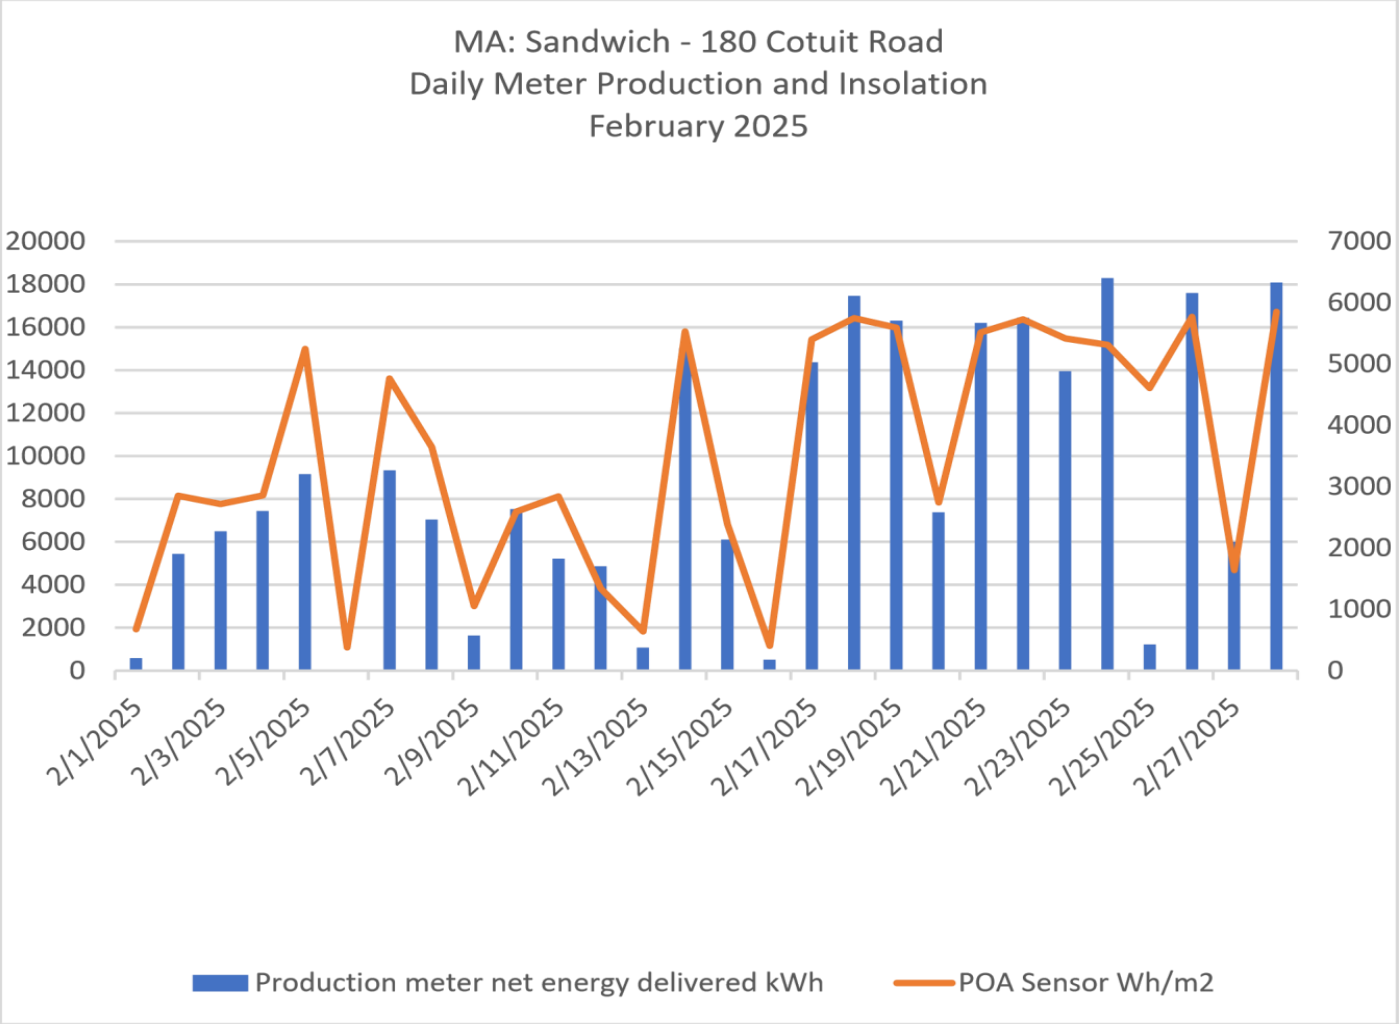
MA: Sandwich - 180 Cotuit Road February Production

1. On 02/18/25, the technician found CB 15 strings 19 & 20 carrying 4 amps. Further investigation is needed to check for a ground fault or module issue. SR096077, SR097256.
2. The site was offline from 6:30 to 14:15 on 02/25/25 due to an inverter fault. The PE technician enabled all modules, put them in start mode, and brought the site back online. SR097746.

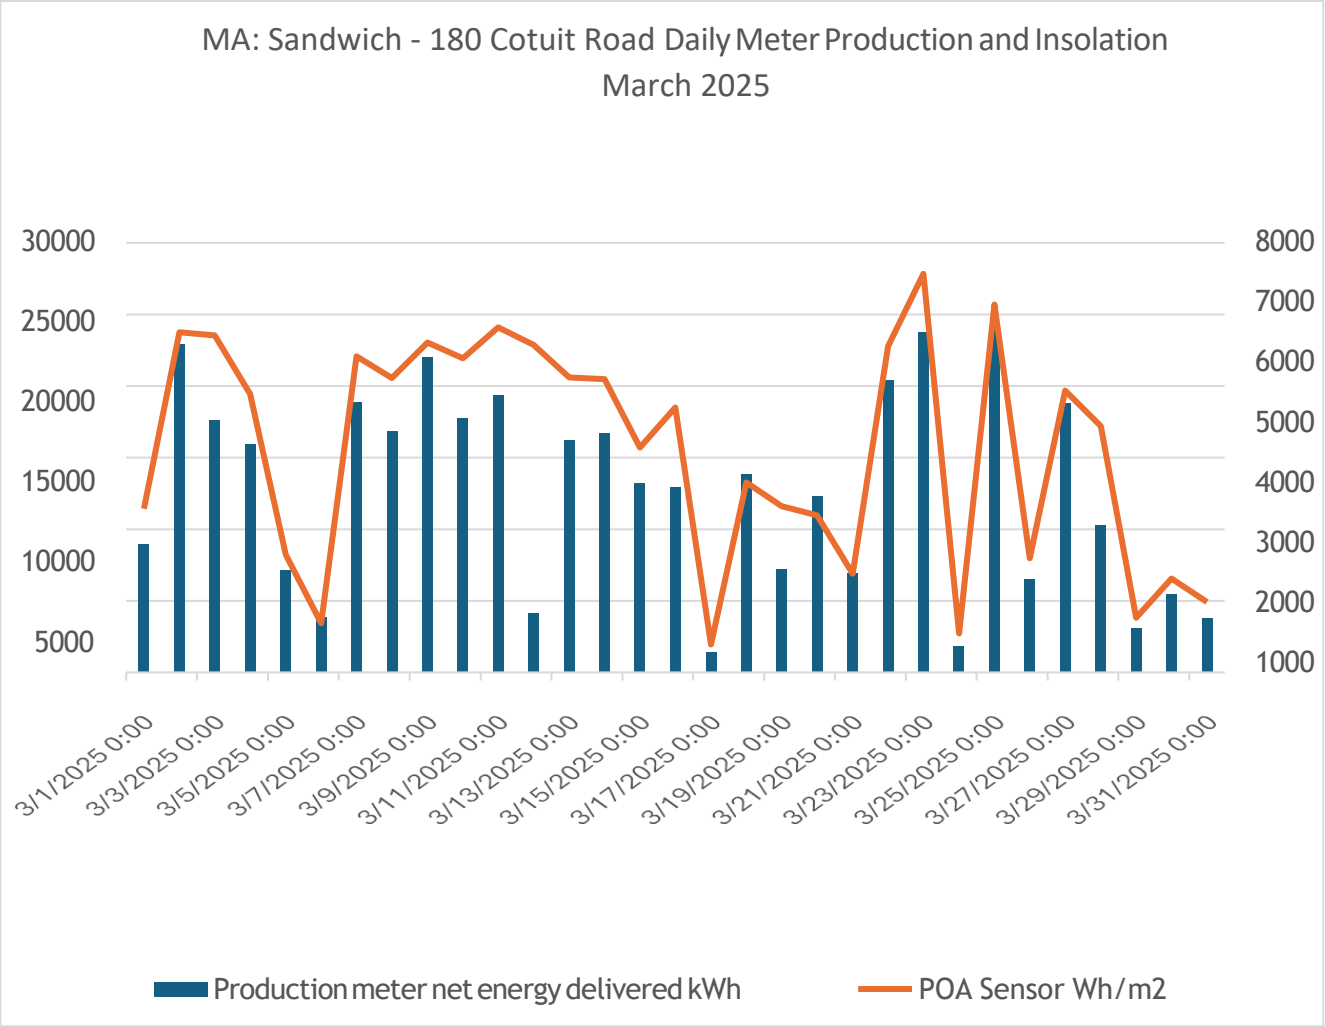
MA: Sandwich - 180 Cotuit Road March Production

1. The site was taken offline from 08:30 to 14:45 on 03/12 due to an HVAC technician being on-site to check the site camera. SR098449
2. Power Electronics on site to perform retrospective ventilation. The Inverter will be taken offline from 11:30 to 13:15 on 03/28. SR099079
3. On 02/18/25, the technician found CB 15 strings 19 & 20 carrying 4 amps. Further investigation is needed to check for a ground fault or module issue. SR096077, SR097256, SR099474

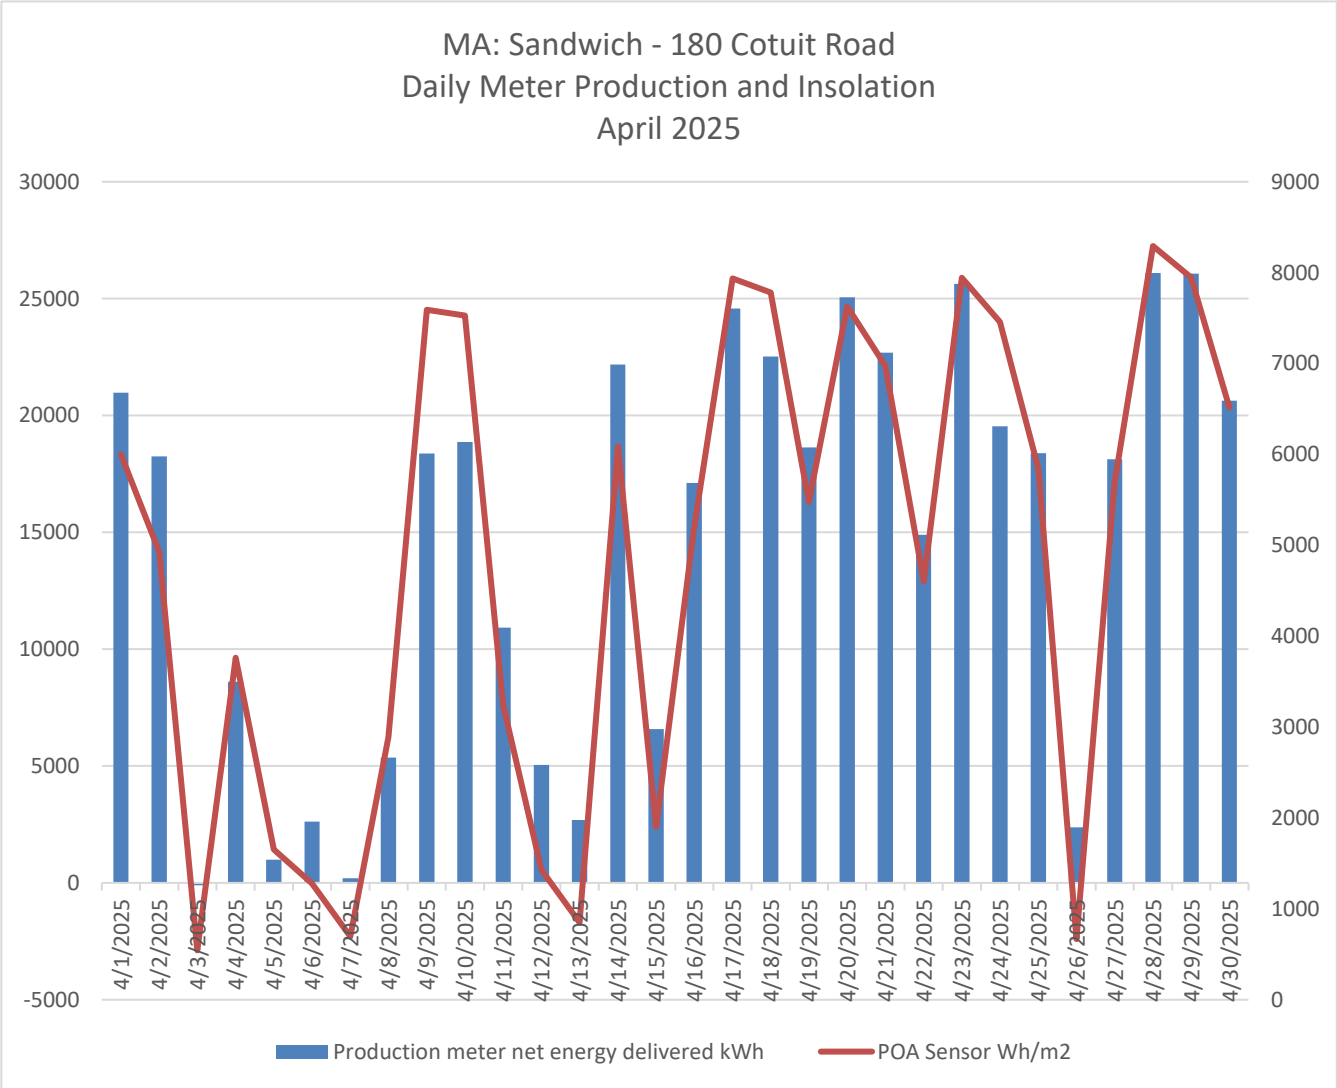
MA: Sandwich - 180 Cotuit Road April Production

1. The site was de-energized from 12:45 PM to 2:45 PM on 04/02 while PE was onsite to inspect inverter settings. **SR099316**
2. On 04/03 and 04/05, the inverter failed to start production but was brought back online after a technician performed a remote reset**. SR099371**

3. On 04/04, a technician checked in to investigate DC strings 19 and 20 in CB15 and discovered reverse polarity in jumper connections to a Northern Row. The jumpers were rewired with correct polarity, and final testing confirmed both strings were producing normally. **SR097256, SR099474 & SR099475.**

4. On 04/11/25, discrepancies were noted between meter and inverter readings, with the meter peaking at 3 MW while the inverter maxed at 2.2 MW. AE responded on 04/15/25, suggesting potential bin size logging or data latency issues and implemented logger setting changes. The issue now appears resolved, though the root cause remains unknown. PowerTrack still needs BESS data configured for accurate PV monitoring. **SR099700**

5. On 04/18, the inverter began production at 10:00 AM after experiencing a Softcharge DC5 fault. **SR099978**

6. Inverter tripped offline at 17:00 on 04/24 due to BW BF. PS. 151 fault and back online at 10Am on 04/25 after PE technician initiated the wake-up and soft charge process. **SR10036**

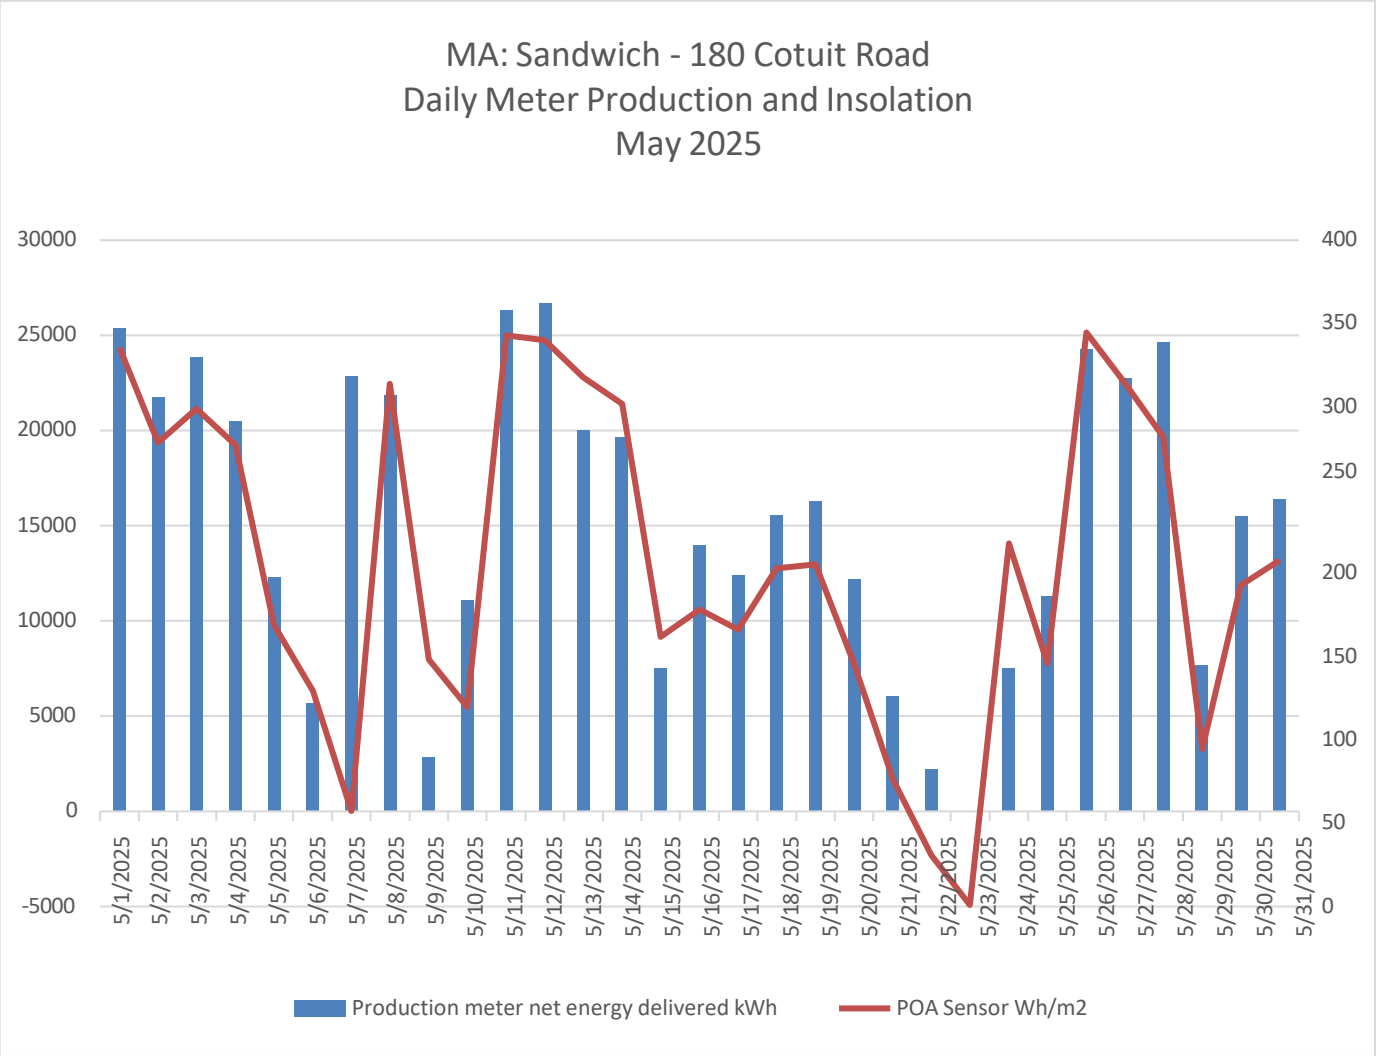
MA: Sandwich - 180 Cotuit Road May Production

1. The site was offline from 09:15 to 13:15 on 05/09. On 05/09, a technician reached out to Power Electronics and worked remotely with Pedro. Pedro was able to make changes to the parameters and get the inverter online. **SR101226**

2. Inverter 1 was offline from 18:15 on 05/13 to 09:45 on 05/14. Inverter was back online after technician with Remote support cleared fault and restarted inverter. **SR101418**

3. The site was offline from 10:30 to 11:45 on 05/15 as Power electronics technicians were on site to replace the main control board in an inverter 1 module. **SR101464**

4. Site was offline from 06:15 on 05/23 to 11:00 on 05/24. On 05/24, a technician was onsite and re-energized the site. The site was back online at 11:00 on 05/24. **SR101873**

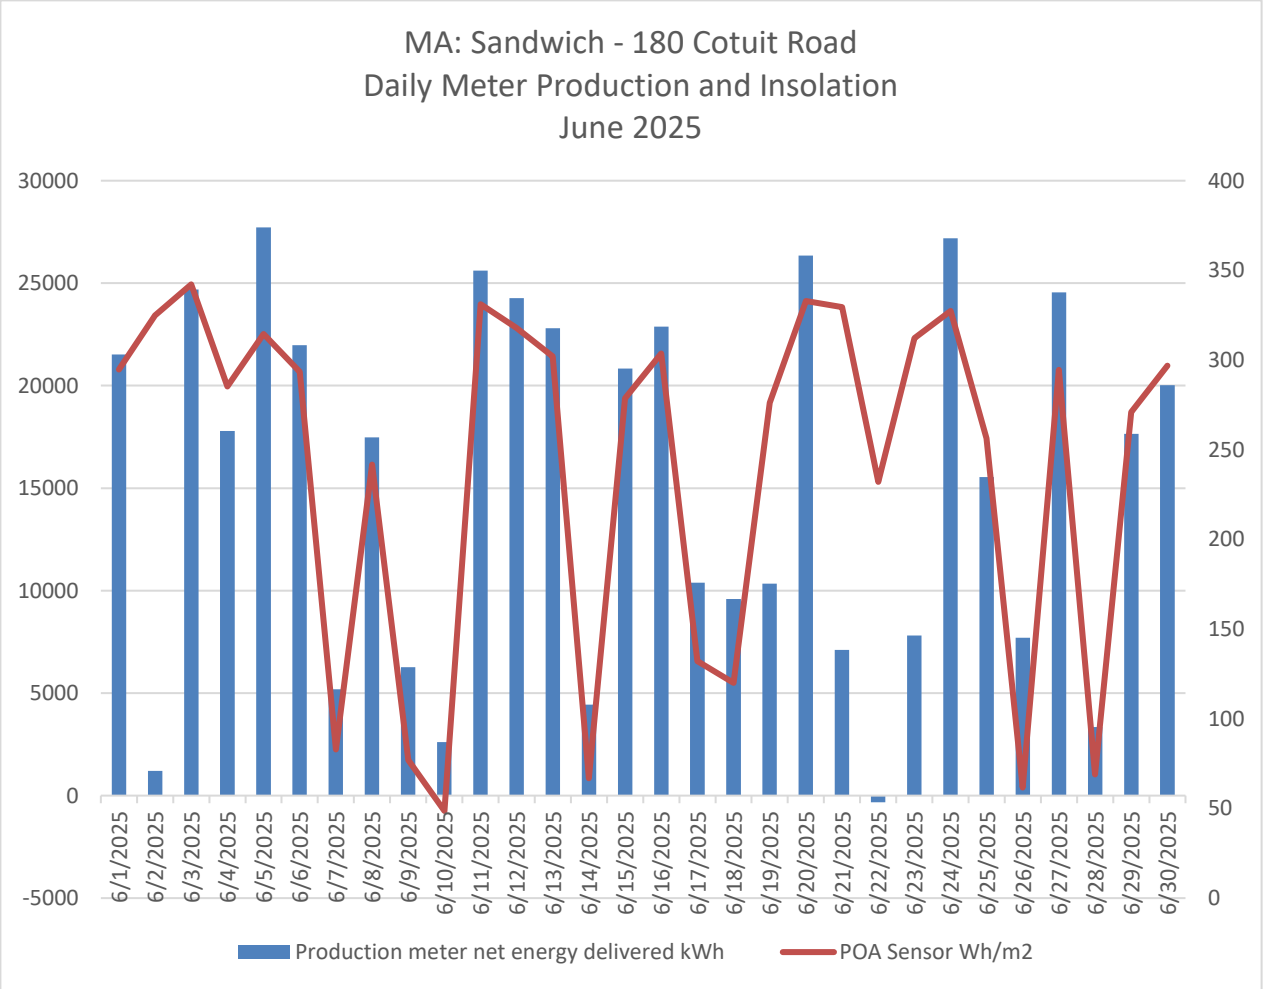
MA: Sandwich - 180 Cotuit Road June Production

1. Site tripped offline on 06/02 at 08:45 and back online on 06/03 at 08:00. **SR102295**
2. Inverter tripped offline at 18:00 on 06/03 and back online on 06/04 at 05:30. **SR102429**
3. The site was offline from 09:30 to 13:45 on 06/19. It was offline again from 08:45 to 11:45 on 06/21 and then went offline once more at 15:15 on the same day. It came back online on 06/23 at 09:00 but experienced another outage from 11:45 to 15:45 on the same day. **SR103172**
