MA: Sandwich - 180 Cotuit Road Performance report

Q4 2025

Name: Sandwich – 180 Cotuit
Road Location: Sandwich, MA
Size AC: 3111 kW
Size DC:4357kWp
Period: Oct 1, 2025 – Oct 31, 2025
Report Date: 11/06/25

Prepared by:
Ameresco
117 Flanders Road, Unit 100
Westborough,MA 01581

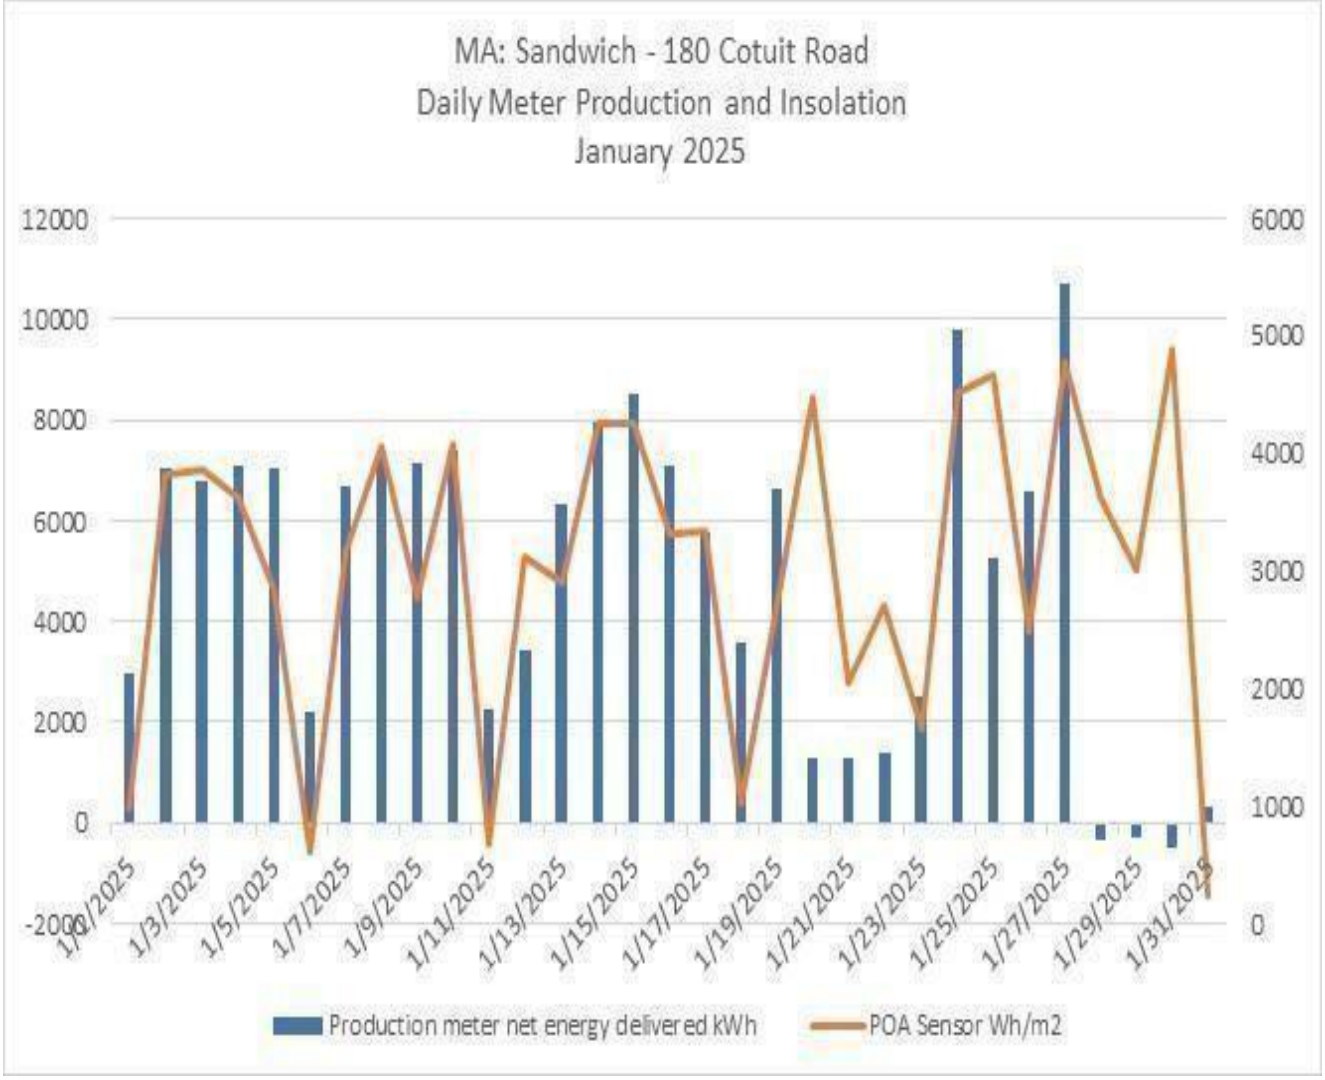
MA: Sandwich - 180 Cotuit Road January Production

1. The site was offline from 01/28 due to an inverter fault. Later, Power Electronics brought the site back online on 01/31 by pulling the logs. SR096048

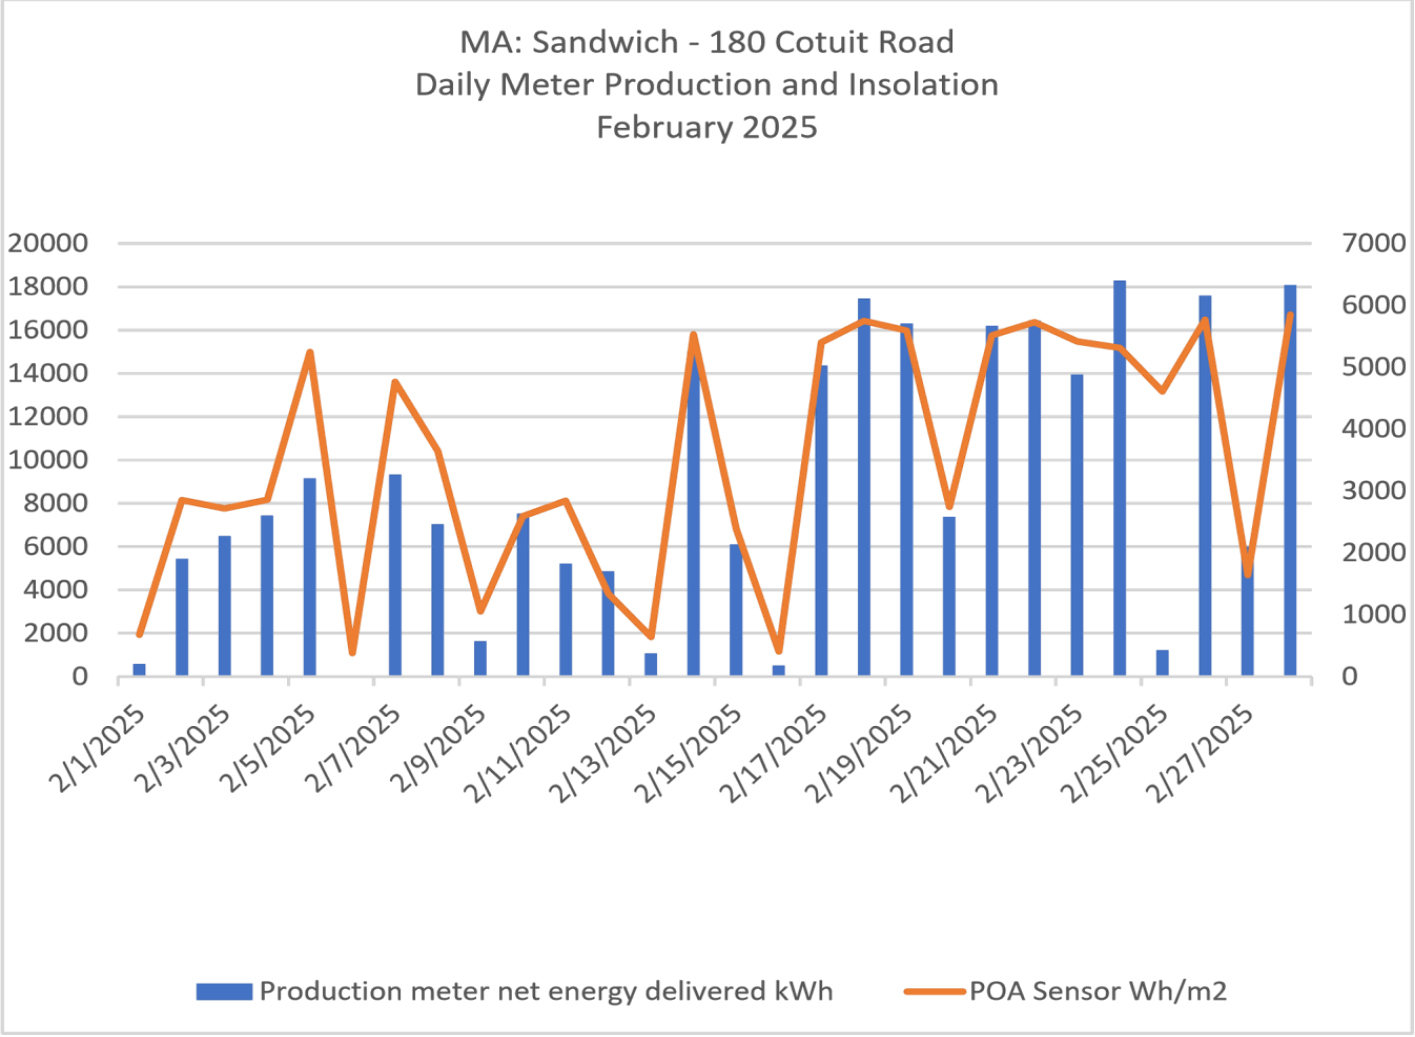
MA: Sandwich - 180 Cotuit Road February Production

1. On 02/18/25, the technician found CB 15 strings 19 & 20 carrying 4 amps. Further investigation is needed to check for a ground fault or module issue. SR096077, SR097256.
2. The site was offline from 6:30 to 14:15 on 02/25/25 due to an inverter fault. The PE technician enabled all modules, put them instartmode, and brought the site back online. SR097746.

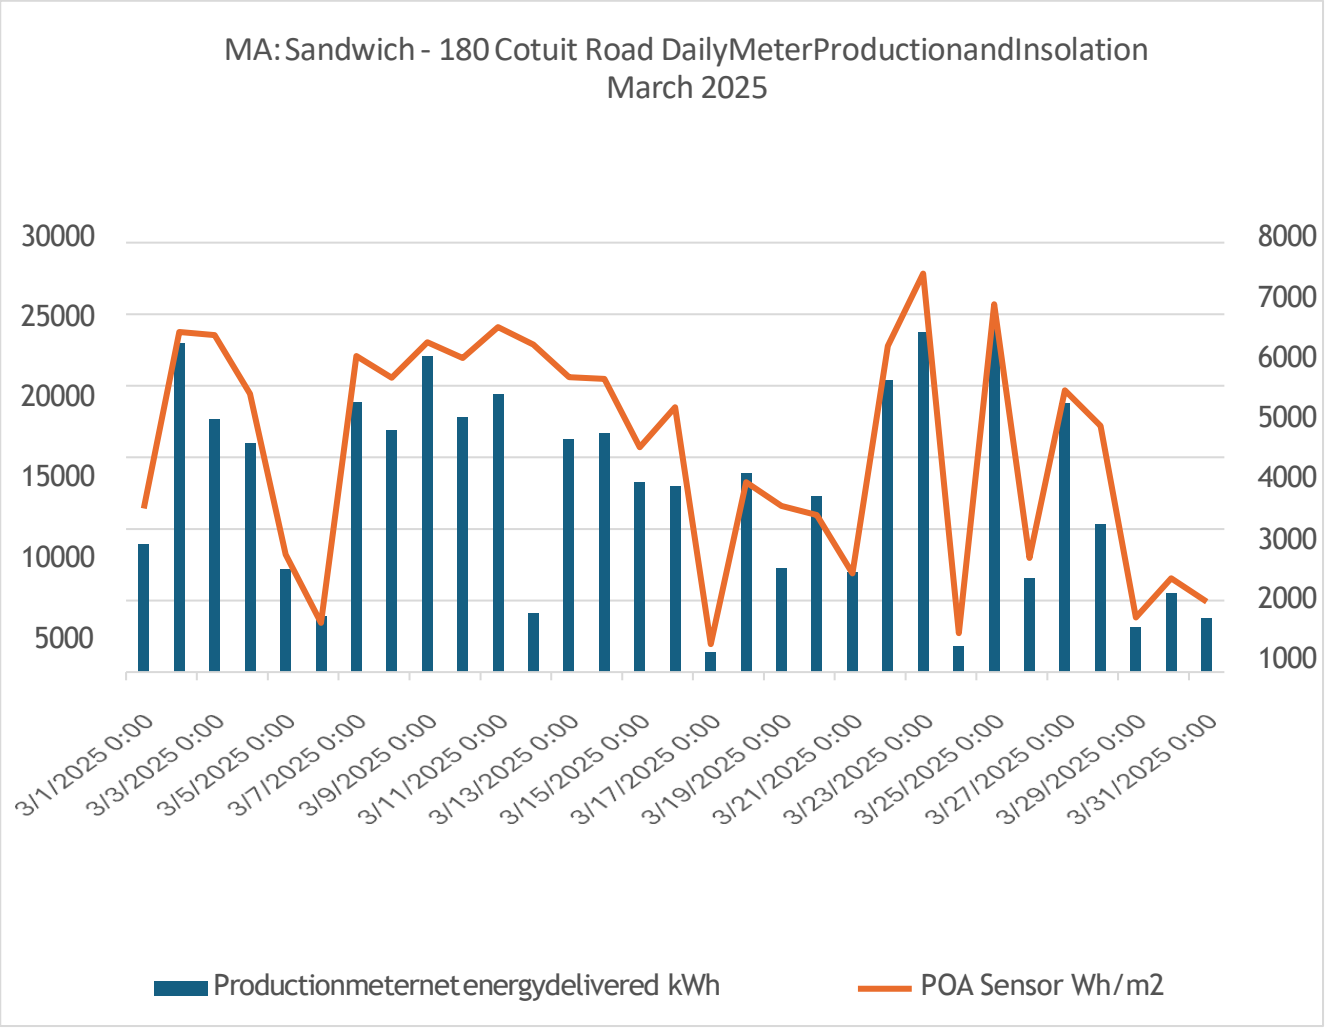
MA: Sandwich - 180 Cotuit Road March Production

1. The site was taken offline from 08:30 to 14:45 on 03/12 due to an HVAC technician being on-site to check the site camera. SR098449
2. Power Electronics on site to perform retrospective ventilation. The Inverter will be taken offline from 11:30 to 13:15 on 03/28. SR099079
3. On 02/18/25, the technician found CB 15 strings 19 & 20 carrying 4 amps. Further investigation is needed tocheck for a ground fault or module issue. SR096077, SR097256, SR099474

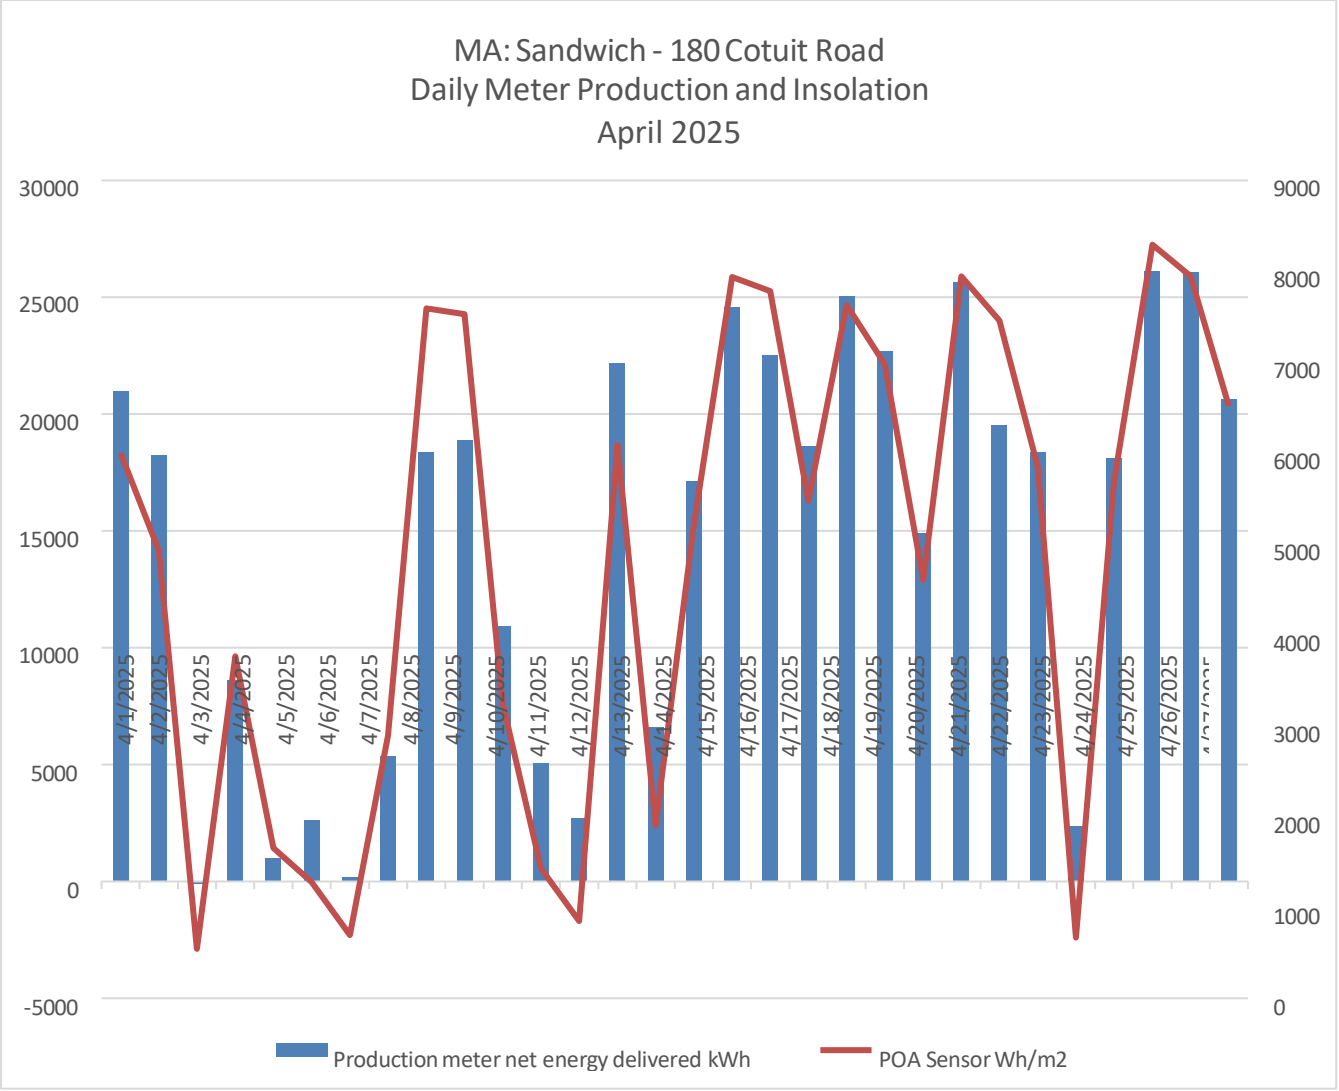
MA: Sandwich - 180 Cotuit Road April Production

1. The site was de-energized from 12:45 PM to 2:45 PM on04/02 while PE was onsite to inspect inverter settings. **SR099316**
2. On 04/03 and 04/05, the inverter failed to start production but was brought back online after a technician performed a remote reset**. SR099371**

3. On 04/04, a technician checked in to investigate DC strings 19 and 20 in CB15 and discovered reverse polarity in jumper connections to a Northern Row. The jumpers were rewired with correct polarity, and final testing confirmed both strings were producing normally. **SR097256, SR099474 & SR099475.**

4. On 04/11/25, discrepancies were noted between meter and inverter readings, with the meter peaking at 3 MW while the inverter maxed at 2.2 MW. AE responded on 04/15/25, suggesting potential bin size logging or data latency issues and implemented logger setting changes. The issue now appears resolved, though the root cause remains unknown. PowerTrack still needs BESS data configured for accurate PV monitoring. **SR099700**

5. On 04/18, the inverter began production at 10:00 AM after experiencing a Softcharge DC5 fault. **SR099978**

6. Inverter tripped offline at 17:00 on 04/24 due to BW BF. PS. 151 fault and back online at 10Am on 04/25 after PE technician initiated the wake-up and soft charge process. **SR10036**

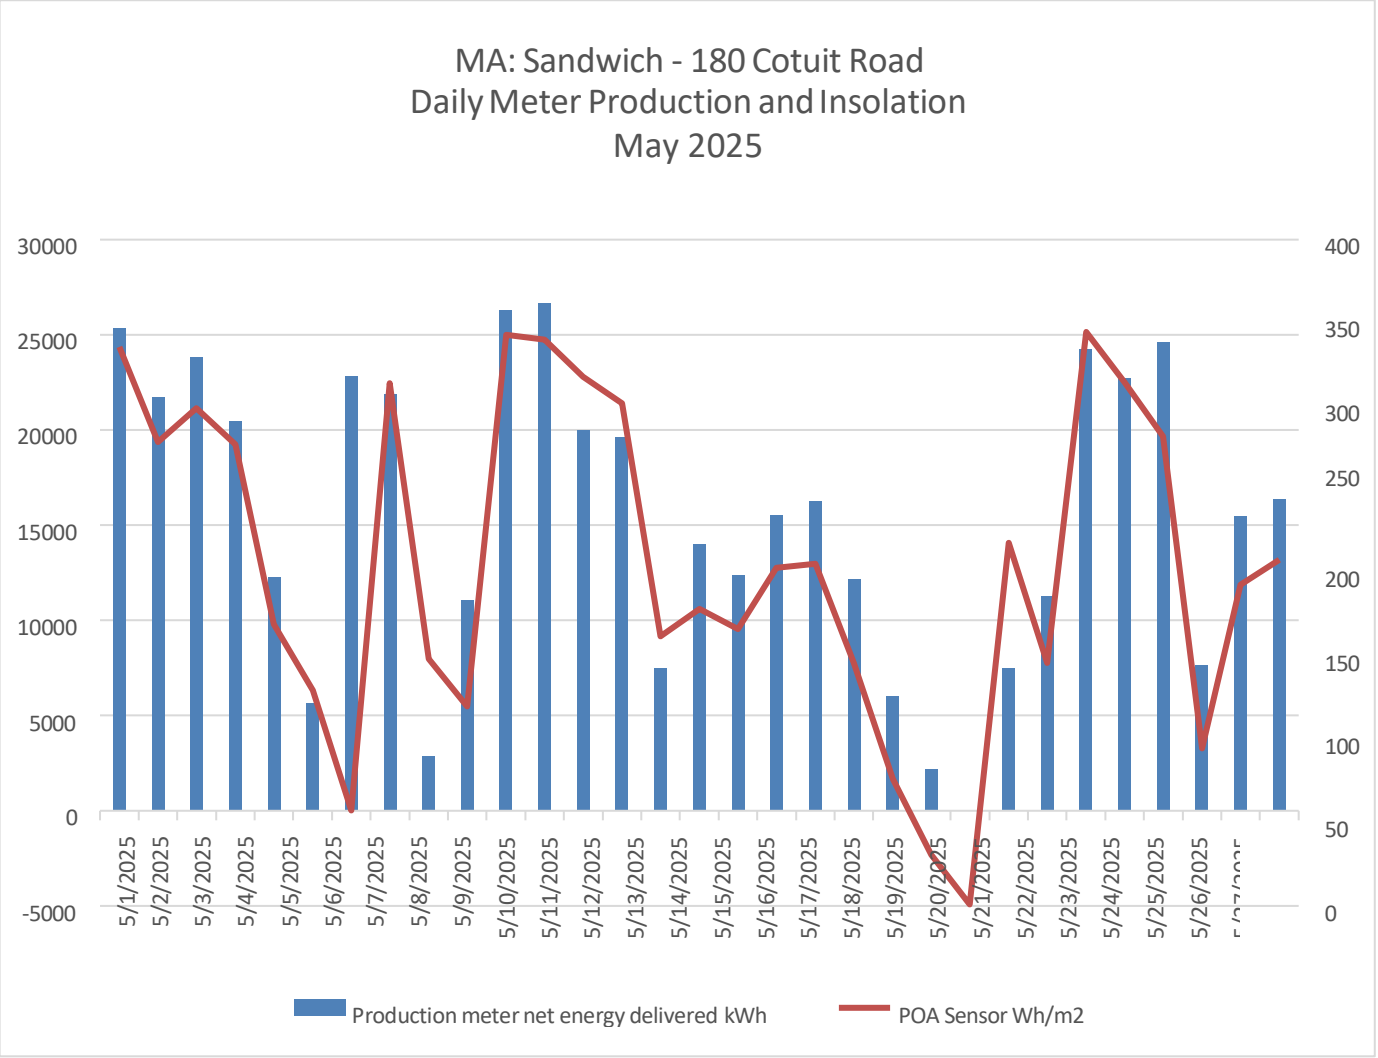
MA: Sandwich - 180 Cotuit Road May Production

1. The site was offline from 09:15 to 13:15 on 05/09. On 05/09, a technician reached out to Power Electronics and worked remotely with Pedro. Pedro was able to make changes to the parameters and get the inverter online. **SR101226**

2. Inverter 1 was offline from 18:15 on 05/13 to 09:45 on 05/14. Inverter was back online after technician with Remote support cleared fault and restarted inverter. **SR101418**

3. The site was offline from 10:30 to 11:45 on 05/15 as Power electronics technicians were on site to replace the main control board in an inverter 1 module. **SR101464**

4. Site was offline from 06:15 on 05/23 to 11:00 on 05/24. On 05/24, a technician was onsite and re-energized the site. The site was back online at 11:00 on 05/24. **SR101873**

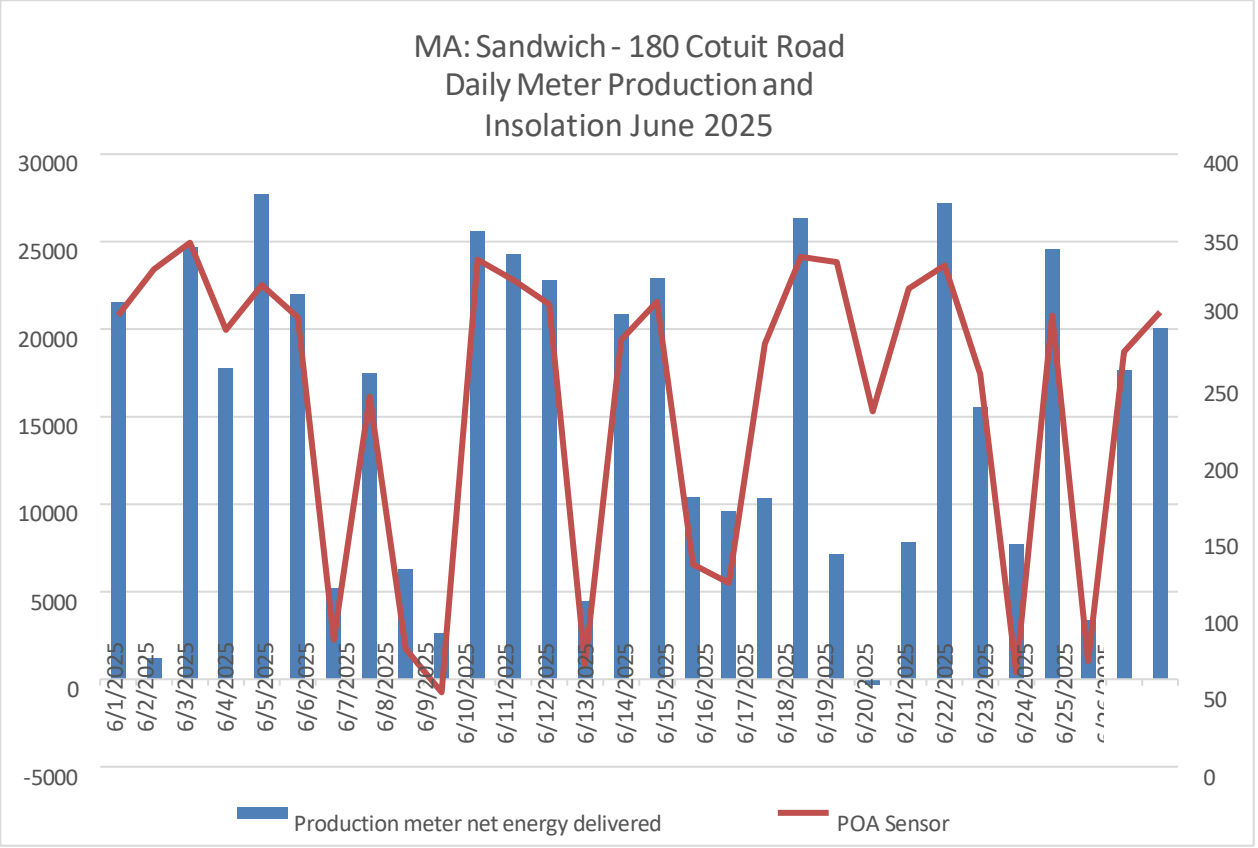
MA: Sandwich - 180 Cotuit Road June Production

1. Site tripped offline on 06/02 at 08:45 and back online on 06/03 at 08:00. **SR102295**
2. Inverter tripped offline at 18:00 on 06/03 and back online on 06/04 at 05:30. **SR102429**
3. The site was offline from 09:30 to 13:45 on 06/19. It was offline again from 08:45 to 11:45 on 06/21 and then went offline once more at 15:15 on the same day. It came back online on 06/23 at 09:00 but experienced another outage from 11:45 to 15:45 on the same day. **SR103172**

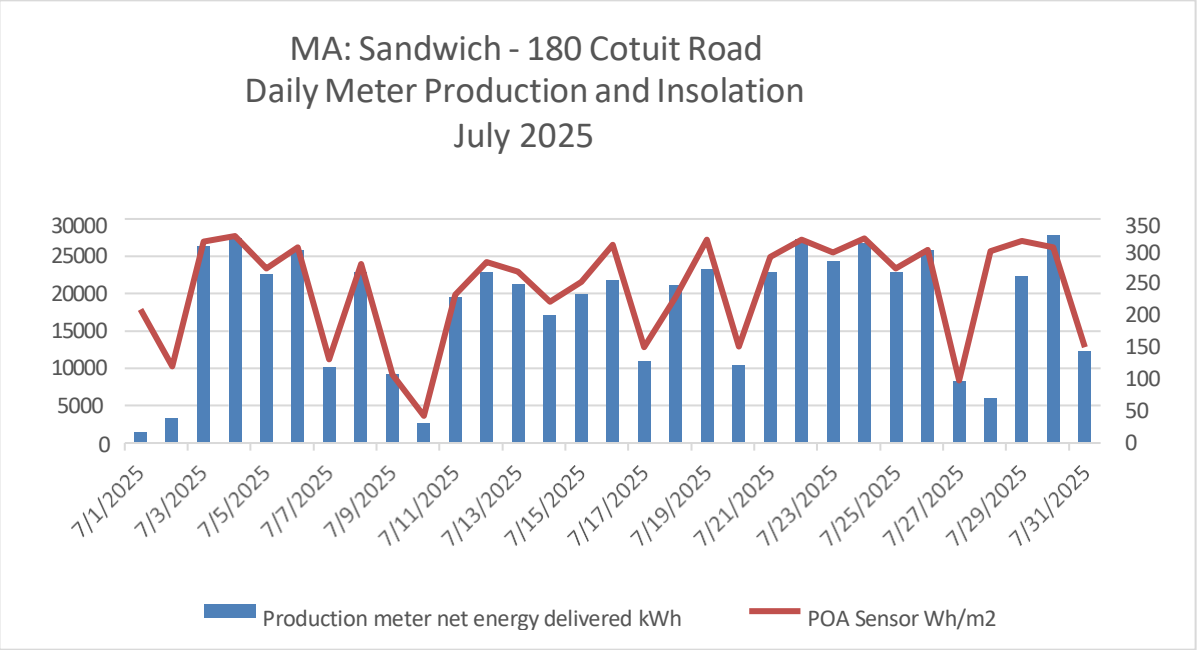
MA: Sandwich - 180 Cotuit Road July Production

1. Inverter tripped offline 10:30 on 07/01 and it came back online at 14:45 on 07/02. PM9454
2. Site tripped offline from 10:30 to 16:00 on 07/28. SR105163

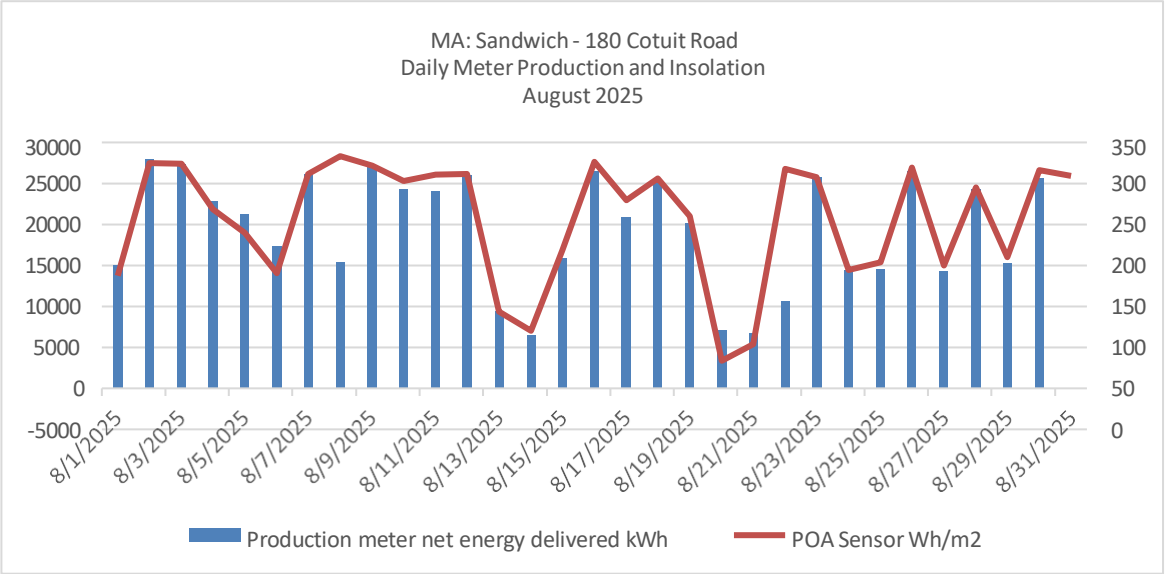
MA: Sandwich - 180 Cotuit Road August Production

1. Site was offline from 04:30 to 11:45 on 08/08. SR105884
2. Inverter offline from 07:00 to 07:34 on 08/13. SR106182
3. Inverter started late for production at 13:00 on 08/22. SR106742
4. Inverter has dropped from over 2MW to grid/Bess to 0 twice in a day on 08/29 and again Inverter tripped offline at 07:45 on 08/31. SR107206

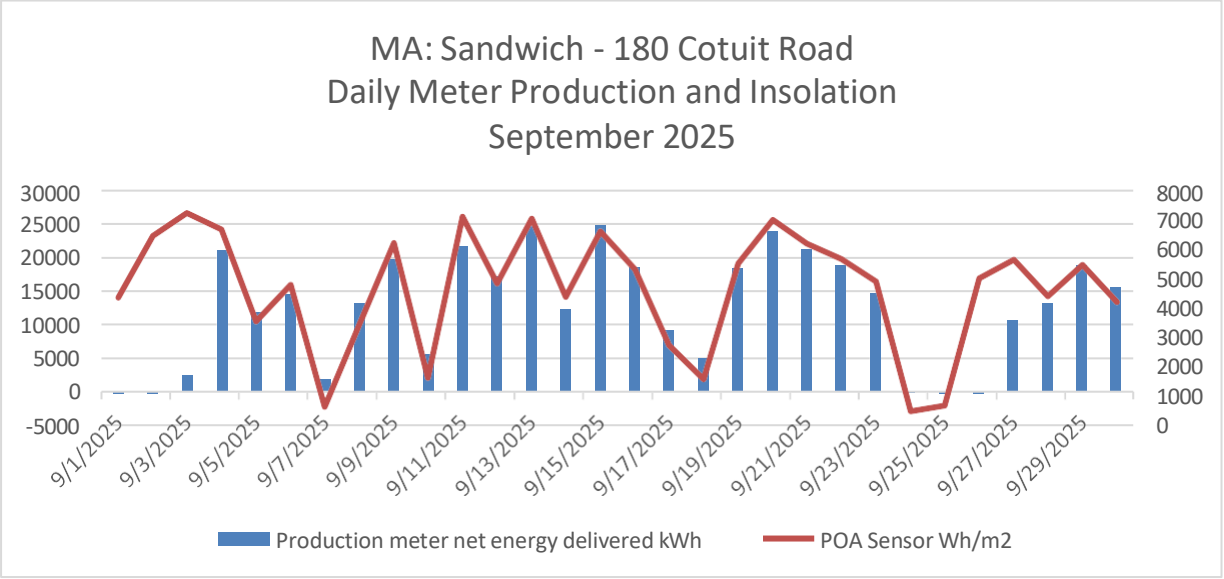
MA: Sandwich - 180 Cotuit Road September Production

1. Site came back online at 15:30 on 09/03. SR107206, SR107304
2. Inverter offline from 10:47 to 11:00 on 09/09. SR107686
3. Inverter offline due to low irradiance at 11:00 on 09/24 and it came back online at 11:15 on 09/27. SR108530

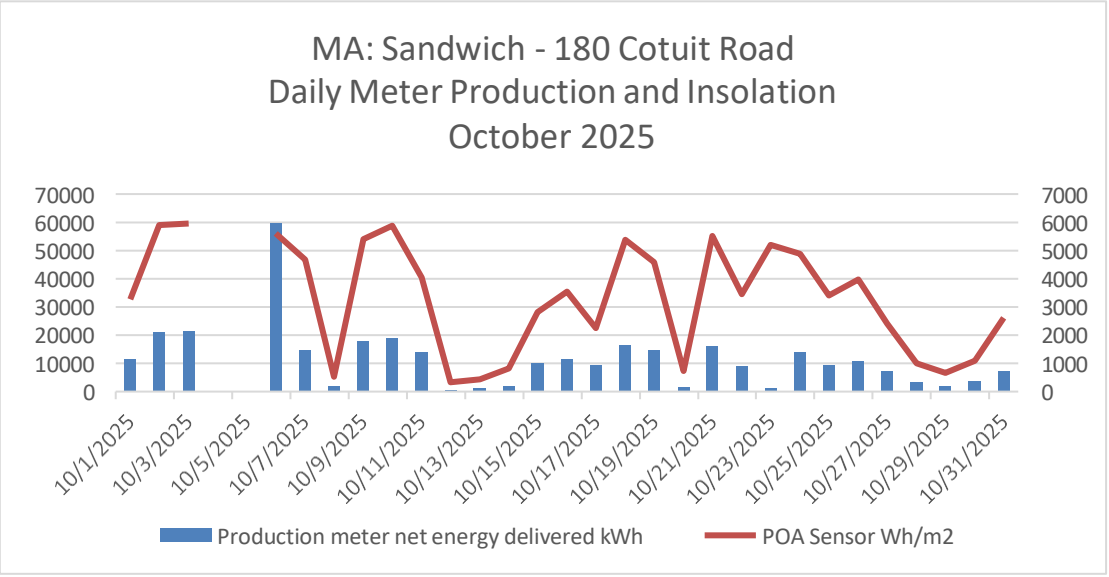
MA: Sandwich - 180 Cotuit Road October Production

1. Site was offline from 09:00 to 14:30 on 10/23. SR109890

2. Site stopped communicating on 10/03 at 18:30 and it came back online on 10/06 at 08:15. SR109055

3. Inverters started production at 10:45 on 10/14. SR109476
