Cleaning Pros Plus, LLC

Report of Service

Report No. RPT-K-SAMPLE · Job No. CPP-K-SAMPLE

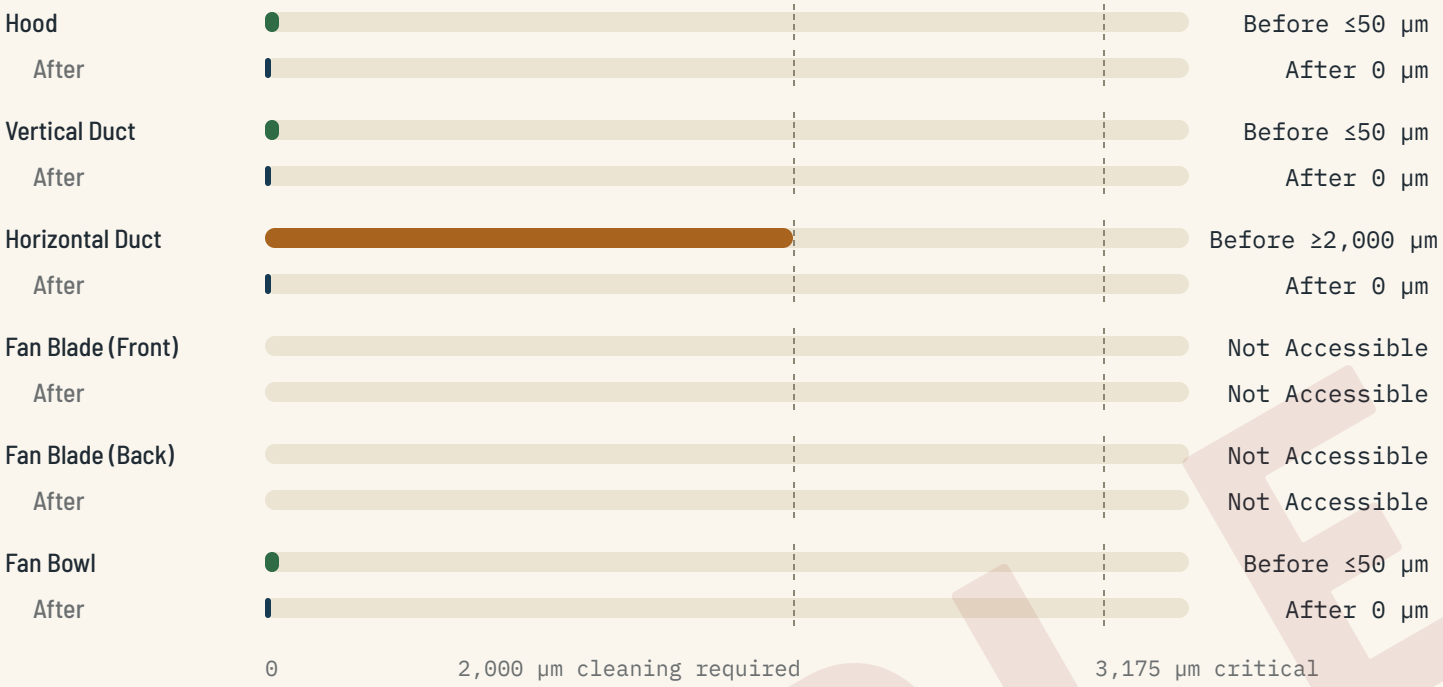
GREASE DEPTH — BEFORE AND AFTER CLEANING

PRE-CLEAN DEPTH BY LOCATION AGAINST THE TWO TRIGGER DEPTHS — EVERY ACCESSIBLE LOCATION READS ZERO AFTER CLEANING

Grease Depth by Location — Before and After Cleaning

Location	Pre-Clean	Post-Clean	Trigger	Result
Hood	Acceptable ≤ 50 µm / 0.002 in	No Grease Build Up 0 µm / 0.000 in	≥ 2,000 µm	Cleaned
Vertical Duct	Acceptable ≤ 50 µm / 0.002 in	No Grease Build Up 0 µm / 0.000 in	≥ 2,000 µm	Cleaned
Horizontal Duct	Cleaning Required ≥ 2,000 µm / 0.078 in	No Grease Build Up 0 µm / 0.000 in	≥ 2,000 µm	Cleaned
Fan Blade (Front)	Not Accessible Not measured	Not Accessible Not measured	≥ 2,000 µm	Not Cleaned
Fan Blade (Back)	Not Accessible Not measured	Not Accessible Not measured	≥ 2,000 µm	Not Cleaned
Fan Bowl	Acceptable ≤ 50 µm / 0.002 in	No Grease Build Up 0 µm / 0.000 in	≥ 3,175 µm	Cleaned
