Service Inspection Sheet

Name: Chris Suwoo
Year/Model: 2018 Lexus IS250
Date: 04/29/2024
RO #: 82093
Odometer: 123,329
VIN: 1GCHK23U56F132343
Email: chrisuwoo@email.com
Phone: 7788553645

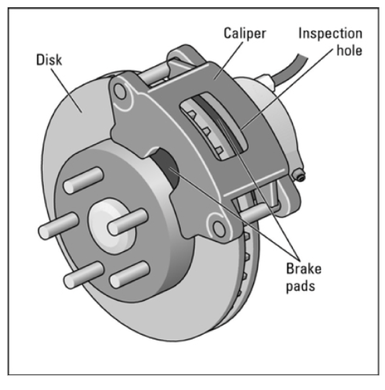
Left Rear
☐ 50% or more
☐ 20%-50%
☑ 20% or less

Right Rear
☐ 50% or more
☐ 20%-50%
☑ 20% or less

Replace rear brake pads @ 3mm
