**EWR D&I ANNOTATION**

FAN-000001L064001DP88-1444

NVS-217ph  
DI07-044

## SYNOPSIS

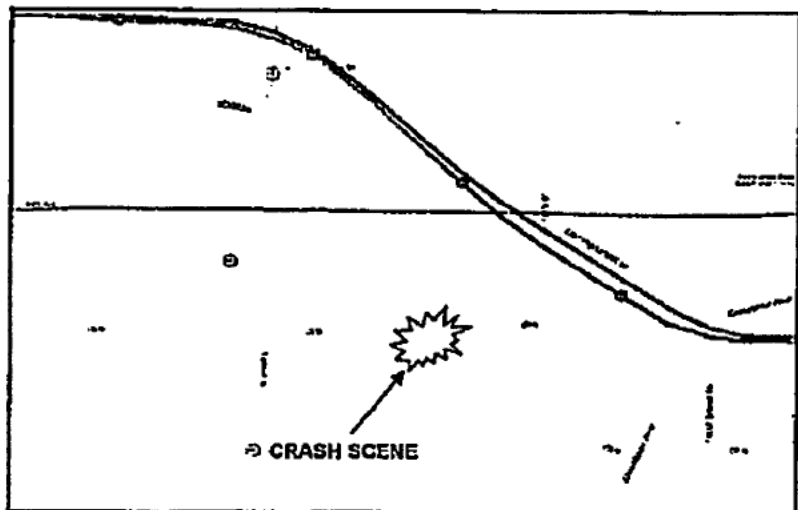
On October 24, 2006, a Chevrolet Cobalt driven by [REDACTED] was eastbound on CTH N just east of North Skyline Drive. The [REDACTED] vehicle traveled onto the south shoulder and into the south ditch. The vehicle then launched off of the west edge of a driveway and became airborne. The vehicle landed and traveled through the ditch before striking a telephone junction box and two trees. The vehicle then rotated clockwise coming to rest in the south ditch facing south. [REDACTED] sustained serious injuries. The right front seat passenger [REDACTED] and left rear seat passenger [REDACTED] later died as a result of injuries they received in the crash.

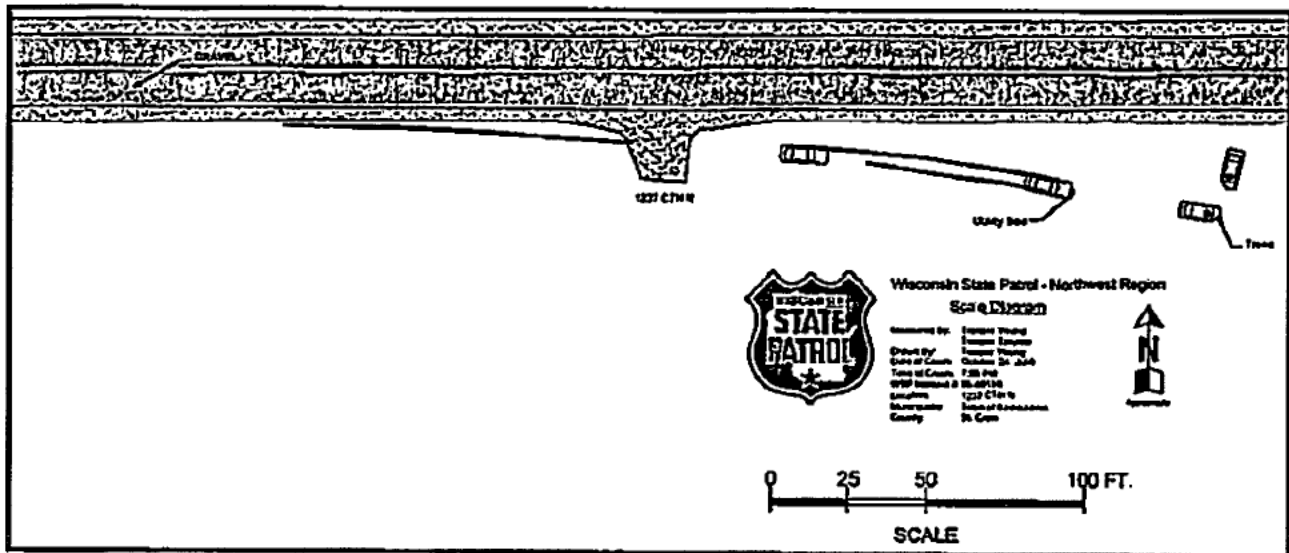
## COLLISION SEQUENCE

As the [REDACTED] vehicle traveled down a slight grade her vehicle went onto the south shoulder and into the south ditch. When the vehicle approached the driveway at house number 1237 it launched off of the west edge of the driveway and was airborne for approximately 59 feet. The vehicle landed and traveled approximately 82 feet before striking a telephone junction box and knocking it down. The vehicle then traveled another 46 feet through some brush before striking two larger trees. The vehicle then rotated clockwise approximately 94 degrees while traveling another 14 feet before coming to rest.
