EWR D&I ANNOTATION

FAN-000001L092001DP94-2333

DI09-096. SEQ ID 94. 2009 Q2. INCIDENT TAKES PLACE ON AN OHIO HWY. POLICE REPORT STATES DRIVER OF A 2007 COBALT LOST CONTROL OF HIS VEHICLE BECAUSE ANOTHER VEHICLE GOING IN THE SAME DIRECTION CUT HER OFF, VEHICLE HIT A GUARDRAIL WITH THE FRONT OF CAR. PRE-CRASH DATA SHOWS VEHICLE AROUND 55 MPH. DRIVER'S SEAT BELT WAS UNBUCKLED. DRIVER ALLEGES AIR BAGS SHOULD HAVE DEPLOYED. VOQ-37. PURSUIT-0 (1 FOR 2006). TSB-0. RECALLS-0. *RM

DI09-096
94 278516408 – 669590
2007 CHEVROLET COBALT

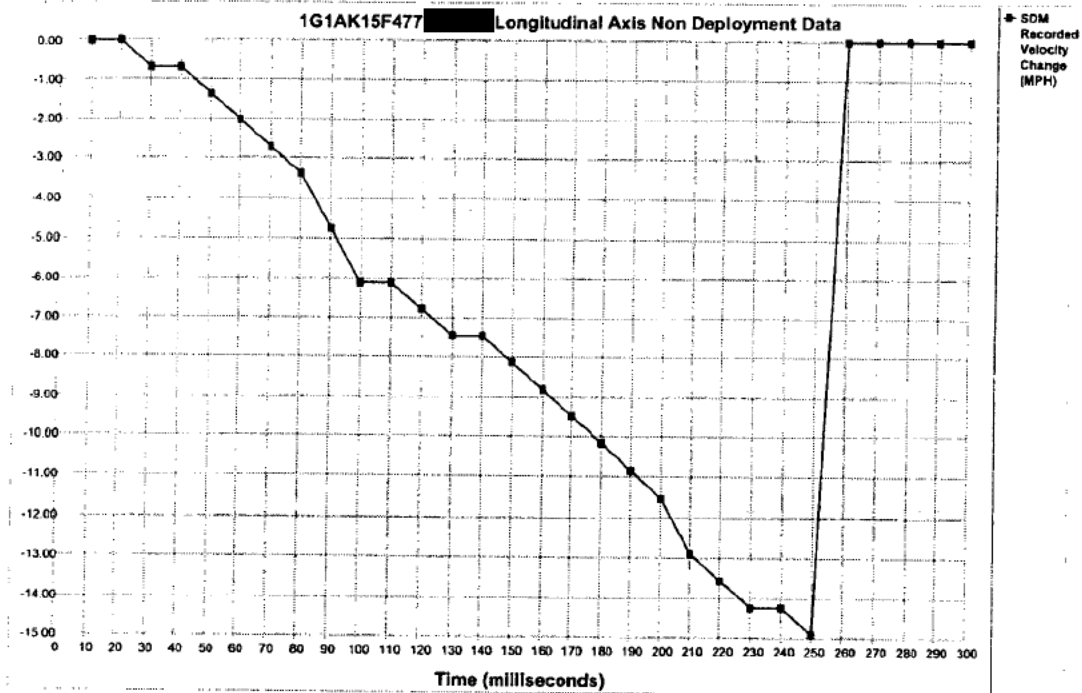
Time (milliseconds)	10	20	30	40	50	60	70	80	90	100	110	120	130	140	150
SDM Longitudinal Axis Recorded Velocity Change (MPH)	0.00	0.00	-0.68	-0.68	-1.36	-2.03	-2.71	-3.39	-4.74	-6.10	-6.10	-6.78	-7.46	-7.46	-8.13
Time (milliseconds)	160	170	180	190	200	210	220	230	240	250	260	270	280	290	300
SDM Longitudinal Axis Recorded Velocity Change (MPH)	-9.81	-9.49	-10.17	-10.85	-11.52	-12.20	-12.88	-13.56	-14.23	-14.91	0.00	0.00	0.00	0.00	0.00

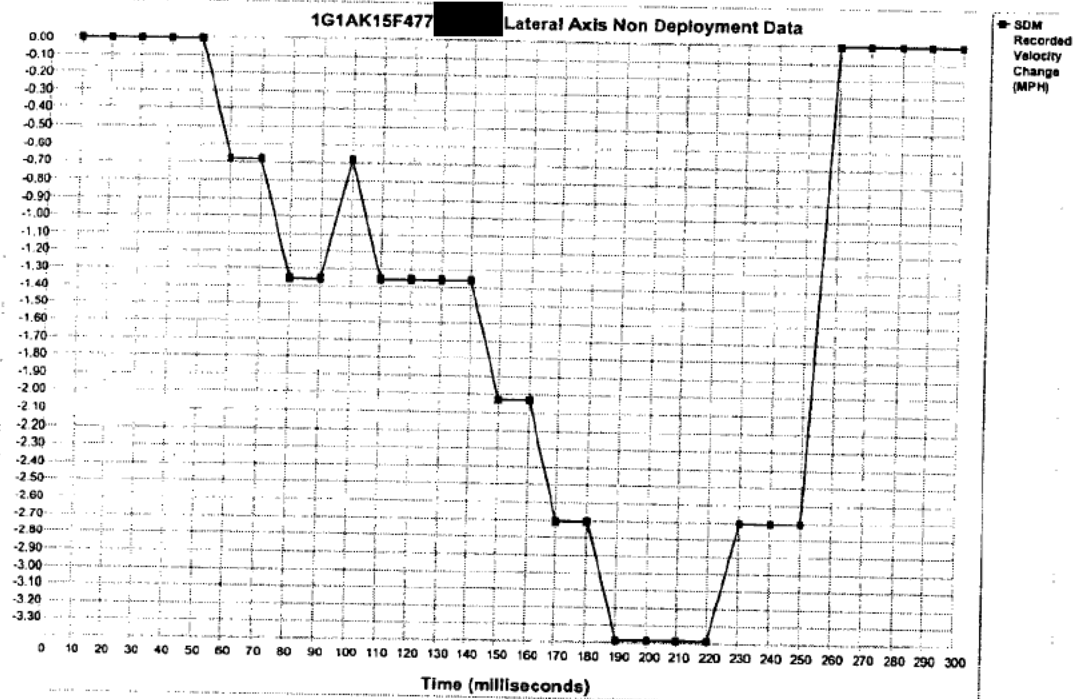
Time (milliseconds)	10	20	30	40	50	60	70	80	90	100	110	120	130	140	150
SDM Lateral Axis Recorded Velocity Change (MPH)	0.00	0.00	0.00	0.00	0.00	-0.68	-0.68	-1.36	-1.36	-0.68	-1.36	-1.36	-1.36	-1.36	-2.03
Time (milliseconds)	160	170	180	190	200	210	220	230	240	250	260	270	280	290	300
SDM Lateral Axis Recorded Velocity Change (MPH)	-2.03	-2.71	-2.71	-3.39	-3.39	-3.39	-3.39	-2.71	-2.71	-2.71	0.00	0.00	0.00	0.00	0.00
