EWR D&I ANNOTATION

FAN-000001L092001DP92-9094

DI09-096. SEQ ID 92. 2009 Q2. A DRIVER OF A 2007 CHEVY COBALT WAS DRIVING ON A STREET IN TENNESSEE WHEN THE INCIDENT HAPPENED. POLICE REPORT STATES THAT ANOTHER VEHICLE TURNED INTO THE COBALT AND PUSHED IT INTO A BUILDING. PRE-CRASH DATA STATES COBALT WAS DRIVING ABOUT 10 MPH DURING THE INCIDENT. DRIVER ALLEGES THAT AIR BAGS SHOULD HAVE DEPLOYED. VOQ-37. PURSUIT-0 (1 FOR 2006). TSB-0. RECALLS-0. *RM

DI09-096
92 278517479 – 671885
2007 CHEVROLET COBALT

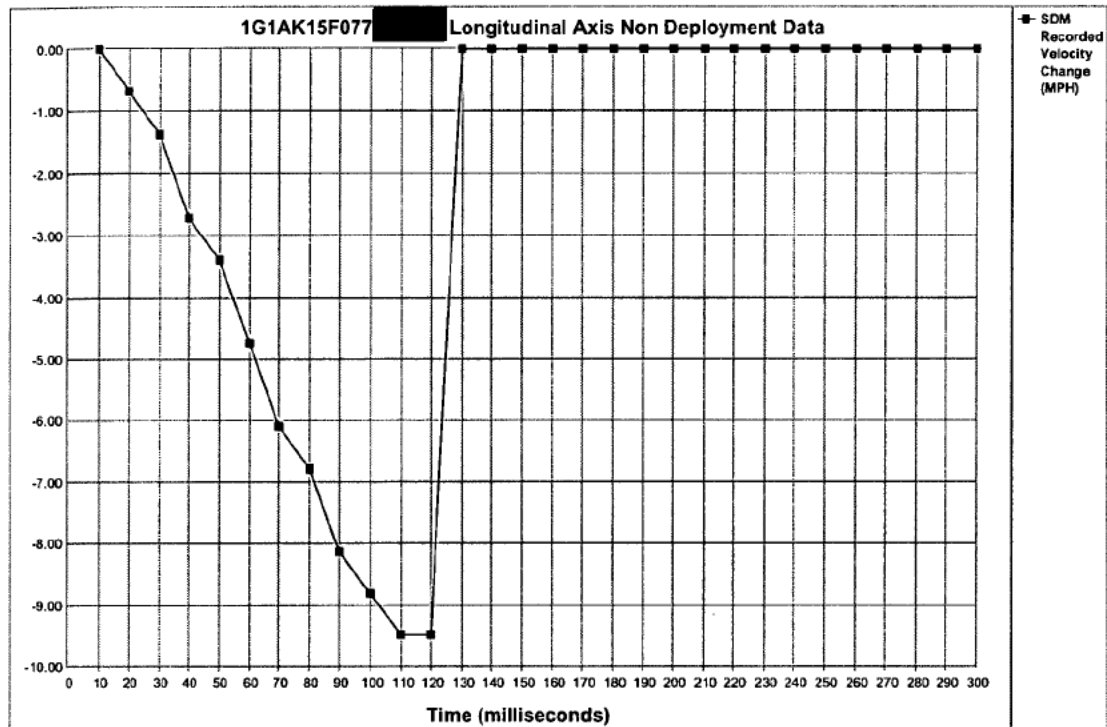
Driver First Stage Deployment Loop Commanded	No
Driver Second Stage Deployment Loop Commanded	No
Driver Side Deployment Loop Commanded	No
Driver Pretensioner Deployment Loop Commanded	No
Driver (Initiator 1) Roof Rail/Head Curtain Loop Commanded	No
Driver (Initiator 2) Roof Rail/Head Curtain Loop Commanded	No
Driver Knee Deployment Loop Commanded	No
Passenger First Stage Deployment Loop Commanded	No
Passenger Second Stage Deployment Loop Commanded	No
Passenger Side Deployment Loop Commanded	No
Passenger Pretensioner Deployment Loop Commanded	No
Passenger (Initiator 1) Roof Rail/Head Curtain Loop Commanded	No
Passenger (Initiator 2) Roof Rail/Head Curtain Loop Commanded	No
Passenger Knee Deployment Loop Commanded	No
Driver Anchor Pretensioner Deployment Loop Commanded (If Equipped)	No
Second Row Left Pretensioner Deployment Loop Commanded	No
Third Row Left Roof Rail/Head Curtain Loop Commanded	No
Passenger Anchor Pretensioner Deployment Loop Commanded (If Equipped)	No

Second Row Right Pretensioner Deployment Loop Commanded	No
Third Row Right Roof Rail/Head Curtain Loop Commanded	No
Second Row Center Pretensioner Deployment Loop Commanded	No
Crash Record Locked	No
Vehicle Event Data (Pre-Crash) Associated With This Event	Yes
Deployment Event Recorded in the Non-Deployment Record	No
Event Recording Complete	Yes

Time (milliseconds)	10	20	30	40	50	60	70	80	90	100	110	120	130	140	150
SDM Longitudinal Axis Recorded Velocity Change (MPH)	0.00	-0.68	-1.36	-2.71	-3.39	-4.74	-6.10	-6.78	-8.13	-8.81	-9.49	-9.49	0.00	0.00	0.00
Time (milliseconds)	160	170	180	190	200	210	220	230	240	250	260	270	280	290	300
SDM Longitudinal Axis Recorded Velocity Change (MPH)	0.00	0.00	0.00	0.00	0.00	0.00	0.00	0.00	0.00	0.00	0.00	0.00	0.00	0.00	0.00
