EWR D&I ANNOTATION

FAN-000001L093001DP129-4460

Description : DI10-006. SEQ ID 129. 2009 Q3. VEHICLE IN QUESTION IS A 2007 CHEVY COBALT THAT WAS TRAVELLING ON THE HIGHWAY. POLICE REPORT STATES THAT THE DRIVER WAS TRAVELING TOO FAST FOR THE CONDITIONS AND TRIED NEGOTIATING A RIGHT HAND CURVE. THE VEHICLE STARTED TO ROTATE, WENT OFF THE ROAD, STRUCK A PHONE BOX, AND ROLLED. THE DRIVER WAS EJECTED DURING THE INCIDENT AND WAS KILLED. THE WIFE OF THE DRIVER SAYS THE AIR BAGS DID NOT DEPLOY AND SHOULD HAVE. THE VEHICLE WAS TOTALLED. THE PRE CRASH DATA SHOWS THE VEHICLE GOING ABOUT 42MPH BEFORE THE ACCIDENT, BUT THE MAXIMUM CHANGE IN VELOCITY WAS LESS THAN 11MPH. GM STATES THAT THEY WILL NOT HONOR THE REQUEST FOR DAMAGES. *RM

NVS-217kb
DI10-006

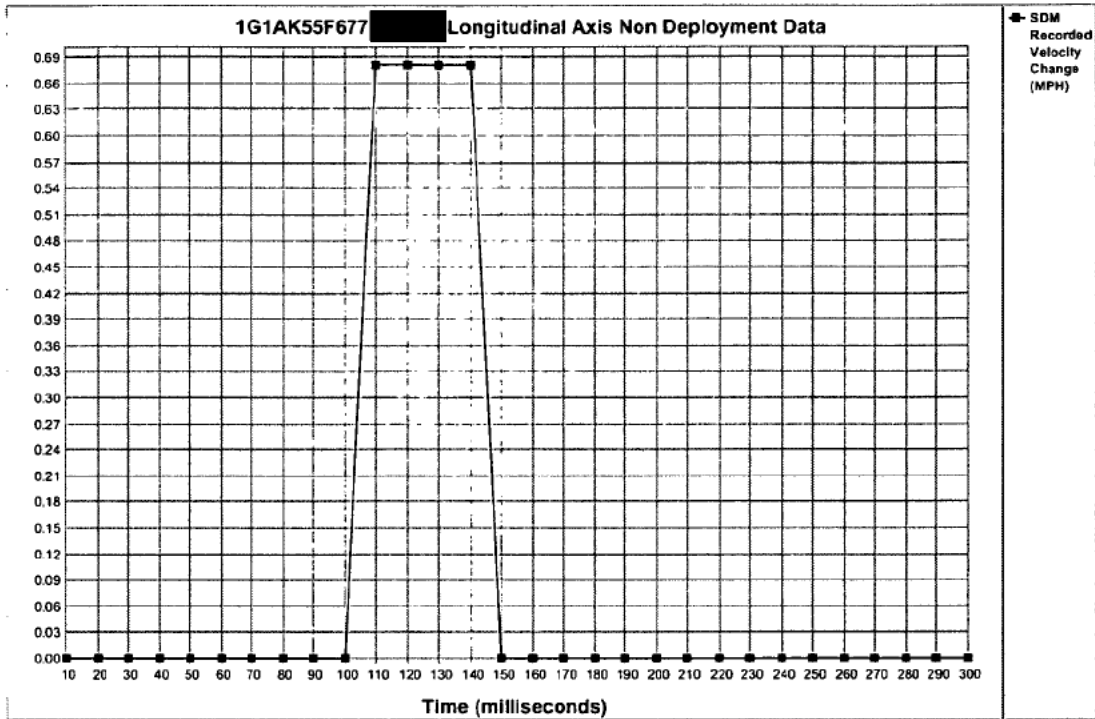
Time (milliseconds)	10	20	30	40	50	60	70	80	90	100	110	120	130	140	150
SDM Longitudinal Axis Recorded Velocity Change (MPH)	0.00	0.00	0.00	0.00	0.00	0.00	0.00	0.00	0.00	0.00	0.68	0.68	0.68	0.68	0.00
Time (milliseconds)	160	170	180	190	200	210	220	230	240	250	260	270	280	290	300
SDM Longitudinal Axis Recorded Velocity Change (MPH)	0.00	0.00	0.00	0.00	0.00	0.00	0.00	0.00	0.00	0.00	0.00	0.00	0.00	0.00	0.00

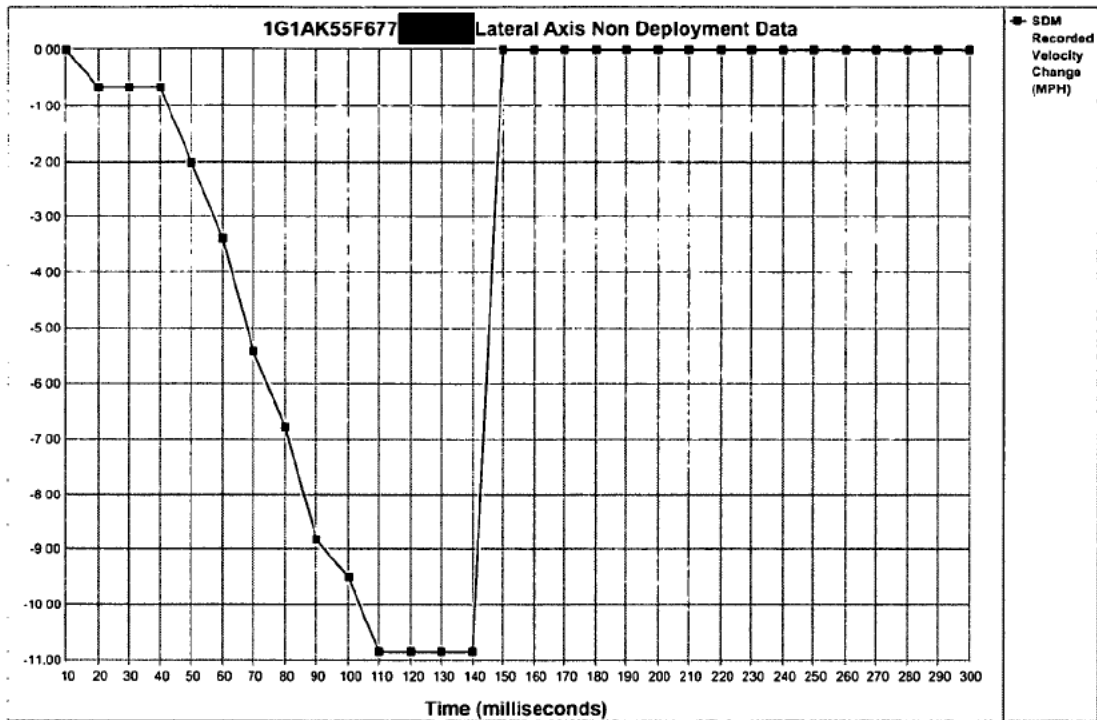
Time (milliseconds)	10	20	30	40	50	60	70	80	90	100	110	120	130	140	150
SDM Lateral Axis Recorded Velocity Change (MPH)	0.00	-0.68	-0.68	-0.68	-2.03	-3.39	-5.42	-6.78	-8.81	-9.49	-10.85	-10.85	-10.85	-10.85	0.00
Time (milliseconds)	160	170	180	190	200	210	220	230	240	250	260	270	280	290	300
SDM Lateral Axis Recorded Velocity Change (MPH)	0.00	0.00	0.00	0.00	0.00	0.00	0.00	0.00	0.00	0.00	0.00	0.00	0.00	0.00	0.00
