EWR D&I ANNOTATION

FAN-000001L093001DP171-9156

DI10-006 SEQUENCE ID 171 A SERVICE REQUEST DETAIL REPORT FROM GM DETAILS A CUSTOMER COMPLAINT OF AIRBAG NON-DEPLOYMENT ON A 2007 CHEVROLET HHR. THE VEHICLE WAS INVOLVED IN A TWO CAR COLLISION THAT RESULTED IN INJURIES TO BOTH OCCUPANTS AND SERIOUS DAMAGE TO THE VEHICLE. THE CALLER STATES THAT HIS WIFE WAS DRIVING WHEN A VEHICLE ENTERED HER LANE. SHE SWERVED TO AVOID A HEAD ON COLLISION AND IN THE PROCESS STRUCK A DIFFERENT VEHICLE. NO SPECIFICS ARE GIVEN REGARDING THIS COLLISION. NONE OF THE AIRBAGS IN THE HHR DEPLOYED; BOTH THE DRIVER AND PASSENGER WERE INJURED AND TAKEN TO THE EMERGENCY ROOM. THE DRIVER SUFFERED FROM A CHEST AND HEAD CONTUSION AND HEAD TRAUMA. THE PASSENGER WAS TREATED FOR HEAD TRAUMA, AND BRUISING OF THE RIGHT HIP. THE PASSENGER ALSO BIT HER TONGUE AND HIT HER CHIN. THE DAMAGE TO THE HHR WAS ENOUGH TO DECLARE IT TOTALED. THE FRONT END WAS SMASHED, THE FRAME BENT, AND SOME OF THE MOTOR MOUNTS WERE BROKEN. ALSO PROVIDED IS A LETTER FROM GM TO THE VEHICLE'S OWNER REJECTING A REQUEST FOR DAMAGES. THE VEHICLE WAS INSPECTED AND AN EDR REPORT IS PROVIDED. THE MAX SDM RECORDED VELOCITY CHANGE IS LISTED AS 23.73MPH. THERE

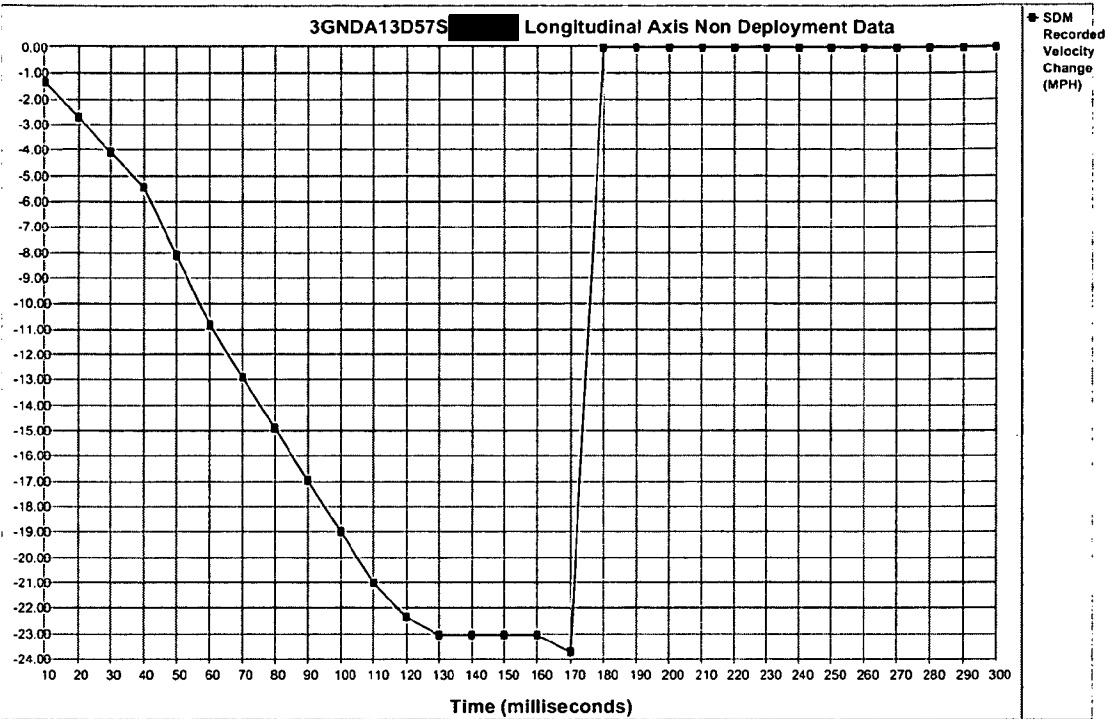
Driver First Stage Deployment Loop Commanded	No
Driver Second Stage Deployment Loop Commanded	No
Driver Side Deployment Loop Commanded	No
Driver Pretensioner Deployment Loop Commanded	No
Driver (Initiator 1) Roof Rail/Head Curtain Loop Commanded	No
Driver (Initiator 2) Roof Rail/Head Curtain Loop Commanded	No
Driver Knee Deployment Loop Commanded	No
Passenger First Stage Deployment Loop Commanded	No
Passenger Second Stage Deployment Loop Commanded	No
Passenger Side Deployment Loop Commanded	No
Passenger Pretensioner Deployment Loop Commanded	No
Passenger (Initiator 1) Roof Rail/Head Curtain Loop Commanded	No
Passenger (Initiator 2) Roof Rail/Head Curtain Loop Commanded	No
Passenger Knee Deployment Loop Commanded	No
Driver Anchor Pretensioner Deployment Loop Commanded (If Equipped)	No
Second Row Left Pretensioner Deployment Loop Commanded	No
Third Row Left Roof Rail/Head Curtain Loop Commanded	No
Passenger Anchor Pretensioner Deployment Loop Commanded (If Equipped)	No

Time (milliseconds)	10	20	30	40	50	60	70	80	90	100	110	120	130	140	150
SDM Longitudinal Axis Recorded Velocity Change (MPH)	-1.36	-2.71	-4.07	-5.42	-8.13	-10.85	-12.88	-14.91	-16.95	-18.98	-21.01	-22.37	-23.05	-23.05	-23.05
Time (milliseconds)	160	170	180	190	200	210	220	230	240	250	260	270	280	290	300
SDM Longitudinal Axis Recorded Velocity Change (MPH)	-23.05	-23.72	0.00	0.00	0.00	0.00	0.00	0.00	0.00	0.00	0.00	0.00	0.00	0.00	0.00

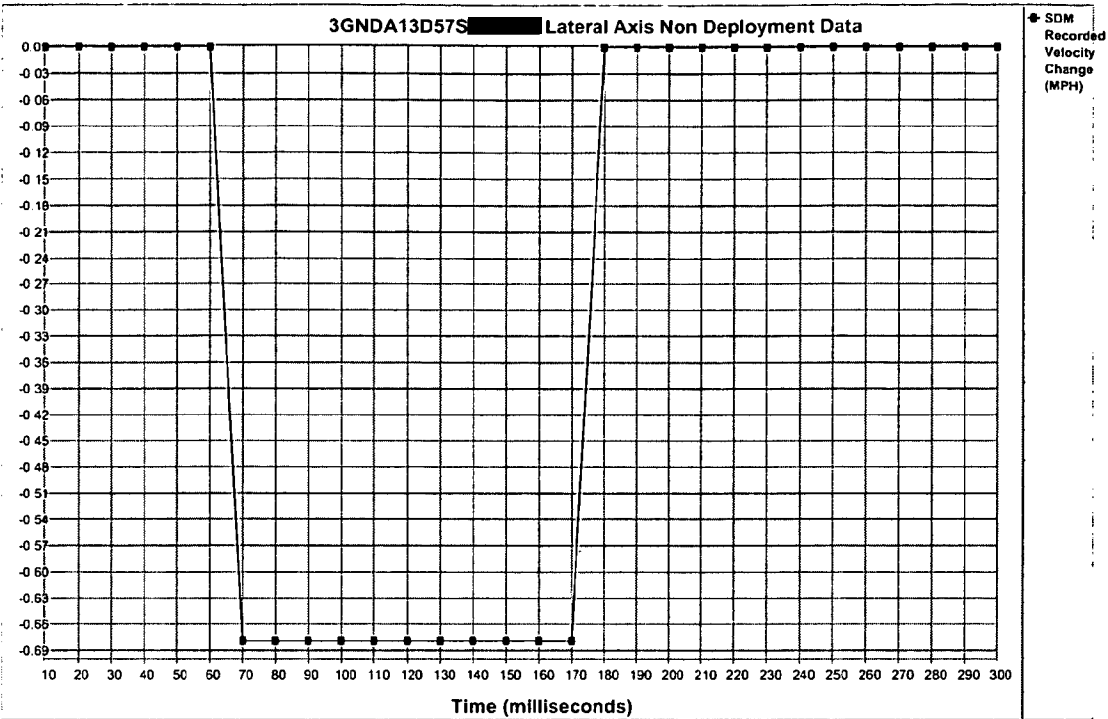
Time (milliseconds)	10	20	30	40	50	60	70	80	90	100	110	120	130	140	150
SDM Lateral Axis Recorded Velocity Change (MPH)	0.00	0.00	0.00	0.00	0.00	0.00	-0.68	-0.68	-0.68	-0.68	-0.68	-0.68	-0.68	-0.68	-0.68
Time (milliseconds)	160	170	180	190	200	210	220	230	240	250	260	270	280	290	300
SDM Lateral Axis Recorded Velocity Change (MPH)	-0.68	-0.68	0.00	0.00	0.00	0.00	0.00	0.00	0.00	0.00	0.00	0.00	0.00	0.00	0.00
