EWR D&I ANNOTATION

FAN-000001L101001DP125-2979

DI10-062 SEQUENCE 125 GENERAL MOTORS 1 INJURY 2006 CHEVROLET COBALT A SINGLE VEHICLE CRASH OCCURRED IN A CALIFORNIA PARKING LOT. THE DRIVER WAS PICKING UP A FRIEND AND WAITING IN THE PARKING LOT FOR HER TO COME OUT. ONCE THE PASSENGER ENTERED THE VEHICLE THE DRIVER RELEASED THE BRAKE AND SHIFTED THE GEAR INTO DRIVE. THE VEHICLE EXPERIENCED SUDDEN ACCELERATION. THE DRIVER LOST CONTROL OF THE CAR AND STRUCK THE SIDE OF A BUILDING. THE SHORT DISTANCE THE VEHICLE TRAVELED IT DAMAGED A TREE AND SOME CHAIRS INSIDE THE BUILDING. THE DRIVER DID NOT SUSTAIN ANY INJURIES BUT THE PASSENGER HAD 2 BROKEN ARMS. THE INSURANCE COMPANY TOTALED THE CAR. NO SIMILAR FIELD REPORTS, VOQS, OR TSBS. *AA

DI10-062
125 299569497 – 71-801365697
2006 CHEVROLET COBALT

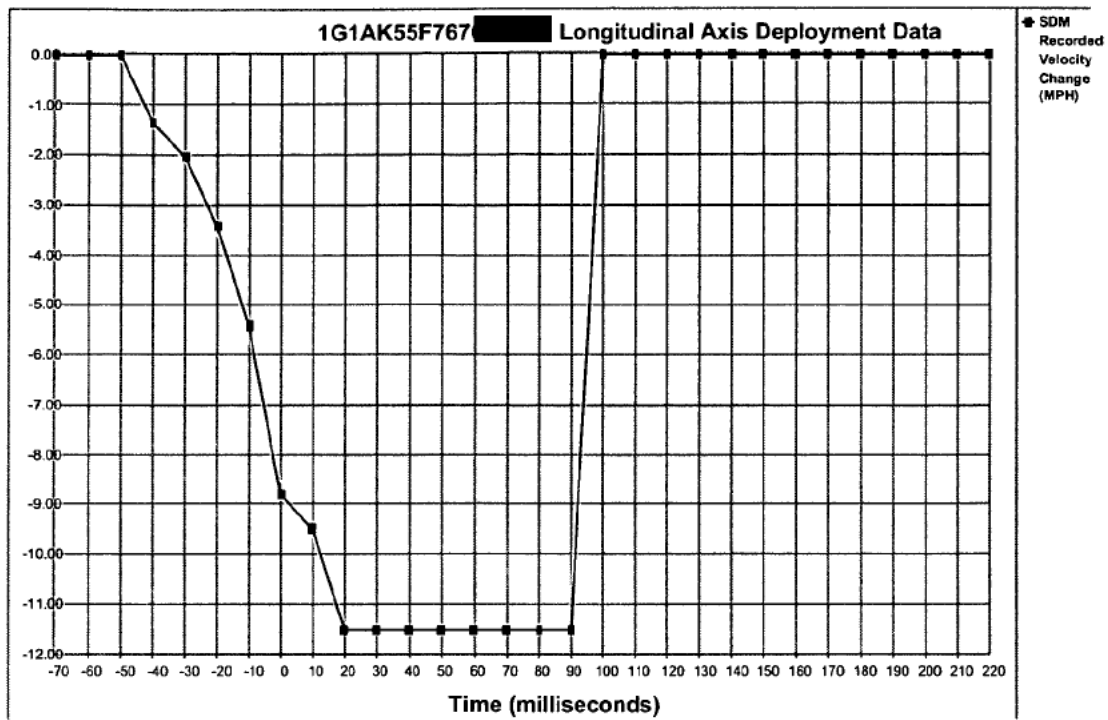
Time (milliseconds)	-70	-60	-50	-40	-30	-20	-10	0	10	20	30	40	50	60	70
SDM Longitudinal Axis Recorded Velocity Change (MPH)	0.00	0.00	0.00	-1.36	-2.03	-3.39	-5.42	-8.81	-9.49	-11.52	-11.52	-11.52	-11.52	-11.52	-11.52
Time (milliseconds)	80	90	100	110	120	130	140	150	160	170	180	190	200	210	220
SDM Longitudinal Axis Recorded Velocity Change (MPH)	-11.52	-11.52	0.00	0.00	0.00	0.00	0.00	0.00	0.00	0.00	0.00	0.00	0.00	0.00	0.00

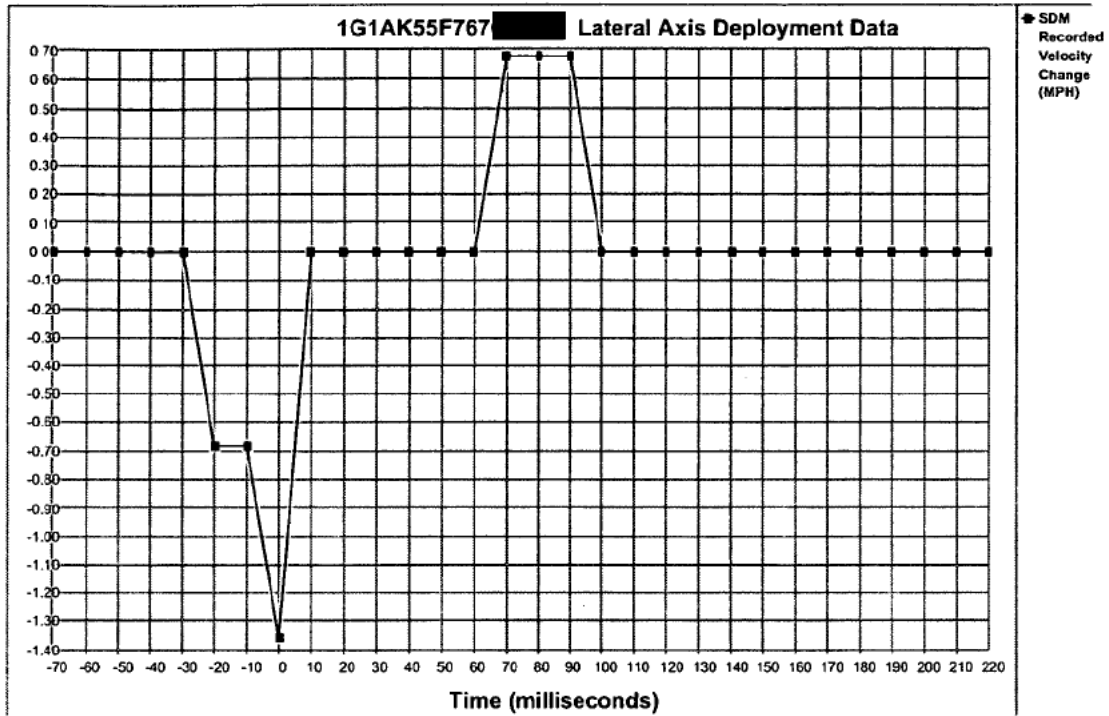
Time (milliseconds)	-70	-60	-50	-40	-30	-20	-10	0	10	20	30	40	50	60	70
SDM Lateral Axis Recorded Velocity Change (MPH)	0.00	0.00	0.00	0.00	0.00	-0.68	-0.68	-1.36	0.00	0.00	0.00	0.00	0.00	0.00	0.68
Time (milliseconds)	80	90	100	110	120	130	140	150	160	170	180	190	200	210	220
SDM Lateral Axis Recorded Velocity Change (MPH)	0.68	0.68	0.00	0.00	0.00	0.00	0.00	0.00	0.00	0.00	0.00	0.00	0.00	0.00	0.00

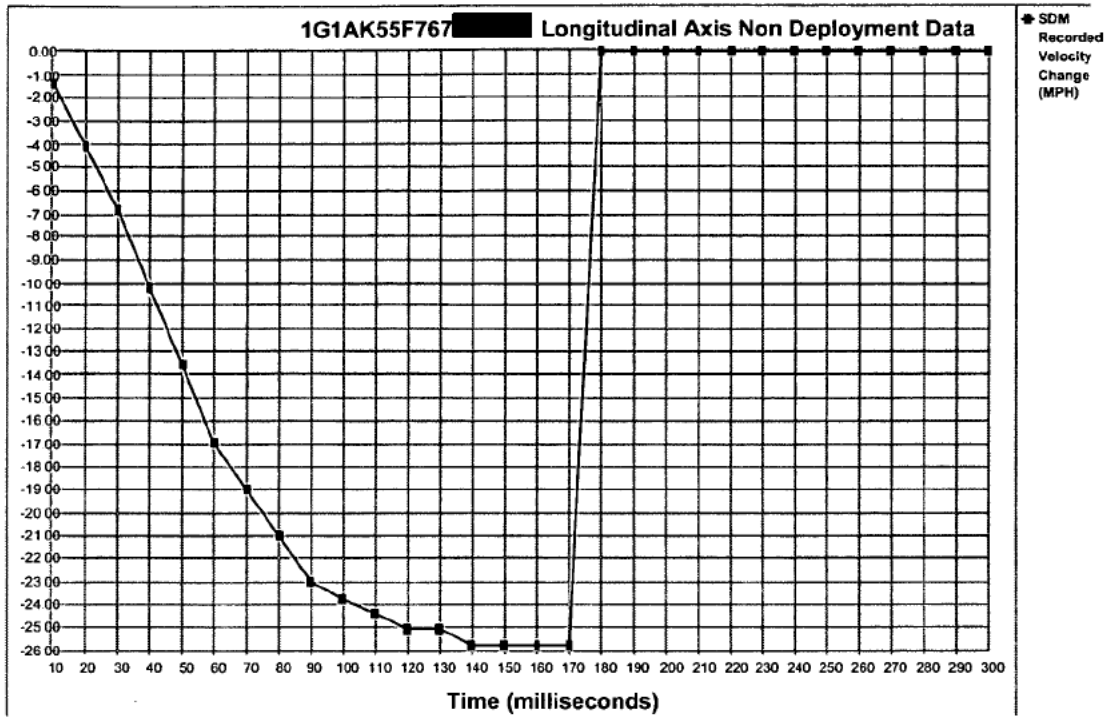
Time (milliseconds)	10	20	30	40	50	60	70	80	90	100	110	120	130	140	150
SDM Longitudinal Axis Recorded Velocity Change (MPH)	-1.36	-4.07	-6.78	-10.17	-13.55	-16.94	-18.98	-21.01	-23.04	-23.72	-24.40	-25.07	-25.07	-25.75	-25.75
Time (milliseconds)	160	170	180	190	200	210	220	230	240	250	260	270	280	290	300
SDM Longitudinal Axis Recorded Velocity Change (MPH)	-25.75	-25.75	0.00	0.00	0.00	0.00	0.00	0.00	0.00	0.00	0.00	0.00	0.00	0.00	0.00

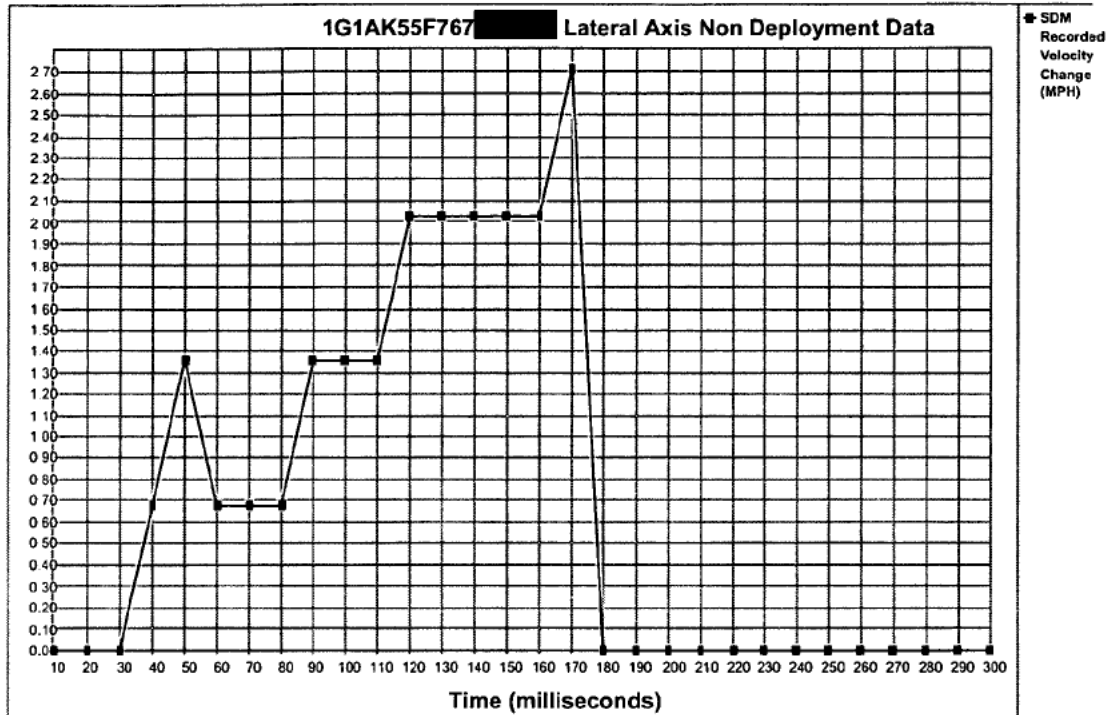
Time (milliseconds)	10	20	30	40	50	60	70	80	90	100	110	120	130	140	150
SDM Lateral Axis Recorded Velocity Change (MPH)	0.00	0.00	0.00	0.68	1.36	0.68	0.68	0.68	1.36	1.36	1.36	2.03	2.03	2.03	2.03
Time (milliseconds)	160	170	180	190	200	210	220	230	240	250	260	270	280	290	300
SDM Lateral Axis Recorded Velocity Change (MPH)	2.03	2.71	0.00	0.00	0.00	0.00	0.00	0.00	0.00	0.00	0.00	0.00	0.00	0.00	0.00
