EWR D&I ANNOTATION

FAN-000001L102001DP150-4219

DI10-107. SEQ ID 150. 2010 Q2. THIS REPORT INCLUDES A CALL LOG AND POLICE REPORT FOR A 2006 CHEVY COBALT. THE DRIVER WAS TRAVELLING ON A STREET WHEN AN ONCOMING VEHICLE TURNED IN FRONT OF THEM CAUSING A HEAD ON COLLISION. THE FRONT OF THE VEHICLE WAS TOTALLED. THE DRIVER STATES SHE WAS GOING ABOUT 30MPH AND IS WONDERING WHY THE AIR BAGS DID NOT DEPLOY. SHE SAID THE DEALERSHIP TOLD HER THE REASON WAS BECAUSE THE SENSOR IS UNDER THE HEADLIGHT. GM HAS DENIED THE COMPLAINT. WITH THIS YEARS MODEL THERE ARE: VOQ-22. PURSUITS-1. RECALL-0. *RM

NVS-217kb
DI10-107

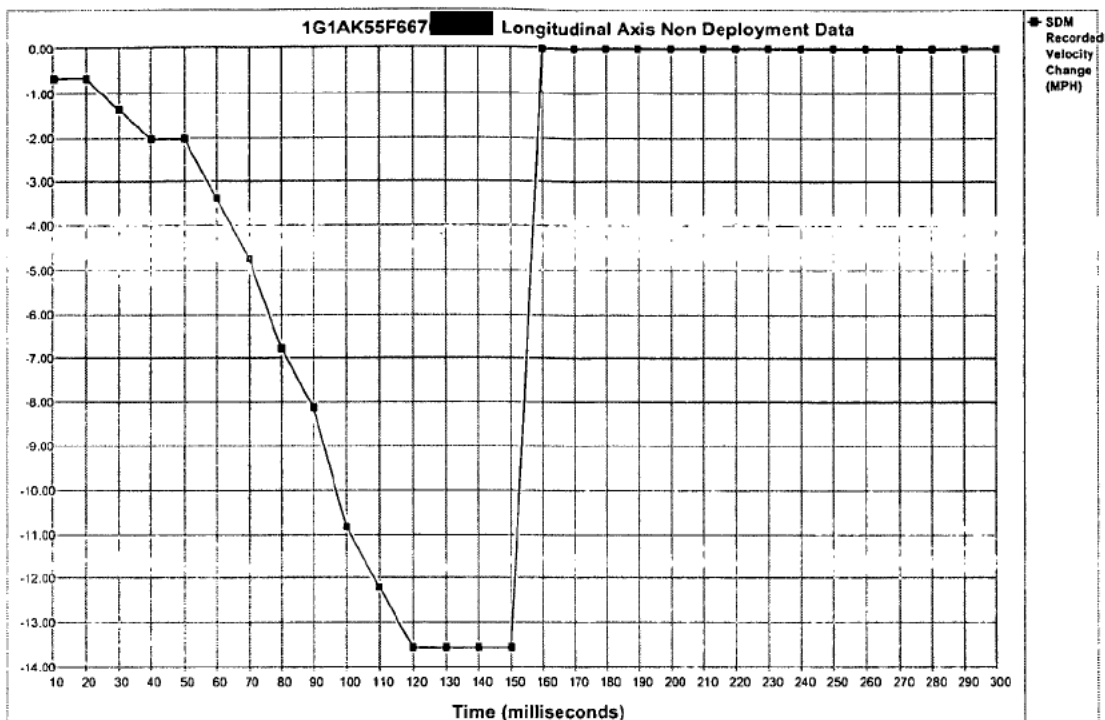
Pre-Crash Data

Parameter	-5 sec	-4 sec	-3 sec	-2 sec	-1 sec
Vehicle Speed (MPH)	25	25	25	26	25
Engine Speed (RPM)	1344	1344	1536	1344	1344
Percent Throttle	18	17	27	16	17
Accelerator Pedal Position (percent)	0	0	5	0	0
Antilock Brake System Active (If Equipped)	Invalid	Invalid	Invalid	Invalid	Invalid
Lateral Acceleration (feet/s ²) (If Equipped)	Invalid	Invalid	Invalid	Invalid	Invalid
Yaw Rate (degrees per second) (If Equipped)	Invalid	Invalid	Invalid	Invalid	Invalid
Steering Wheel Angle (degrees) (If Equipped)	0	0	0	0	0

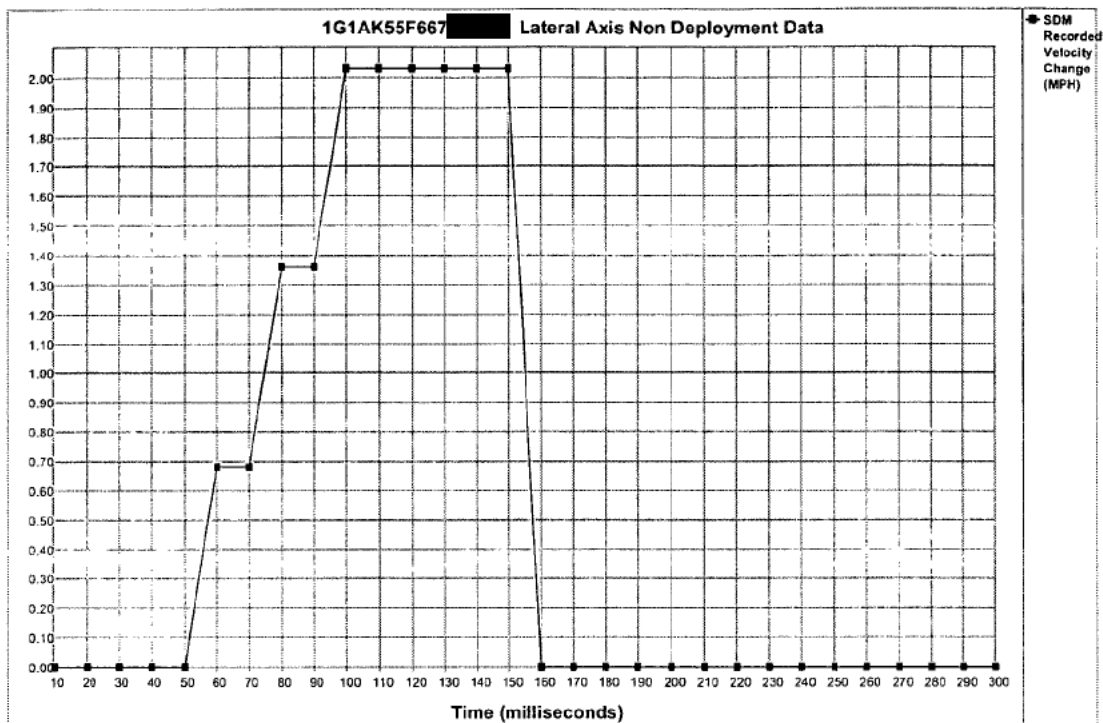
Time (milliseconds)	10	20	30	40	50	60	70	80	90	100	110	120	130	140	150
SDM Longitudinal Axis Recorded Velocity Change (MPH)	-0.68	-0.68	-1.36	-2.03	-2.03	-3.39	-4.74	-6.78	-8.13	-10.84	-12.20	-13.55	-13.55	-13.55	-13.55
Time (milliseconds)	160	170	180	190	200	210	220	230	240	250	260	270	280	290	300
SDM Longitudinal Axis Recorded Velocity Change (MPH)	0.00	0.00	0.00	0.00	0.00	0.00	0.00	0.00	0.00	0.00	0.00	0.00	0.00	0.00	0.00

Time (milliseconds)	10	20	30	40	50	60	70	80	90	100	110	120	130	140	150
SDM Lateral Axis Recorded Velocity Change (MPH)	0.00	0.00	0.00	0.00	0.00	0.68	0.68	1.36	1.36	2.03	2.03	2.03	2.03	2.03	2.03
Time (milliseconds)	160	170	180	190	200	210	220	230	240	250	260	270	280	290	300
SDM Lateral Axis Recorded Velocity Change (MPH)	0.00	0.00	0.00	0.00	0.00	0.00	0.00	0.00	0.00	0.00	0.00	0.00	0.00	0.00	0.00
